**LAUGHLIN RANCH OWNERS ASSOCIATION (NEIGHBORHOODS)**

## **Level 1 -- Full Reserve Study with Site Visit**

**Prepared By: Byron Goetting      NV Permit #072**

**Date of Site Inspection:      07/07/2017**

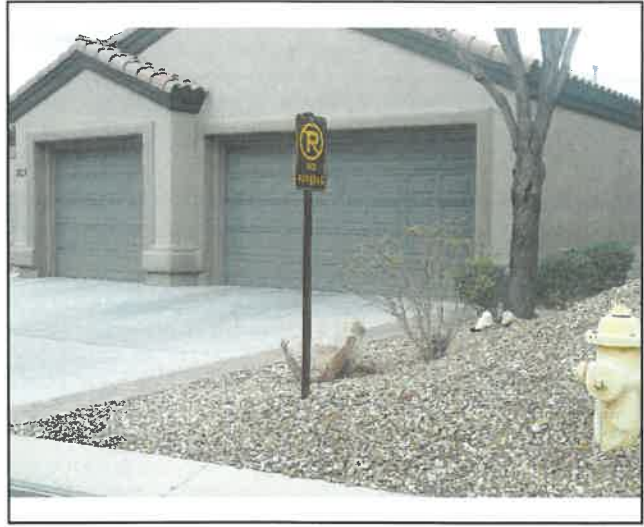
<b>Quantity:</b>	45 Signs	<b>Unit Cost:</b>	\$75.00
<b>Orig. Service:</b>	2007	<b>% of Unit Cost:</b>	100.0%
<b>Useful Life:</b>	15	<b>Total Current Cost:</b>	\$3,375.00
<b>RUL Adjustment:</b>	0	<b>Cost Explanation:</b>	Estimate to replace
<b>Rem. Useful Life:</b>	4	<b>Cost Source:</b>	GeoReserves Database
<b>Vendor:</b>			
<b>Description:</b>	This component includes the various traffic signs. These include the "Stop", "Speed Limit" and other traffic signs. If any sign becomes broken due to vandalism or other circumstance, it should be replaced immediately. However, in total, these signs have a useful life of approximately 15 years.		
<b>Evaluation:</b>	No problems with these signs noted.		
<b>Quantity Notes:</b>

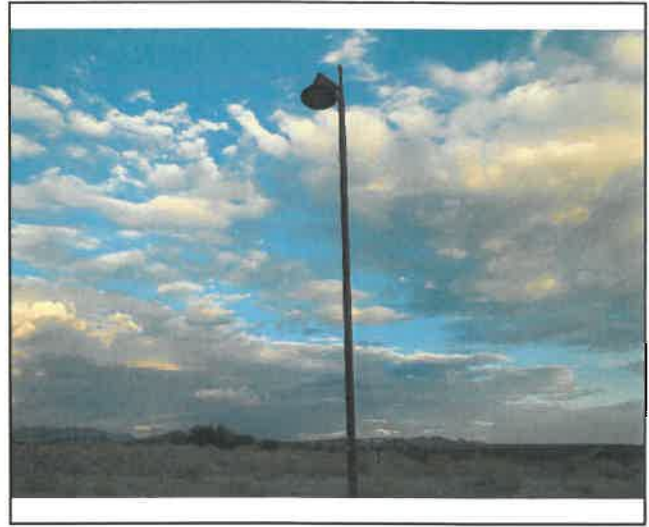
<b>Quantity:</b>	59 Light Poles	<b>Unit Cost:</b>	\$125.00
<b>Orig. Service:</b>	2012	<b>% of Unit Cost:</b>	100.0%
<b>Useful Life:</b>	5	<b>Total Current Cost:</b>	\$7,375.00
<b>RUL Adjustment:</b>	1	<b>Cost Explanation:</b>	Estimate to repaint
<b>Rem. Useful Life:</b>	0	<b>Cost Source:</b>	GeoReserves Database
<b>Vendor:</b>			
<b>Description:</b>	This component includes repainting and repairing the street light poles. These poles should be painted and inspected for repairs approximately every 5 years or when necessary. With proper maintenance the poles should have an extended useful life with no expectation to replace.		
<b>Evaluation:</b>	These light poles appeared painted and should be painted in the near future.		
<b>Quantity Notes:</b>

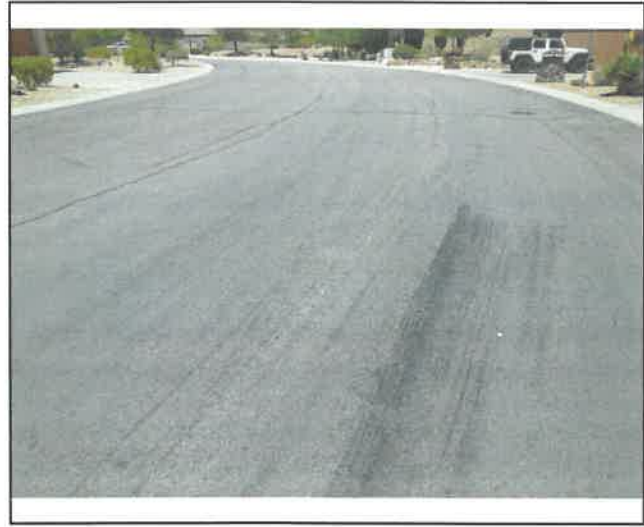
<b>Quantity:</b>	1347575 Sq.ft.	<b>Unit Cost:</b>	\$0.24
<b>Orig. Service:</b>	2015	<b>% of Unit Cost:</b>	100.0%
<b>Useful Life:</b>	6	<b>Total Current Cost:</b>	\$323,418.00
<b>RUL Adjustment:</b>	0	<b>Cost Explanation:</b>	Estimate for asphalt preservation
<b>Rem. Useful Life:</b>	3	<b>Cost Source:</b>	GeoReserves Database
<b>Vendor:</b>			
<b>Description:</b>	<p>The purpose of the asphalt streets is to provide a smooth driving experience, with adequate surface friction as well as to distribute the wheel load evenly to support weight and protect the natural soil. Different treatments may be applied to maintain and preserve the asphalt and underlying base. These include: crack sealing, fog seal, slurry seal, chip seal, microsurfacing, patching, and other types of repairs. Factors to be considered to determine the appropriate treatment include age, condition, homeowner preferences, and budget. This community should consult with an expert to determine the appropriate treatment and scope of work. Additional information can be found at <a href="http://www.asphaltpavement.org">www.asphaltpavement.org</a>, <a href="http://www.rtcsnv.com">www.rtcsnv.com</a>, and <a href="http://www.appliedpavement.com">www.appliedpavement.com</a>.</p>

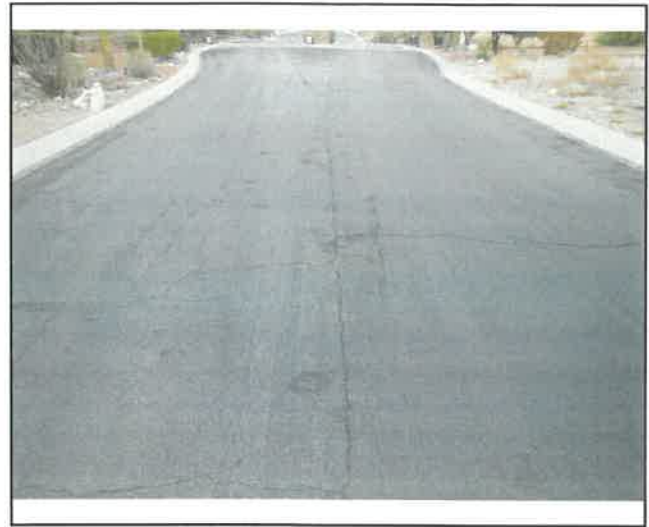
<b>Quantity:</b>	1347575 Sq.ft.	<b>Unit Cost:</b>	\$2.25
<b>Orig. Service:</b>	2007	<b>% of Unit Cost:</b>	100.0%
<b>Useful Life:</b>	36	<b>Total Current Cost:</b>	\$3,032,043.75
<b>RUL Adjustment:</b>	2	<b>Cost Explanation:</b>	Estimate for a major repair project
<b>Rem. Useful Life:</b>	27	<b>Cost Source:</b>	GeoReserves Database
<b>Vendor:</b>			
<b>Description:</b>	As the asphalt ages certain signs of damage may appear. These signs can include alligator cracking, block cracking, thermal cracking, potholes, raveling, and other issues. It is imperative that proper asphalt preservation and maintenance is performed to prevent these problems from developing prematurely. However, over time, the asphalt will begin to fail and more significant work will be needed. Major asphalt repair work can include a thin overlay, mill and overlay, or more significant reconstruction. It can be difficult to predict when this major repair work will occur, or the appropriate scope of work. It is therefore necessary for the community to continually consult the advice of an expert and develop a suitable maintenance plan. This component budgets for a major repair project to occur every 30 to 40 years.

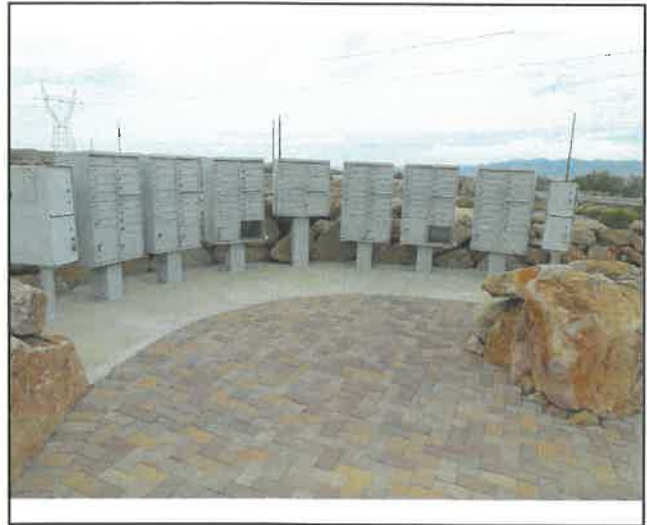
<b>Quantity:</b>	1 Area	<b>Unit Cost:</b>	\$17,000.00
<b>Orig. Service:</b>	2006	<b>% of Unit Cost:</b>	100.0%
<b>Useful Life:</b>	20	<b>Total Current Cost:</b>	\$17,000.00
<b>RUL Adjustment:</b>	0	<b>Cost Explanation:</b>	Estimate to replace CBUs and refurbish area
<b>Rem. Useful Life:</b>	8	<b>Cost Source:</b>	GeoReserves Database
<b>Vendor:</b>			
<b>Description:</b>	This component funds to replace the Cluster Box Units (CBU's) and make any other repairs, refurbishments, or replacements to the surrounding mailbox area such as any concrete pavers, standard concrete, rock wall, or other associated costs. Current standard Cluster Box Units (CBU's) are usually made of a heavy duty aluminum and stainless steel hardware and should be replaced every 20 years. Some of the paint may fade or peel, and other minor issues may arise which can be addressed as an operating expense.		
<b>Evaluation:</b>	Usually these CBUs will show some minor cosmetic issues such as faded or peeling paint. However, no major functionality problems were noted at time of site visit.

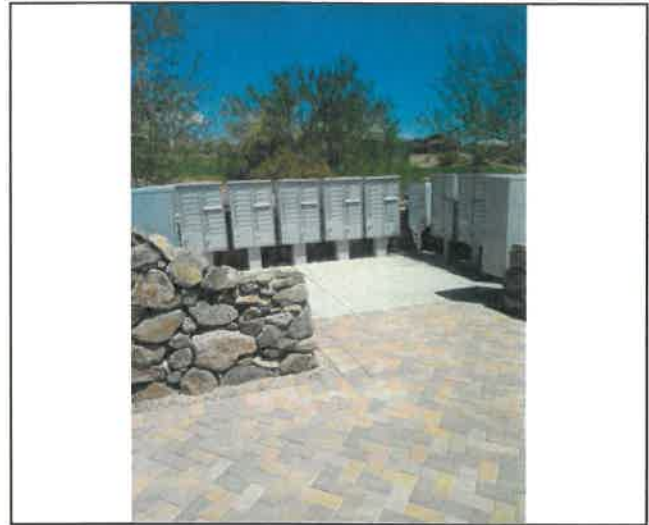
<b>Quantity:</b>	1 Area	<b>Unit Cost:</b>	\$25,000.00
<b>Orig. Service:</b>	2006	<b>% of Unit Cost:</b>	100.0%
<b>Useful Life:</b>	20	<b>Total Current Cost:</b>	\$25,000.00
<b>RUL Adjustment:</b>	0	<b>Cost Explanation:</b>	Estimate to replace CBUs and refurbish area
<b>Rem. Useful Life:</b>	8	<b>Cost Source:</b>	GeoReserves Database
<b>Vendor:</b>			
<b>Description:</b>	This component funds to replace the Cluster Box Units (CBU's) and make any other repairs, refurbishments, or replacements to the surrounding mailbox area such as any concrete pavers, standard concrete, rock wall, or other associated costs. Current standard Cluster Box Units (CBU's) are usually made of a heavy duty aluminum and stainless steel hardware and should be replaced every 20 years. Some of the paint may fade or peel, and other minor issues may arise which can be addressed as an operating expense.		
<b>Evaluation:</b>	Usually these CBUs will show some minor cosmetic issues such as faded or peeling paint. However, no major functionality problems were noted at time of site visit.

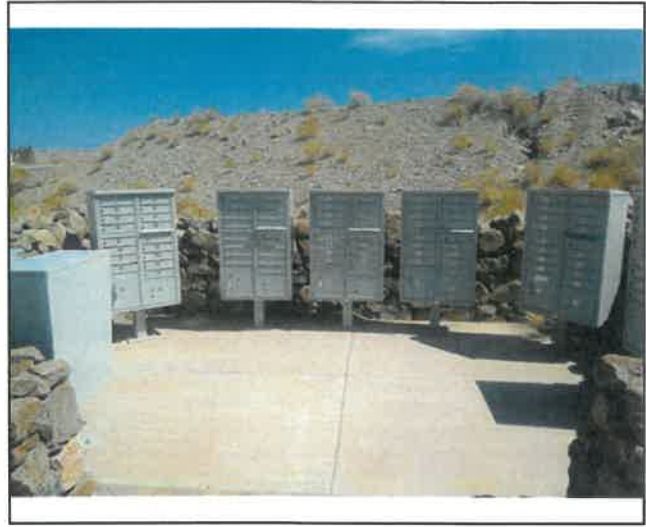
<b>Quantity:</b>	1 Area	<b>Unit Cost:</b>	\$15,000.00
<b>Orig. Service:</b>	2006	<b>% of Unit Cost:</b>	100.0%
<b>Useful Life:</b>	20	<b>Total Current Cost:</b>	\$15,000.00
<b>RUL Adjustment:</b>	0	<b>Cost Explanation:</b>	Estimate to replace CBUs and refurbish area
<b>Rem. Useful Life:</b>	8	<b>Cost Source:</b>	GeoReserves Database
<b>Vendor:</b>			
<b>Description:</b>	This component funds to replace the Cluster Box Units (CBU's) and make any other repairs, refurbishments, or replacements to the surrounding mailbox area such as any concrete pavers, standard concrete, rock wall, or other associated costs. Current standard Cluster Box Units (CBU's) are usually made of a heavy duty aluminum and stainless steel hardware and should be replaced every 20 years. Some of the paint may fade or peel, and other minor issues may arise which can be addressed as an operating expense.		
<b>Evaluation:</b>	Usually these CBUs will show some minor cosmetic issues such as faded or peeling paint. However, no major functionality problems were noted at time of site visit.

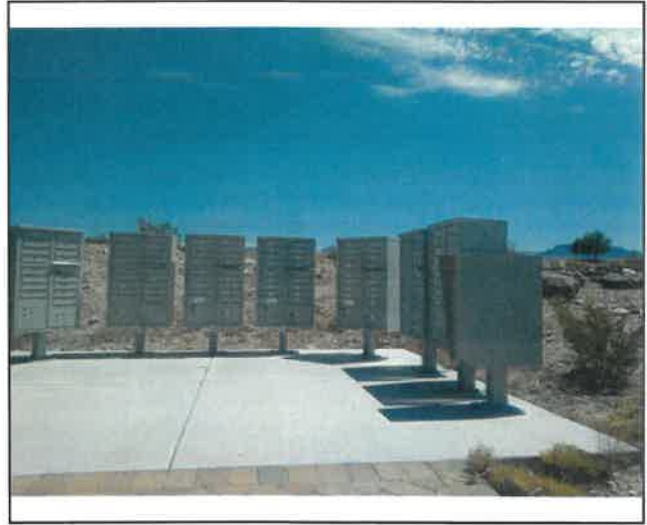
<b>Quantity:</b>	1 Area	<b>Unit Cost:</b>	\$19,000.00
<b>Orig. Service:</b>	2006	<b>% of Unit Cost:</b>	100.0%
<b>Useful Life:</b>	20	<b>Total Current Cost:</b>	\$19,000.00
<b>RUL Adjustment:</b>	0	<b>Cost Explanation:</b>	Estimate to replace CBUs and refurbish area
<b>Rem. Useful Life:</b>	8	<b>Cost Source:</b>	GeoReserves Database
<b>Vendor:</b>			
<b>Description:</b>	This component funds to replace the Cluster Box Units (CBU's) and make any other repairs, refurbishments, or replacements to the surrounding mailbox area such as any concrete pavers, standard concrete, rock wall, or other associated costs. Current standard Cluster Box Units (CBU's) are usually made of a heavy duty aluminum and stainless steel hardware and should be replaced every 20 years. Some of the paint may fade or peel, and other minor issues may arise which can be addressed as an operating expense.		
<b>Evaluation:</b>	Usually these CBUs will show some minor cosmetic issues such as faded or peeling paint. However, no major functionality problems were noted at time of site visit.

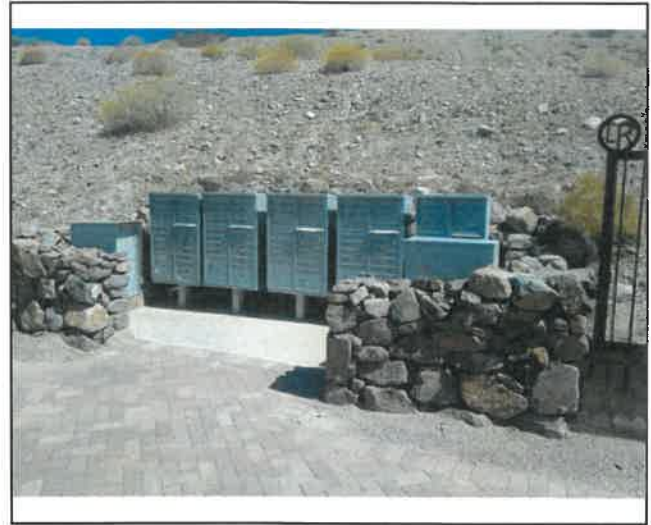
<b>Quantity:</b>	1 Area	<b>Unit Cost:</b>	\$13,000.00
<b>Orig. Service:</b>	2006	<b>% of Unit Cost:</b>	100.0%
<b>Useful Life:</b>	20	<b>Total Current Cost:</b>	\$13,000.00
<b>RUL Adjustment:</b>	0	<b>Cost Explanation:</b>	Estimate to replace CBUs and refurbish area
<b>Rem. Useful Life:</b>	8	<b>Cost Source:</b>	GeoReserves Database
<b>Vendor:</b>			
<b>Description:</b>	This component funds to replace the Cluster Box Units (CBU's) and make any other repairs, refurbishments, or replacements to the surrounding mailbox area such as any concrete pavers, standard concrete, rock wall, or other associated costs. Current standard Cluster Box Units (CBU's) are usually made of a heavy duty aluminum and stainless steel hardware and should be replaced every 20 years. Some of the paint may fade or peel, and other minor issues may arise which can be addressed as an operating expense.		
<b>Evaluation:</b>	Usually these CBUs will show some minor cosmetic issues such as faded or peeling paint. However, no major functionality problems were noted at time of site visit.

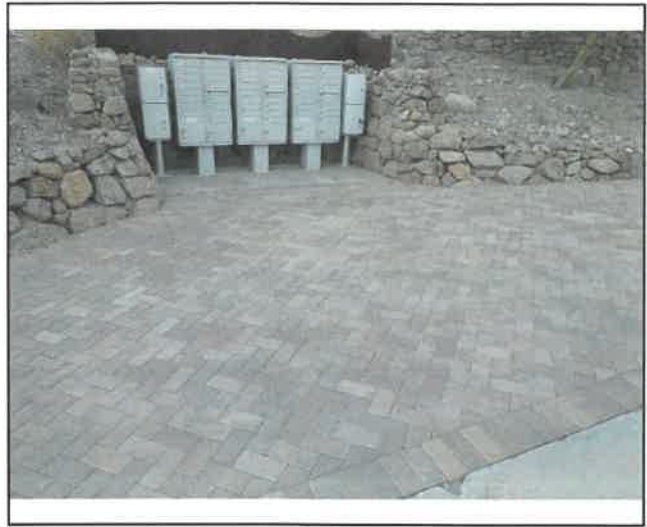
<b>Quantity:</b>	1 Area	<b>Unit Cost:</b>	\$9,000.00
<b>Orig. Service:</b>	2006	<b>% of Unit Cost:</b>	100.0%
<b>Useful Life:</b>	20	<b>Total Current Cost:</b>	\$9,000.00
<b>RUL Adjustment:</b>	0	<b>Cost Explanation:</b>	Estimate to replace CBU's and refurbish area
<b>Rem. Useful Life:</b>	8	<b>Cost Source:</b>	GeoReserves Database
<b>Vendor:</b>			
<b>Description:</b>	This component funds to replace the Cluster Box Units (CBU's) and make any other repairs, refurbishments, or replacements to the surrounding mailbox area such as any concrete pavers, standard concrete, rock wall, or other associated costs. Current standard Cluster Box Units (CBU's) are usually made of a heavy duty aluminum and stainless steel hardware and should be replaced every 20 years. Some of the paint may fade or peel, and other minor issues may arise which can be addressed as an operating expense.		
<b>Evaluation:</b>	Usually these CBU's will show some minor cosmetic issues such as faded or peeling paint. However, no major functionality problems were noted at time of site visit.

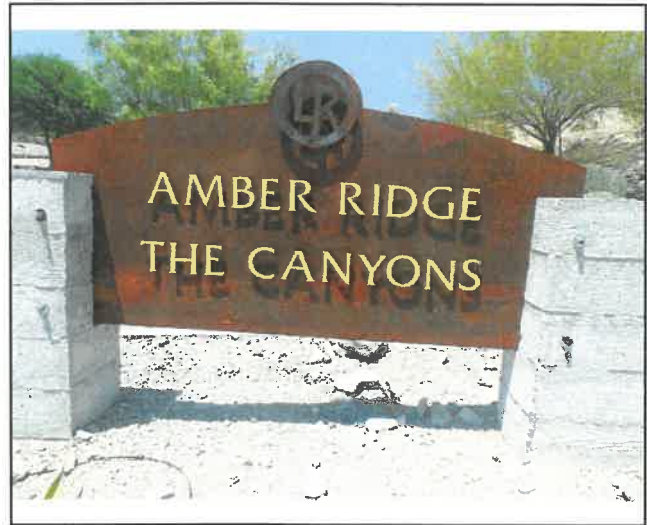
<b>Quantity:</b>	1 Monument	<b>Unit Cost:</b>	\$5,000.00
<b>Orig. Service:</b>	2016	<b>% of Unit Cost:</b>	100.0%
<b>Useful Life:</b>	20	<b>Total Current Cost:</b>	\$5,000.00
<b>RUL Adjustment:</b>	0	<b>Cost Explanation:</b>	Estimate to refurbish
<b>Rem. Useful Life:</b>	18	<b>Cost Source:</b>	GeoReserves Database
<b>Vendor:</b>			
<b>Description:</b>	Monuments can come in a wide range of sizes, materials, and designs. However, over time they will eventually need to be updated to maintain appearance and to keep a current look. This component can include a general refurbishment or a complete replacement. The cost and useful life of this project can vary depending on what type of monument the association has installed. Any minor repairs should be done regularly as an operating expense.		
<b>Evaluation:</b>	No major appearance concerns noted.		
<b>Quantity Notes:</b>

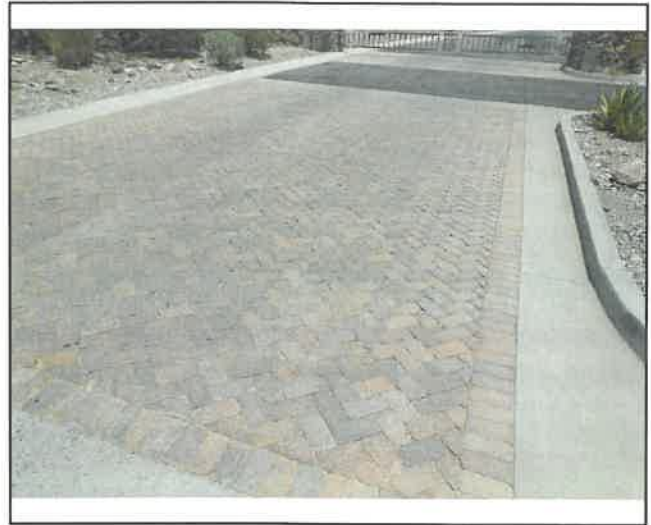
<b>Quantity:</b>	1450 Sq.ft.	<b>Unit Cost:</b>	\$10.00
<b>Orig. Service:</b>	2007	<b>% of Unit Cost:</b>	15.0%
<b>Useful Life:</b>	10	<b>Total Current Cost:</b>	\$2,175.00
<b>RUL Adjustment:</b>	5	<b>Cost Explanation:</b>	Estimate to make repairs
<b>Rem. Useful Life:</b>	4	<b>Cost Source:</b>	GeoReserves Database
<b>Vendor:</b>			
<b>Description:</b>	This component includes making any repairs to the concrete pavers. These pavers should have a very long useful life. However, over time some pavers may break and repairs and replacements will be necessary. This component funds to repair and replace 15% of the total area every 10 years. This schedule may need to be adjusted as a cost history is developed.		
<b>Evaluation:</b>	No problems noted.		
<b>Quantity Notes:</b>

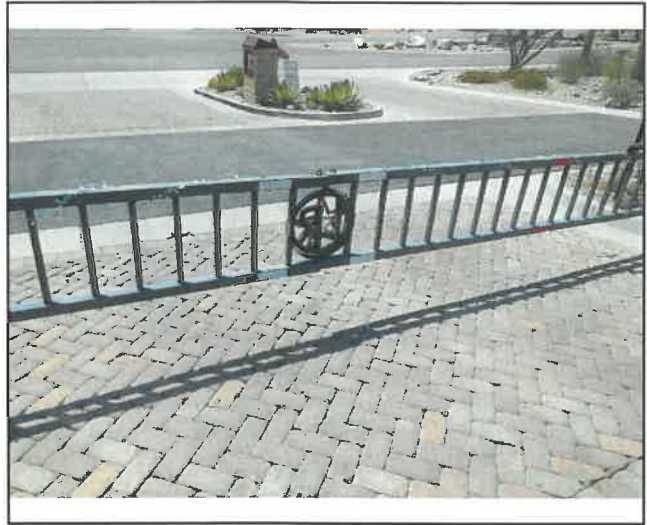
<b>Quantity:</b>	4 Vehicle Gates	<b>Unit Cost:</b>	\$2,500.00
<b>Orig. Service:</b>	2015	<b>% of Unit Cost:</b>	100.0%
<b>Useful Life:</b>	30	<b>Total Current Cost:</b>	\$10,000.00
<b>RUL Adjustment:</b>	0	<b>Cost Explanation:</b>	Estimate to replace
<b>Rem. Useful Life:</b>	27	<b>Cost Source:</b>	GeoReserves Database
<b>Vendor:</b>			
<b>Description:</b>	This component includes replacing the vehicle gates. These gates should last approximately 25 to 30 years before they should be replaced to improve the appearance of the entrance area. Any accidents from cars hitting these gates should be considered an insurance issue and not a normal reserve expense. Additional information can be found at <a href="http://iframe.americanfenceassociation.com">iframe.americanfenceassociation.com</a> .		
<b>Evaluation:</b>	No problems with these gates noted.		
<b>Quantity Notes:</b>

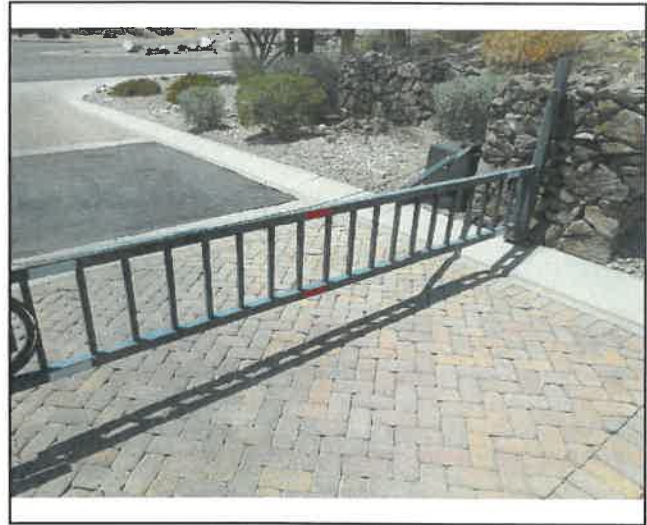
<b>Quantity:</b>	4 Gate Leafs	<b>Unit Cost:</b>	\$125.00
<b>Orig. Service:</b>	2015	<b>% of Unit Cost:</b>	100.0%
<b>Useful Life:</b>	5	<b>Total Current Cost:</b>	\$500.00
<b>RUL Adjustment:</b>	0	<b>Cost Explanation:</b>	Estimate to repaint
<b>Rem. Useful Life:</b>	2	<b>Cost Source:</b>	GeoReserves Database
<b>Vendor:</b>			
<b>Description:</b>	This component includes painting the gates, along with making any repairs to bent or rusted areas. This project should be performed every 5 years or when necessary to maintain appearance and ensure the fence realizes a full useful life. Different paint materials and techniques will determine the actual useful life and may result in adjusting this schedule.		
<b>Evaluation:</b>	No rusting or other appearance concerns such as faded paint noted.		
<b>Quantity Notes:</b>

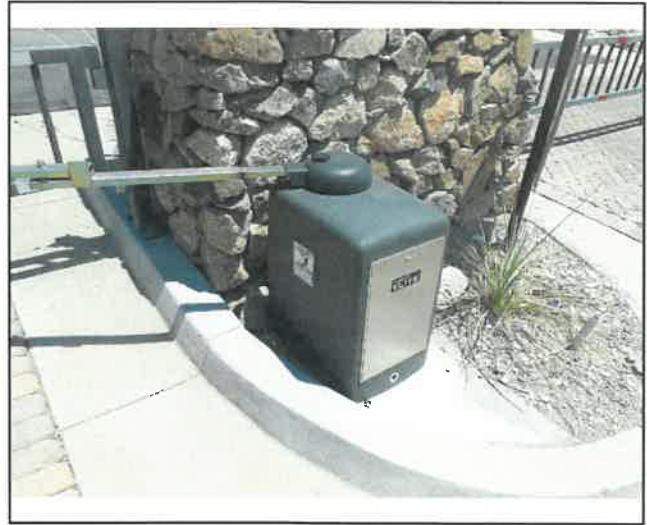
<b>Quantity:</b>	4 Gate Operators	<b>Unit Cost:</b>	\$125.00
<b>Orig. Service:</b>	2017	<b>% of Unit Cost:</b>	100.0%
<b>Useful Life:</b>	1	<b>Total Current Cost:</b>	\$500.00
<b>RUL Adjustment:</b>	0	<b>Cost Explanation:</b>	Estimate to make repairs and replacements
<b>Rem. Useful Life:</b>	0	<b>Cost Source:</b>	GeoReserves Database
<b>Vendor:</b>			
<b>Description:</b>	This component includes the battery backups, which are replaced every year as a reserve expense. This component also funds for any additional parts may need to be repaired or replaced as necessary.		
<b>Evaluation:</b>	No operational problems noted. This site visit does not include any mechanical testing and a maintenance plan with frequent inspections from a trained professional is recommended.		
<b>Quantity Notes:</b>

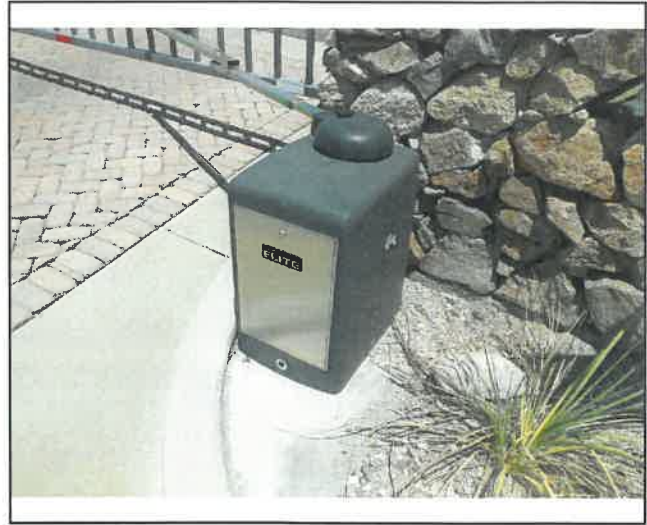
<b>Quantity:</b>	4 Gate Operators	<b>Unit Cost:</b>	\$4,000.00
<b>Orig. Service:</b>	2015	<b>% of Unit Cost:</b>	100.0%
<b>Useful Life:</b>	12	<b>Total Current Cost:</b>	\$16,000.00
<b>RUL Adjustment:</b>	0	<b>Cost Explanation:</b>	Estimate to replace
<b>Rem. Useful Life:</b>	9	<b>Cost Source:</b>	GeoReserves Database
<b>Vendor:</b>			
<b>Description:</b>	This component includes replacing the entire gate operator unit. During the normal life of these gate operators certain parts, such as battery backups, circuit boards and motors may need to be repaired or replaced. For most associations, these minor costs should be considered an operating expense. Gate operators should last between 10 to 12 years however the actual life could be longer if individual parts are routinely replaced. Additional information can be found at <a href="http://www.dasma.com">www.dasma.com</a> .		
<b>Evaluation:</b>	These gate operators were functioning normally at time of site visit with no problems noted.

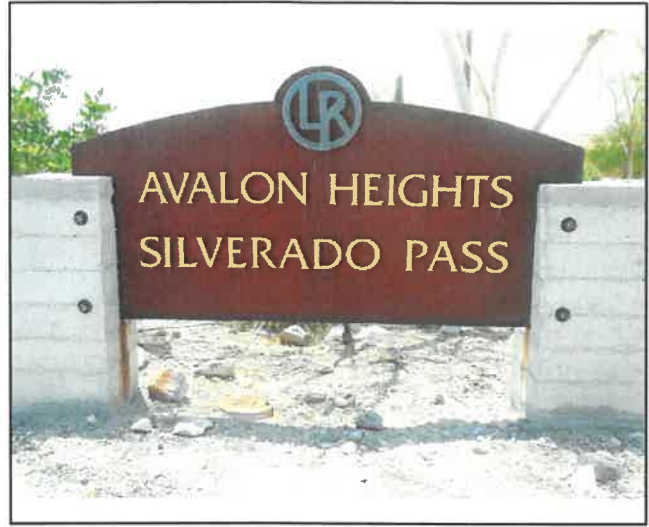
<b>Quantity:</b>	1 Monument	<b>Unit Cost:</b>	\$5,000.00
<b>Orig. Service:</b>	2006	<b>% of Unit Cost:</b>	100.0%
<b>Useful Life:</b>	20	<b>Total Current Cost:</b>	\$5,000.00
<b>RUL Adjustment:</b>	0	<b>Cost Explanation:</b>	Estimate to refurbish
<b>Rem. Useful Life:</b>	8	<b>Cost Source:</b>	GeoReserves Database
<b>Vendor:</b>			
<b>Description:</b>	Monuments can come in a wide range of sizes, materials, and designs. However, over time they will eventually need to be updated to maintain appearance and to keep a current look. This component can include a general refurbishment or a complete replacement. The cost and useful life of this project can vary depending on what type of monument the association has installed. Any minor repairs should be done regularly as an operating expense.		
<b>Evaluation:</b>	No major appearance concerns noted.		
<b>Quantity Notes:</b>

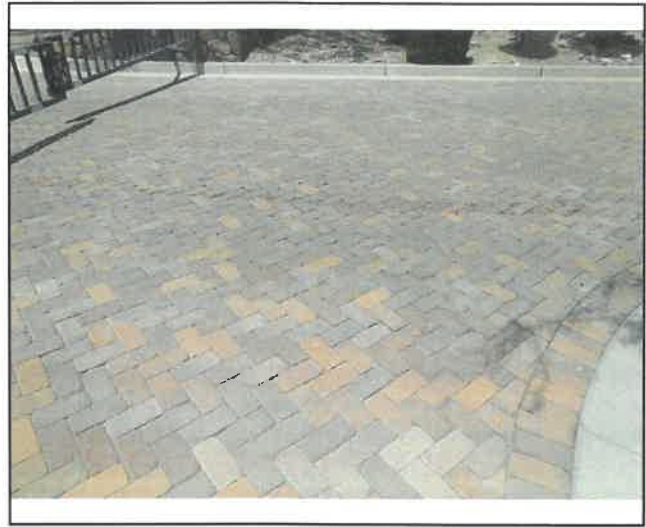
<b>Quantity:</b>	1950 Sq.ft.	<b>Unit Cost:</b>	\$10.00
<b>Orig. Service:</b>	2007	<b>% of Unit Cost:</b>	15.0%
<b>Useful Life:</b>	10	<b>Total Current Cost:</b>	\$2,925.00
<b>RUL Adjustment:</b>	5	<b>Cost Explanation:</b>	Estimate to repair and replace
<b>Rem. Useful Life:</b>	4	<b>Cost Source:</b>	GeoReserves Database
<b>Vendor:</b>			
<b>Description:</b>	This component includes making any repairs to the concrete pavers. These pavers should have a very long useful life. However, over time some pavers may break and repairs and replacements will be necessary. This component funds to repair and replace 15% of the total area every 10 years. This schedule may need to be adjusted as a cost history is developed.		
<b>Evaluation:</b>	No problems noted.		
<b>Quantity Notes:</b>

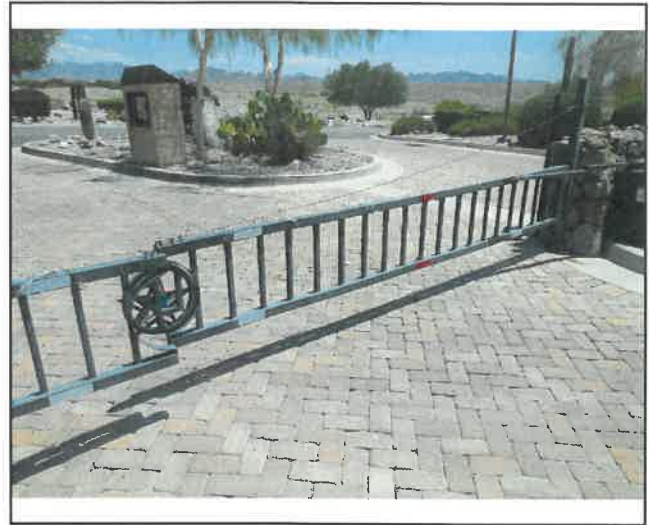
<b>Quantity:</b>	4 Gate Leafs	<b>Unit Cost:</b>	\$2,500.00
<b>Orig. Service:</b>	2007	<b>% of Unit Cost:</b>	100.0%
<b>Useful Life:</b>	30	<b>Total Current Cost:</b>	\$10,000.00
<b>RUL Adjustment:</b>	0	<b>Cost Explanation:</b>	Estimate to replace
<b>Rem. Useful Life:</b>	19	<b>Cost Source:</b>	GeoReserves Database
<b>Vendor:</b>			
<b>Description:</b>	This component includes replacing the vehicle gates. These gates should last approximately 25 to 30 years before they should be replaced to improve the appearance of the entrance area. Any accidents from cars hitting these gates should be considered an insurance issue and not a normal reserve expense. Additional information can be found at <a href="http://iframe.americanfenceassociation.com">iframe.americanfenceassociation.com</a> .		
<b>Evaluation:</b>	No problems with these gates noted.		
<b>Quantity Notes:</b>

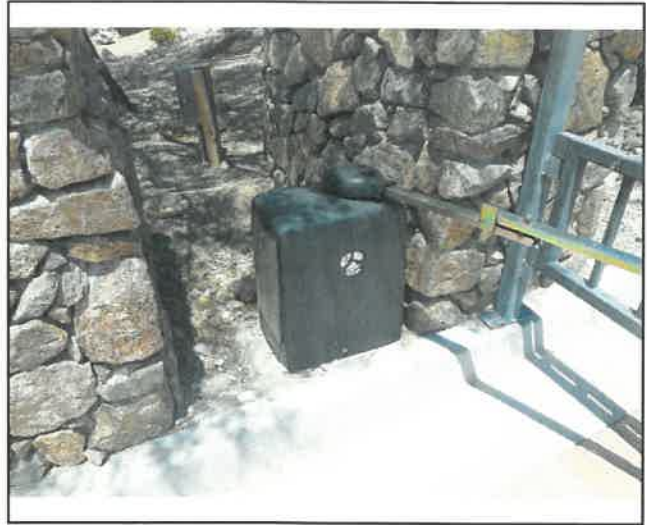
<b>Quantity:</b>	4 Gate Operators	<b>Unit Cost:</b>	\$125.00
<b>Orig. Service:</b>	2017	<b>% of Unit Cost:</b>	100.0%
<b>Useful Life:</b>	1	<b>Total Current Cost:</b>	\$500.00
<b>RUL Adjustment:</b>	0	<b>Cost Explanation:</b>	Estimate to make repairs and replacements
<b>Rem. Useful Life:</b>	0	<b>Cost Source:</b>	GeoReserves Database
<b>Vendor:</b>			
<b>Description:</b>	This component includes the battery backups, which are replaced every year as a reserve expense. This component also funds for any additional parts may need to be repaired or replaced as necessary.		
<b>Evaluation:</b>	No operational problems noted. This site visit does not include any mechanical testing and a maintenance plan with frequent inspections from a trained professional is recommended.		
<b>Quantity Notes:</b>

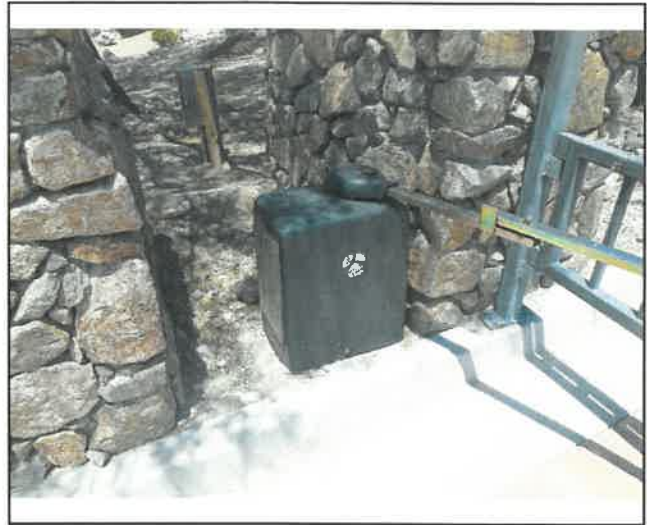
<b>Quantity:</b>	4 Gate Operators	<b>Unit Cost:</b>	\$4,000.00
<b>Orig. Service:</b>	2017	<b>% of Unit Cost:</b>	100.0%
<b>Useful Life:</b>	12	<b>Total Current Cost:</b>	\$16,000.00
<b>RUL Adjustment:</b>	0	<b>Cost Explanation:</b>	Estimate to replace
<b>Rem. Useful Life:</b>	11	<b>Cost Source:</b>	GeoReserves Database
<b>Vendor:</b>			
<b>Description:</b>	This component includes replacing the entire gate operator unit. During the normal life of these gate operators certain parts, such as battery backups, circuit boards and motors may need to be repaired or replaced. For most associations, these minor costs should be considered an operating expense. Gate operators should last between 10 to 12 years however the actual life could be longer if individual parts are routinely replaced. Additional information can be found at <a href="http://www.dasma.com">www.dasma.com</a> .		
<b>Evaluation:</b>	These gate operators were functioning normally at time of site visit with no problems noted.

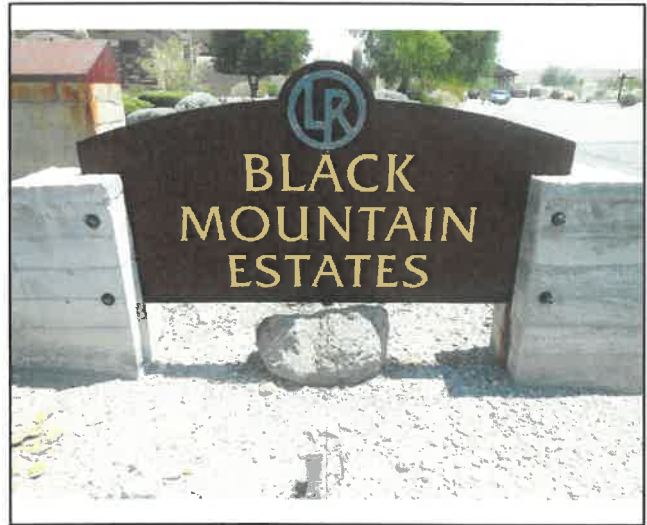
<b>Quantity:</b>	1 Monument	<b>Unit Cost:</b>	\$5,000.00
<b>Orig. Service:</b>	2006	<b>% of Unit Cost:</b>	100.0%
<b>Useful Life:</b>	20	<b>Total Current Cost:</b>	\$5,000.00
<b>RUL Adjustment:</b>	0	<b>Cost Explanation:</b>	Estimate to refurbish
<b>Rem. Useful Life:</b>	8	<b>Cost Source:</b>	GeoReserves Database
<b>Vendor:</b>			
<b>Description:</b>	Monuments can come in a wide range of sizes, materials, and designs. However, over time they will eventually need to be updated to maintain appearance and to keep a current look. This component can include a general refurbishment or a complete replacement. The cost and useful life of this project can vary depending on what type of monument the association has installed. Any minor repairs should be done regularly as an operating expense.		
<b>Evaluation:</b>	No major appearance concerns noted.		
<b>Quantity Notes:</b>

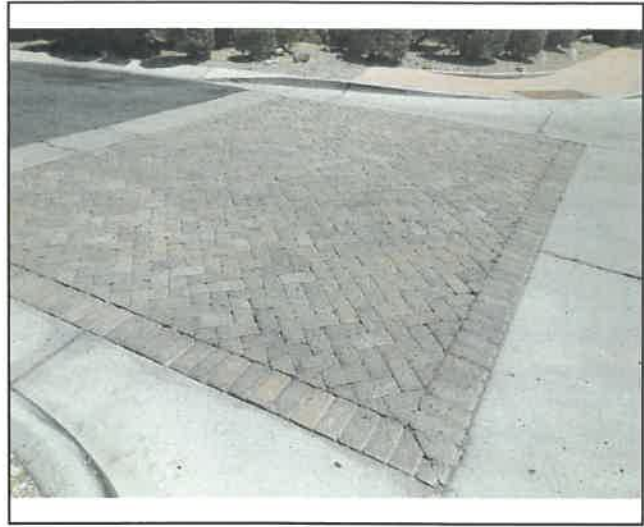
<b>Quantity:</b>	1500 Sq.ft.	<b>Unit Cost:</b>	\$10.00
<b>Orig. Service:</b>	2007	<b>% of Unit Cost:</b>	15.0%
<b>Useful Life:</b>	10	<b>Total Current Cost:</b>	\$2,250.00
<b>RUL Adjustment:</b>	5	<b>Cost Explanation:</b>	Estimate to repair
<b>Rem. Useful Life:</b>	4	<b>Cost Source:</b>	GeoReserves Database
<b>Vendor:</b>			
<b>Description:</b>	This component includes making any repairs to the concrete pavers. These pavers should have a very long useful life. However, over time some pavers may break and repairs and replacments will be necessary. This component funds to repair and replace 15% of the total area every 10 years. This schedule may need to be adjusted as a cost history is developed.		
<b>Evaluation:</b>	No problems noted.		
<b>Quantity Notes:</b>

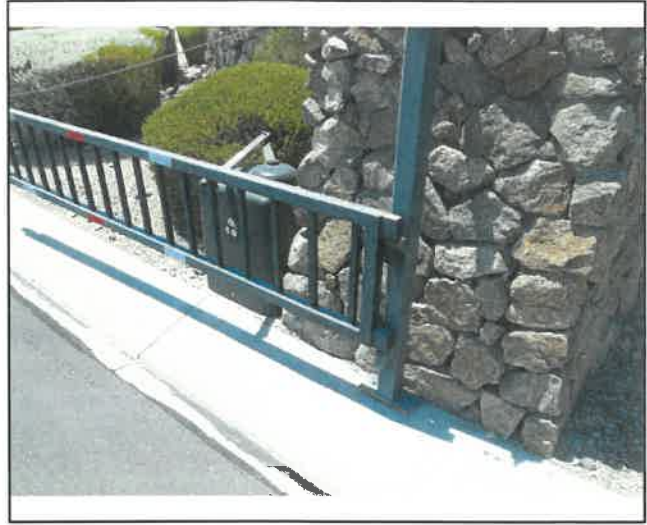
<b>Quantity:</b>	4 Gate Leafs	<b>Unit Cost:</b>	\$2,500.00
<b>Orig. Service:</b>	2007	<b>% of Unit Cost:</b>	100.0%
<b>Useful Life:</b>	30	<b>Total Current Cost:</b>	\$10,000.00
<b>RUL Adjustment:</b>	0	<b>Cost Explanation:</b>	Estimate to replace
<b>Rem. Useful Life:</b>	19	<b>Cost Source:</b>	GeoReserves Database
<b>Vendor:</b>			
<b>Description:</b>	This component includes replacing the vehicle gates. These gates should last approximately 25 to 30 years before they should be replaced to improve the appearance of the entrance area. Any accidents from cars hitting these gates should be considered an insurance issue and not a normal reserve expense. Additional information can be found at <a href="http://iframe.americanfenceassociation.com">iframe.americanfenceassociation.com</a> .		
<b>Evaluation:</b>	No problems with these gates noted.		
<b>Quantity Notes:</b>

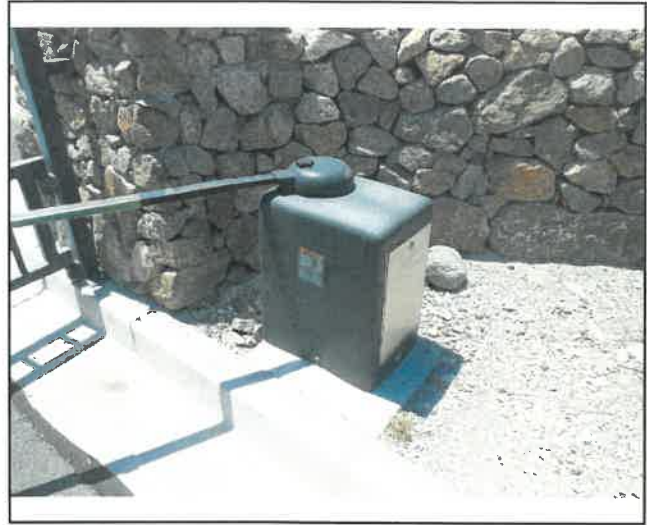
<b>Quantity:</b>	4 Gate Operators	<b>Unit Cost:</b>	\$125.00
<b>Orig. Service:</b>	2017	<b>% of Unit Cost:</b>	100.0%
<b>Useful Life:</b>	1	<b>Total Current Cost:</b>	\$500.00
<b>RUL Adjustment:</b>	0	<b>Cost Explanation:</b>	Estimate to make repairs and replacements
<b>Rem. Useful Life:</b>	0	<b>Cost Source:</b>	GeoReserves Database
<b>Vendor:</b>			
<b>Description:</b>	This component includes the battery backups, which are replaced every year as a reserve expense. This component also funds for any additional parts may need to be repaired or replaced as necessary.		
<b>Evaluation:</b>	No operational problems noted. This site visit does not include any mechanical testing and a maintenance plan with frequent inspections from a trained professional is recommended.		
<b>Quantity Notes:</b>

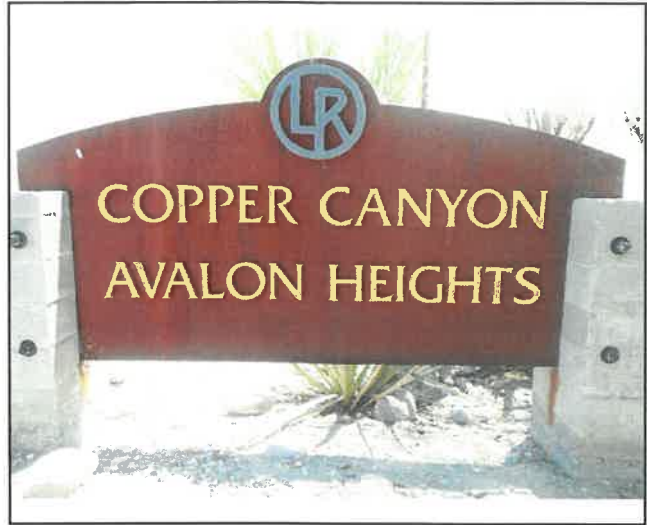
<b>Quantity:</b>	1 Monument	<b>Unit Cost:</b>	\$5,000.00
<b>Orig. Service:</b>	2006	<b>% of Unit Cost:</b>	100.0%
<b>Useful Life:</b>	20	<b>Total Current Cost:</b>	\$5,000.00
<b>RUL Adjustment:</b>	0	<b>Cost Explanation:</b>	Estimate to refurbish
<b>Rem. Useful Life:</b>	8	<b>Cost Source:</b>	GeoReserves Database
<b>Vendor:</b>			
<b>Description:</b>	Monuments can come in a wide range of sizes, materials, and designs. However, over time they will eventually need to be updated to maintain appearance and to keep a current look. This component can include a general refurbishment or a complete replacement. The cost and useful life of this project can vary depending on what type of monument the association has installed. Any minor repairs should be done regularly as an operating expense.		
<b>Evaluation:</b>	No major appearance concerns noted.		
<b>Quantity Notes:</b>

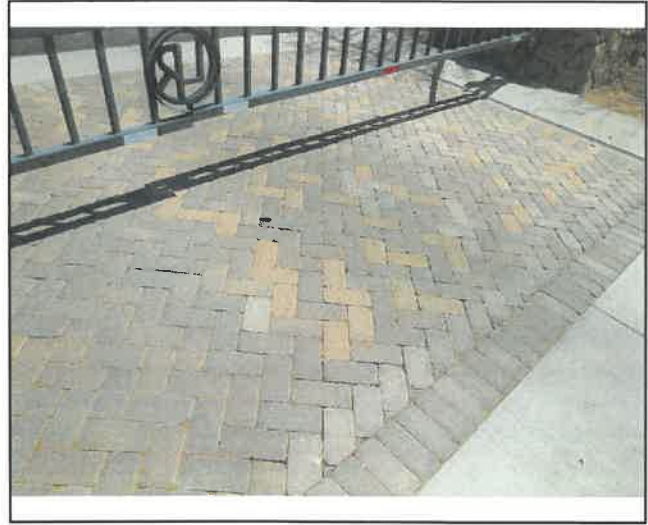
<b>Quantity:</b>	1150 Sq.ft.	<b>Unit Cost:</b>	\$10.00
<b>Orig. Service:</b>	2007	<b>% of Unit Cost:</b>	15.0%
<b>Useful Life:</b>	10	<b>Total Current Cost:</b>	\$1,725.00
<b>RUL Adjustment:</b>	5	<b>Cost Explanation:</b>	Estimate to repair
<b>Rem. Useful Life:</b>	4	<b>Cost Source:</b>	GeoReserves Database
<b>Vendor:</b>			
<b>Description:</b>	This component includes making any repairs to the concrete pavers. These pavers should have a very long useful life. However, over time some pavers may break and repairs and replacements will be necessary. This component funds to repair and replace 15% of the total area every 10 years. This schedule may need to be adjusted as a cost history is developed.		
<b>Evaluation:</b>	No problems noted.		
<b>Quantity Notes:</b>

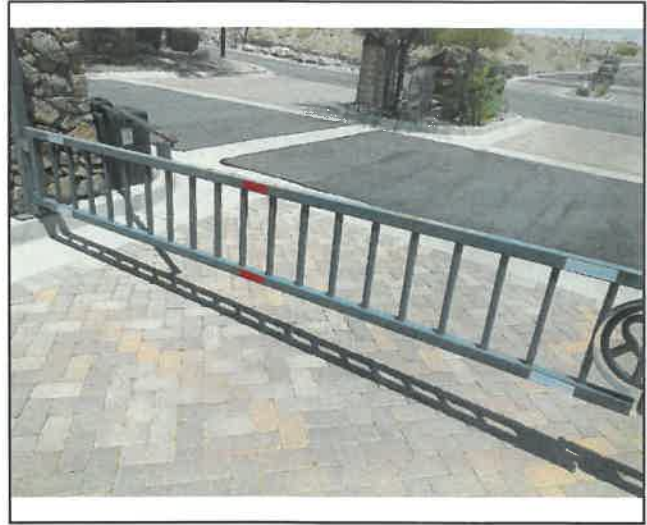
<b>Quantity:</b>	4 Gate Leafs	<b>Unit Cost:</b>	\$2,500.00
<b>Orig. Service:</b>	2007	<b>% of Unit Cost:</b>	100.0%
<b>Useful Life:</b>	30	<b>Total Current Cost:</b>	\$10,000.00
<b>RUL Adjustment:</b>	0	<b>Cost Explanation:</b>	Estimate to replace
<b>Rem. Useful Life:</b>	19	<b>Cost Source:</b>	GeoReserves Database
<b>Vendor:</b>			
<b>Description:</b>	This component includes replacing the vehicle gates. These gates should last approximately 25 to 30 years before they should be replaced to improve the appearance of the entrance area. Any accidents from cars hitting these gates should be considered an insurance issue and not a normal reserve expense. Additional information can be found at <a href="http://iframe.americanfenceassociation.com">iframe.americanfenceassociation.com</a> .		
<b>Evaluation:</b>	No problems with these gates noted.		
<b>Quantity Notes:</b>

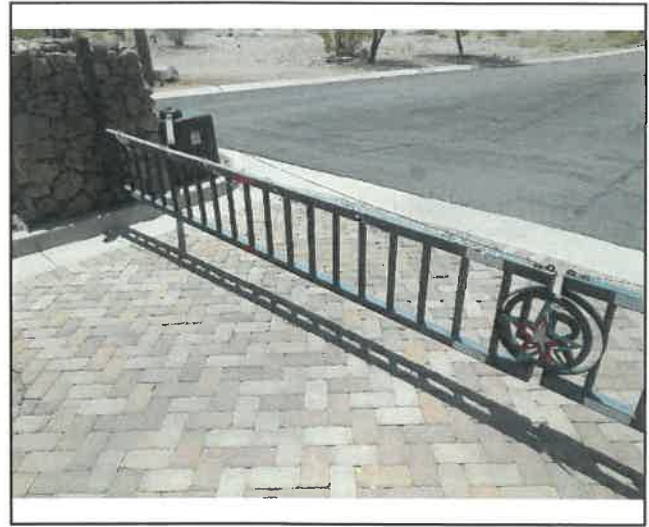
<b>Quantity:</b>	4 Gate Leafs	<b>Unit Cost:</b>	\$125.00
<b>Orig. Service:</b>	2017	<b>% of Unit Cost:</b>	100.0%
<b>Useful Life:</b>	5	<b>Total Current Cost:</b>	\$500.00
<b>RUL Adjustment:</b>	0	<b>Cost Explanation:</b>	Estimate to repaint
<b>Rem. Useful Life:</b>	4	<b>Cost Source:</b>	GeoReserves Database
<b>Vendor:</b>			
<b>Description:</b>	This component includes painting the gates, along with making any repairs to bent or rusted areas. This project should be performed every 5 years or when necessary to maintain appearance and ensure the fence realizes a full useful life. Different paint materials and techniques will determine the actual useful life and may result in adjusting this schedule.		
<b>Evaluation:</b>	No rusting or other appearance concerns such as faded paint noted.		
<b>Quantity Notes:</b>

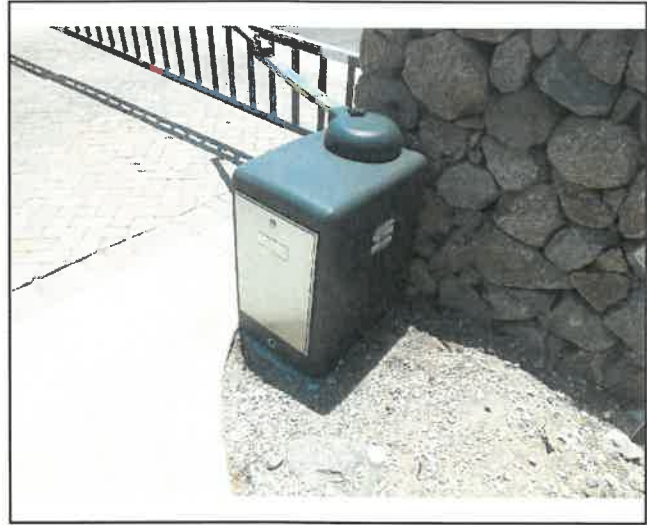
<b>Quantity:</b>	4 Gate Operators	<b>Unit Cost:</b>	\$125.00
<b>Orig. Service:</b>	2017	<b>% of Unit Cost:</b>	100.0%
<b>Useful Life:</b>	1	<b>Total Current Cost:</b>	\$500.00
<b>RUL Adjustment:</b>	0	<b>Cost Explanation:</b>	Estimate to make repairs and replacements
<b>Rem. Useful Life:</b>	0	<b>Cost Source:</b>	GeoReserves Database
<b>Vendor:</b>			
<b>Description:</b>	This component includes the battery backups, which are replaced every year as a reserve expense. This component also funds for any additional parts may need to be repaired or replaced as necessary.		
<b>Evaluation:</b>	No operational problems noted. This site visit does not include any mechanical testing and a maintenance plan with frequent inspections from a trained professional is recommended.		
<b>Quantity Notes:</b>

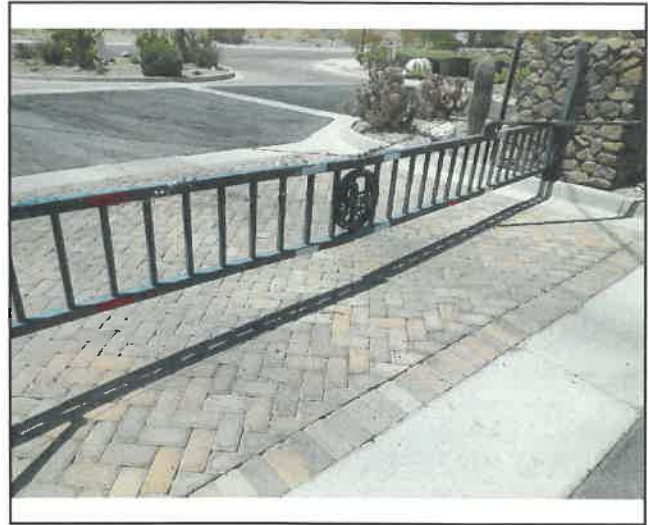
<b>Quantity:</b>	4 Gate Leafs	<b>Unit Cost:</b>	\$2,500.00
<b>Orig. Service:</b>	2007	<b>% of Unit Cost:</b>	100.0%
<b>Useful Life:</b>	30	<b>Total Current Cost:</b>	\$10,000.00
<b>RUL Adjustment:</b>	0	<b>Cost Explanation:</b>	Estimate to replace
<b>Rem. Useful Life:</b>	19	<b>Cost Source:</b>	GeoReserves Database
<b>Vendor:</b>			
<b>Description:</b>	This component includes replacing the vehicle gates. These gates should last approximately 25 to 30 years before they should be replaced to improve the appearance of the entrance area. Any accidents from cars hitting these gates should be considered an insurance issue and not a normal reserve expense. Additional information can be found at <a href="http://iframe.americanfenceassociation.com">iframe.americanfenceassociation.com</a> .		
<b>Evaluation:</b>	No problems with these gates noted.		
<b>Quantity Notes:</b>

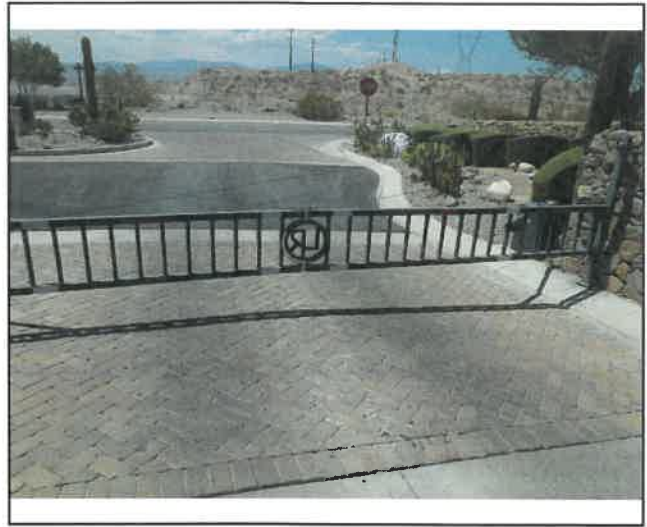
<b>Quantity:</b>	4 Gate Leafs	<b>Unit Cost:</b>	\$125.00
<b>Orig. Service:</b>	2017	<b>% of Unit Cost:</b>	100.0%
<b>Useful Life:</b>	5	<b>Total Current Cost:</b>	\$500.00
<b>RUL Adjustment:</b>	0	<b>Cost Explanation:</b>	Estimate to repaint
<b>Rem. Useful Life:</b>	4	<b>Cost Source:</b>	GeoReserves Database
<b>Vendor:</b>			
<b>Description:</b>	This component includes painting the gates, along with making any repairs to bent or rusted areas. This project should be performed every 5 years or when necessary to maintain appearance and ensure the fence realizes a full useful life. Different paint materials and techniques will determine the actual useful life and may result in adjusting this schedule.		
<b>Evaluation:</b>	No rusting or other appearance concerns such as faded paint noted.		
<b>Quantity Notes:</b>

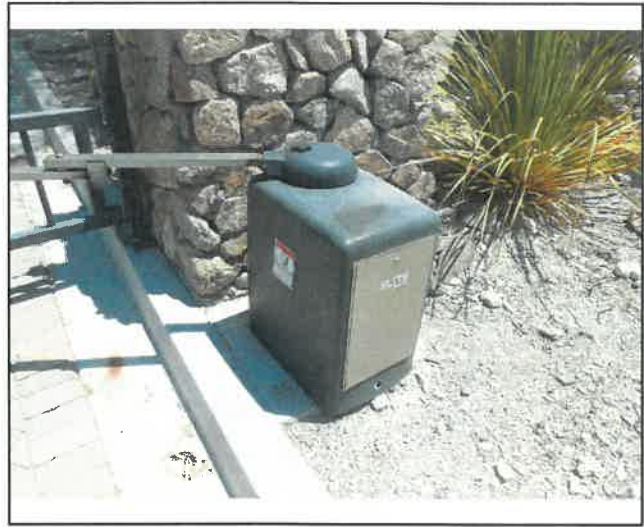
<b>Quantity:</b>	4 Gate Operators	<b>Unit Cost:</b>	\$125.00
<b>Orig. Service:</b>	2017	<b>% of Unit Cost:</b>	100.0%
<b>Useful Life:</b>	1	<b>Total Current Cost:</b>	\$500.00
<b>RUL Adjustment:</b>	0	<b>Cost Explanation:</b>	Estimate to make repairs and replacements
<b>Rem. Useful Life:</b>	0	<b>Cost Source:</b>	GeoReserves Database
<b>Vendor:</b>			
<b>Description:</b>	This component includes the battery backups, which are replaced every year as a reserve expense. This component also funds for any additional parts may need to be repaired or replaced as necessary.		
<b>Evaluation:</b>	No operational problems noted. This site visit does not include any mechanical testing and a maintenance plan with frequent inspections from a trained professional is recommended.		
<b>Quantity Notes:</b>

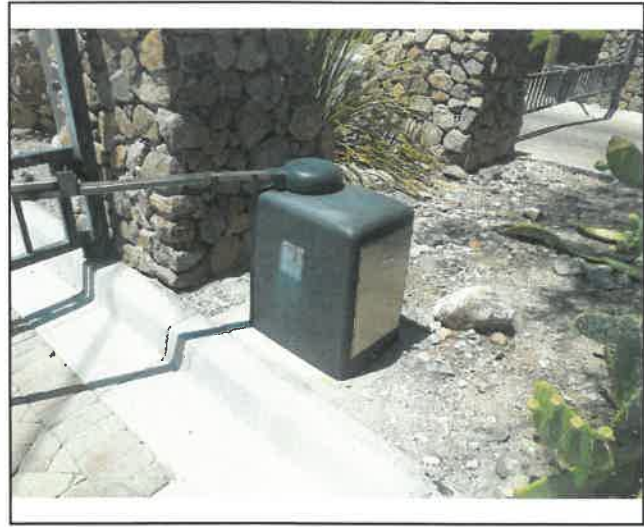
<b>Quantity:</b>	4 Gate Operators	<b>Unit Cost:</b>	\$4,000.00
<b>Orig. Service:</b>	2017	<b>% of Unit Cost:</b>	100.0%
<b>Useful Life:</b>	12	<b>Total Current Cost:</b>	\$16,000.00
<b>RUL Adjustment:</b>	0	<b>Cost Explanation:</b>	Estimate to replace
<b>Rem. Useful Life:</b>	11	<b>Cost Source:</b>	GeoReserves Database
<b>Vendor:</b>			
<b>Description:</b>	This component includes replacing the entire gate operator unit. During the normal life of these gate operators certain parts, such as battery backups, circuit boards and motors may need to be repaired or replaced. For most associations, these minor costs should be considered an operating expense. Gate operators should last between 10 to 12 years however the actual life could be longer if individual parts are routinely replaced. Additional information can be found at <a href="http://www.dasma.com">www.dasma.com</a> .		
<b>Evaluation:</b>	These gate operators were functioning normally at time of site visit with no problems noted.

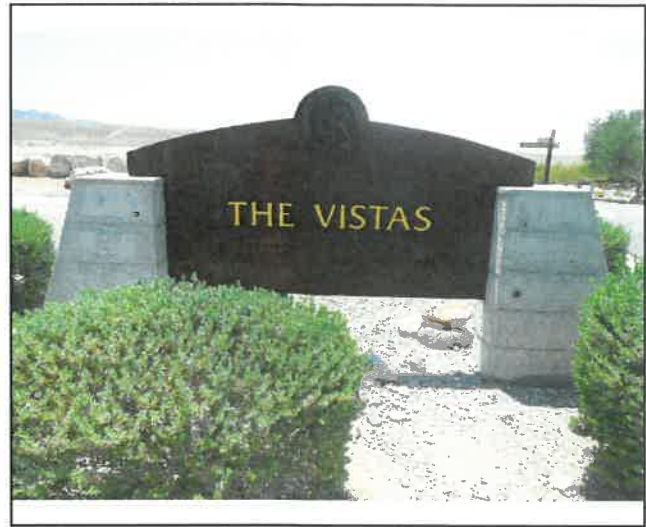
<b>Quantity:</b>	1 Monument	<b>Unit Cost:</b>	\$5,000.00
<b>Orig. Service:</b>	2016	<b>% of Unit Cost:</b>	100.0%
<b>Useful Life:</b>	20	<b>Total Current Cost:</b>	\$5,000.00
<b>RUL Adjustment:</b>	0	<b>Cost Explanation:</b>	Estimate to refurbish
<b>Rem. Useful Life:</b>	18	<b>Cost Source:</b>	GeoReserves Database
<b>Vendor:</b>			
<b>Description:</b>	Monuments can come in a wide range of sizes, materials, and designs. However, over time they will eventually need to be updated to maintain appearance and to keep a current look. This component can include a general refurbishment or a complete replacement. The cost and useful life of this project can vary depending on what type of monument the association has installed. Any minor repairs should be done regularly as an operating expense.		
<b>Evaluation:</b>	No major appearance concerns noted.		
<b>Quantity Notes:</b>

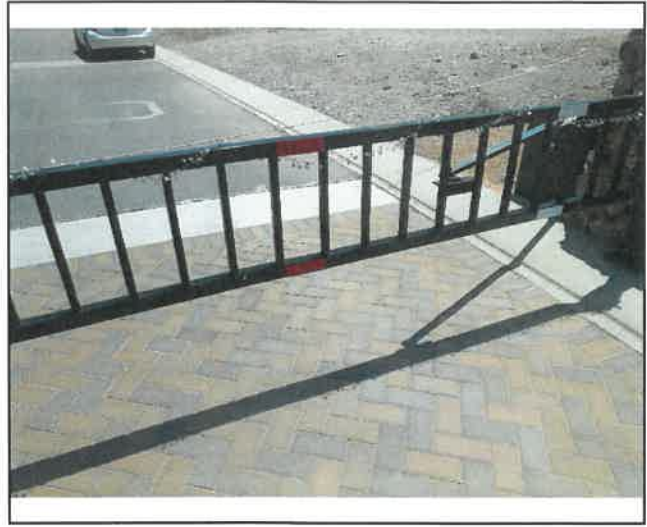
<b>Quantity:</b>	4 Gate Leafs	<b>Unit Cost:</b>	\$125.00
<b>Orig. Service:</b>	2015	<b>% of Unit Cost:</b>	100.0%
<b>Useful Life:</b>	5	<b>Total Current Cost:</b>	\$500.00
<b>RUL Adjustment:</b>	0	<b>Cost Explanation:</b>	Estimate to repaint
<b>Rem. Useful Life:</b>	2	<b>Cost Source:</b>	GeoReserves Database
<b>Vendor:</b>			
<b>Description:</b>	This component includes painting the gates, along with making any repairs to bent or rusted areas. This project should be performed every 5 years or when necessary to maintain appearance and ensure the fence realizes a full useful life. Different paint materials and techniques will determine the actual useful life and may result in adjusting this schedule.		
<b>Evaluation:</b>	No rusting or other appearance concerns such as faded paint noted.		
<b>Quantity Notes:</b>

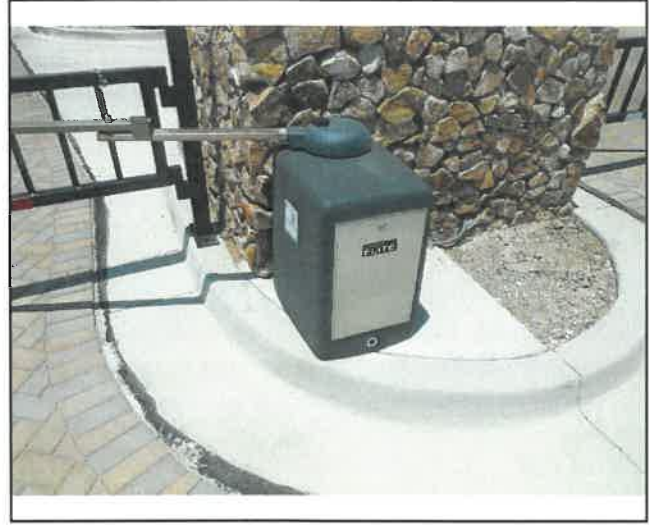
<b>Quantity:</b>	4 Gate Operators	<b>Unit Cost:</b>	\$4,000.00
<b>Orig. Service:</b>	2015	<b>% of Unit Cost:</b>	100.0%
<b>Useful Life:</b>	12	<b>Total Current Cost:</b>	\$16,000.00
<b>RUL Adjustment:</b>	0	<b>Cost Explanation:</b>	Estimate to replace
<b>Rem. Useful Life:</b>	9	<b>Cost Source:</b>	GeoReserves Database
<b>Vendor:</b>			
<b>Description:</b>	This component includes replacing the entire gate operator unit. During the normal life of these gate operators certain parts, such as battery backups, circuit boards and motors may need to be repaired or replaced. For most associations, these minor costs should be considered an operating expense. Gate operators should last between 10 to 12 years however the actual life could be longer if individual parts are routinely replaced. Additional information can be found at <a href="http://www.dasma.com">www.dasma.com</a> .		
<b>Evaluation:</b>	These gate operators were functioning normally at time of site visit with no problems noted.
