**LAUGHLIN RANCH OWNERS ASSOCIATION (NEIGHBORHOODS)**

## **Level 1 -- Full Reserve Study with Site Visit**

**Prepared By: Byron Goetting      NV Permit #072**

**Date of Site Inspection:      07/07/2017**

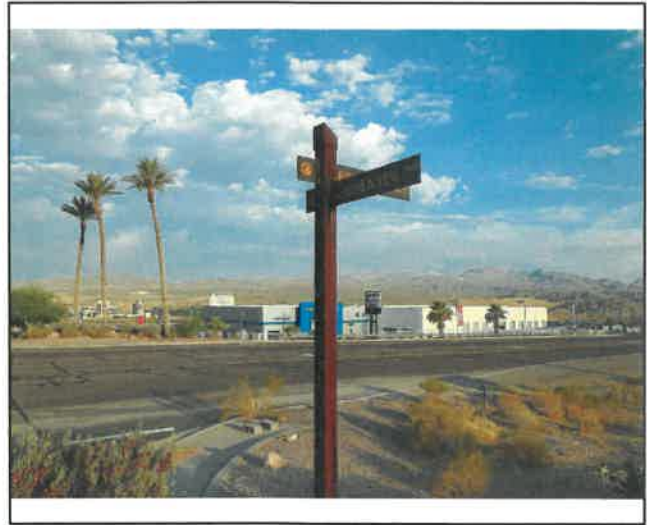
<b>Quantity:</b>	14 Signs	<b>Unit Cost:</b>	\$300.00
<b>Orig. Service:</b>	2007	<b>% of Unit Cost:</b>	100.0%
<b>Useful Life:</b>	15	<b>Total Current Cost:</b>	\$4,200.00
<b>RUL Adjustment:</b>	0	<b>Cost Explanation:</b>	Estimate to replace
<b>Rem. Useful Life:</b>	4	<b>Cost Source:</b>	GeoReserves Database
<b>Vendor:</b>			
<b>Description:</b>	Street Signs and other general traffic signs should maintain a minimum level of retroreflectivity to ensure nighttime visibility. As these signs age, this level of nighttime visibility will decrease until they do not meet minimum standards as defined by the Manual on Uniform Traffic Control Devices (MUTCD). This community should develop a plan to replace these street signs. This reserve study funds for a complete replacement of all signs based on average age. Additional information can be found at <a href="http://www.fhwa.dot.gov/retro">www.fhwa.dot.gov/retro</a> , <a href="http://www.mutcd.fhwa.dot.gov">www.mutcd.fhwa.dot.gov</a> , and <a href="http://www.nevadadot.com">www.nevadadot.com</a> .

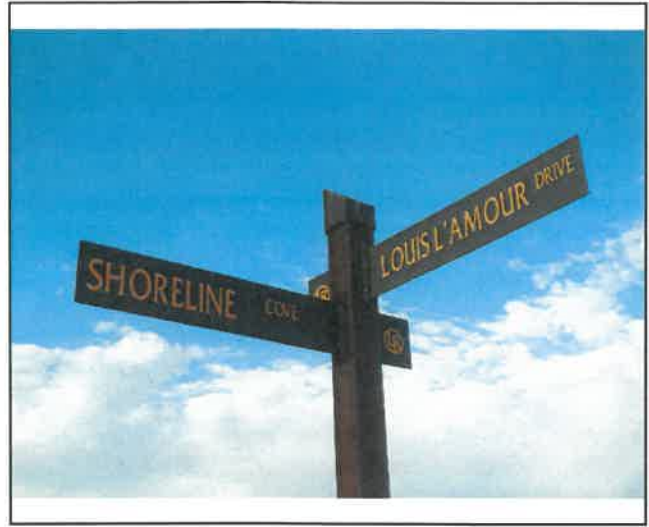
<b>Quantity:</b>	7 Sign Poles	<b>Unit Cost:</b>	\$75.00
<b>Orig. Service:</b>	2012	<b>% of Unit Cost:</b>	100.0%
<b>Useful Life:</b>	5	<b>Total Current Cost:</b>	\$525.00
<b>RUL Adjustment:</b>	1	<b>Cost Explanation:</b>	Estimate to repaint
<b>Rem. Useful Life:</b>	0	<b>Cost Source:</b>	GeoReserves Database
<b>Vendor:</b>			
<b>Description:</b>	This component includes repainting and repairing the street sign poles. These poles should be painted and inspected for repairs approximately every 5 years or when necessary. With proper maintenance the poles should have an extended useful life with no expectation to replace.		
<b>Evaluation:</b>	These street poles appear faded and should be painted in the near future.		
<b>Quantity Notes:</b>

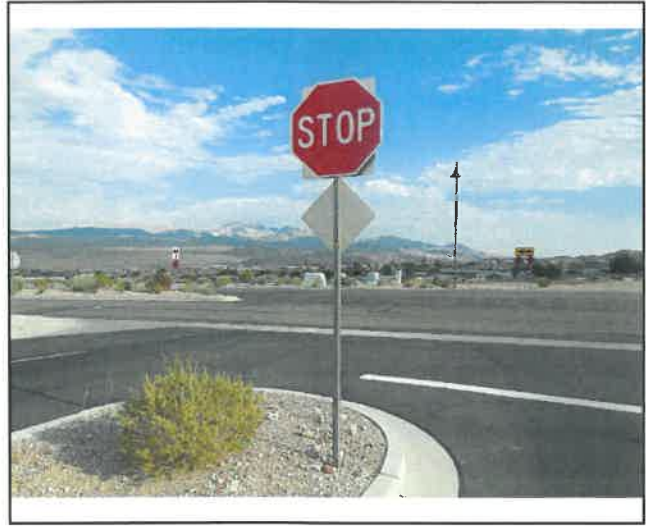
<b>Quantity:</b>	17 Signs	<b>Unit Cost:</b>	\$75.00
<b>Orig. Service:</b>	2007	<b>% of Unit Cost:</b>	100.0%
<b>Useful Life:</b>	15	<b>Total Current Cost:</b>	\$1,275.00
<b>RUL Adjustment:</b>	0	<b>Cost Explanation:</b>	Estimate to replace
<b>Rem. Useful Life:</b>	4	<b>Cost Source:</b>	GeoReserves Database
<b>Vendor:</b>			
<b>Description:</b>	This component includes the various traffic signs. These include the "Stop", "Speed Limit" and other traffic signs. If any sign becomes broken due to vandalism or other circumstance, it should be replaced immediately. However, in total, these signs have a useful life of approximately 15 years.		
<b>Evaluation:</b>	No problems with these signs noted.		
<b>Quantity Notes:</b>	Quantity breakdown: 4 Stop Signs 3 Turn Arrow Direction Signs 4 Bridge Max Height & Weight Signs 2 Speed Limit Signs 4 Other Signs

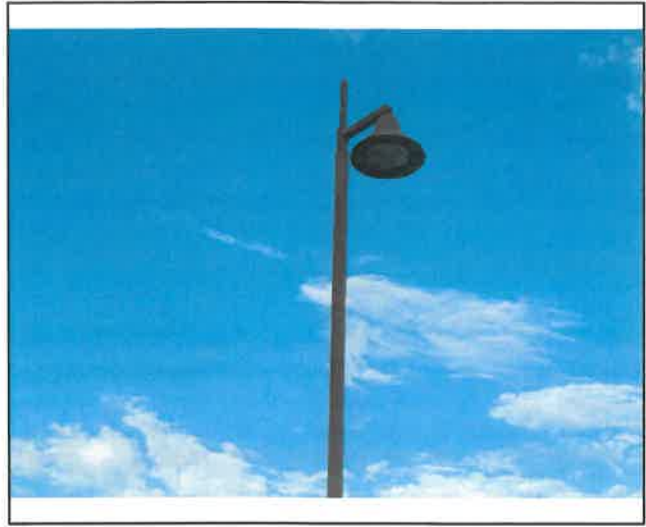
<b>Quantity:</b>	10 Light Fixtures	<b>Unit Cost:</b>	\$750.00
<b>Orig. Service:</b>	2007	<b>% of Unit Cost:</b>	100.0%
<b>Useful Life:</b>	25	<b>Total Current Cost:</b>	\$7,500.00
<b>RUL Adjustment:</b>	0	<b>Cost Explanation:</b>	Estimate to replace
<b>Rem. Useful Life:</b>	14	<b>Cost Source:</b>	GeoReserves Database
<b>Vendor:</b>			
<b>Description:</b>	<p>This component includes replacing the light fixture as well as any associated costs to upgrade the electrical work. The poles are designed to last the life of the community with no expectation for replacement under normal circumstances. The current trend for communities is to retrofit existing light poles with LED light fixtures. These types of light fixtures are expected to last approximately 100,000 hours or about 25 years and offer lower energy and maintenance costs compared to standard, high-pressure sodium light fixtures. Additional information can be found at <a href="http://www.publicpower.org">www.publicpower.org</a>, <a href="http://www.darksky.org">www.darksky.org</a>, <a href="http://www.lightingfacts.com">www.lightingfacts.com</a>.</p>

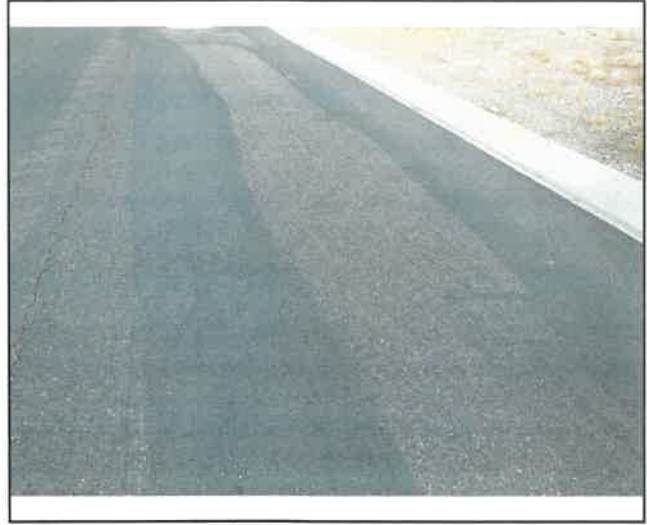
<b>Quantity:</b>	137375 Sq.ft.	<b>Unit Cost:</b>	\$0.24
<b>Orig. Service:</b>	2012	<b>% of Unit Cost:</b>	100.0%
<b>Useful Life:</b>	6	<b>Total Current Cost:</b>	\$32,970.00
<b>RUL Adjustment:</b>	0	<b>Cost Explanation:</b>	Estimate for asphalt preservation
<b>Rem. Useful Life:</b>	0	<b>Cost Source:</b>	GeoReserves Database
<b>Vendor:</b>			
<b>Description:</b>	<p>The purpose of the asphalt streets is to provide a smooth driving experience, with adequate surface friction as well as to distribute the wheel load evenly to support weight and protect the natural soil. Different treatments may be applied to maintain and preserve the asphalt and underlying base. These include: crack sealing, fog seal, slurry seal, chip seal, microsurfacing, patching, and other types of repairs. Factors to be considered to determine the appropriate treatment include age, condition, homeowner preferences, and budget. This community should consult with an expert to determine the appropriate treatment and scope of work. Additional information can be found at <a href="http://www.asphaltpavement.org">www.asphaltpavement.org</a>, <a href="http://www.rtcsv.com">www.rtcsv.com</a>, and <a href="http://www.appliedpavement.com">www.appliedpavement.com</a>.</p>
