**LAUGHLIN RANCH OWNERS ASSOCIATION (NEIGHBORHOODS)**

## **Level 1 -- Full Reserve Study with Site Visit**

**Prepared By: Byron Goetting      NV Permit #072**

**Date of Site Inspection:      07/07/2017**

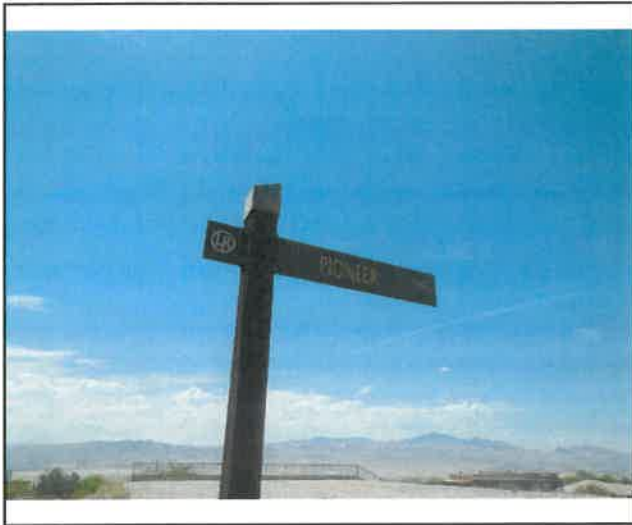
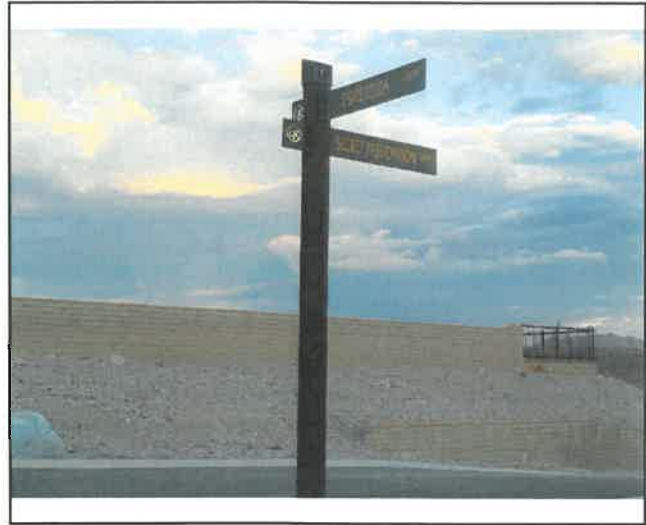
**Comp #: 1.101 Street Signs - Replace**

<b>Evaluation:</b>	These signs are in good to fair condition and aging normally.		
<b>Quantity Notes:</b>

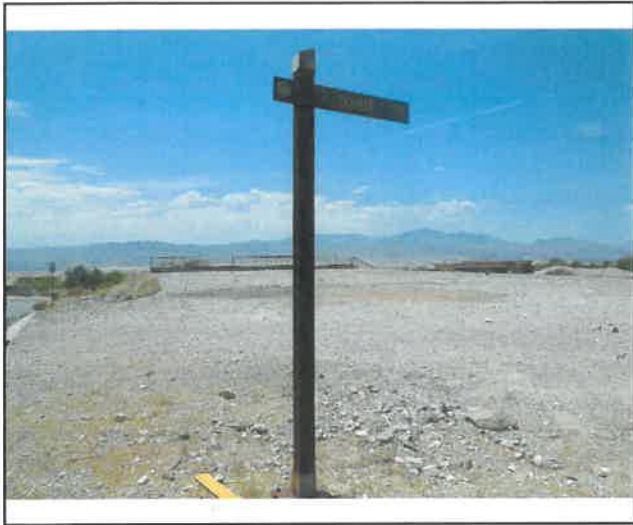
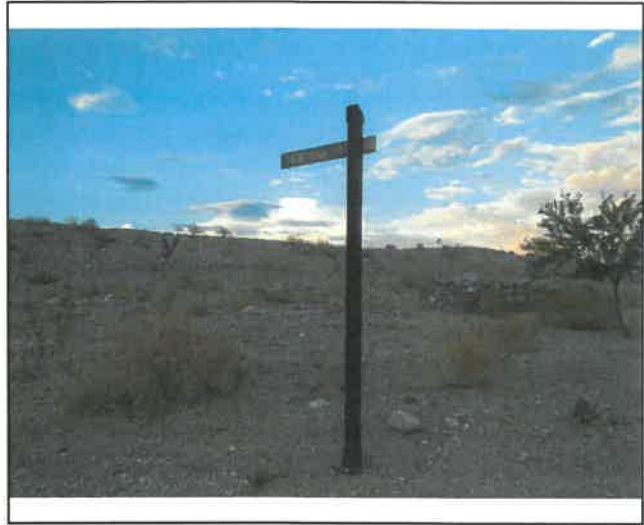
**Comp #: 1.102 Street Sign Poles - Repaint**

<b>Quantity:</b>	37 Sign Poles	<b>Unit Cost:</b>	\$75.00
<b>Orig. Service:</b>	2012	<b>% of Unit Cost:</b>	100.0%
<b>Useful Life:</b>	5	<b>Total Current Cost:</b>	\$2,775.00
<b>RUL Adjustment:</b>	1	<b>Cost Explanation:</b>	Estimate to repaint
<b>Rem. Useful Life:</b>	0	<b>Cost Source:</b>	GeoReserves Database
<b>Vendor:</b>			
<b>Description:</b>	This component includes repainting and repairing the street sign poles. These poles should be painted and inspected for repairs approximately every 5 years or when necessary. With proper maintenance the poles should have an extended useful life with no expectation to replace.		
<b>Evaluation:</b>	These street sign poles are faded and should be repainted and repaired in the near future.		
<b>Quantity Notes:</b>	Quantity breakdown: 35 Street Sign Poles 2 Stop Sign Poles  (Only included the painted sign poles)

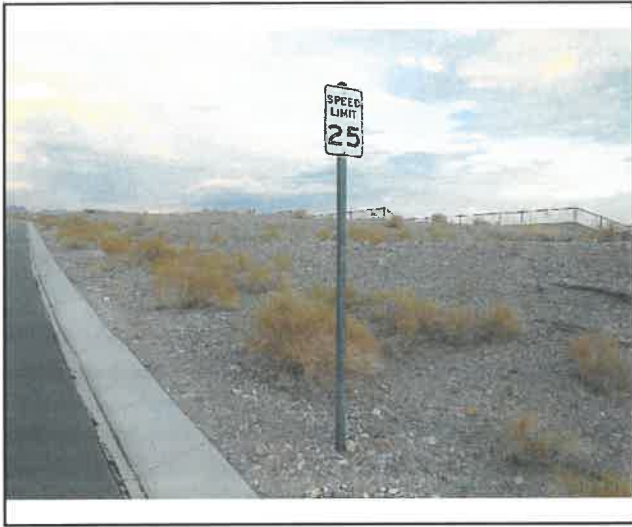
**Comp #: 1.108 Misc. Traffic Signs - Replace**

<b>Quantity:</b>	45 Signs	<b>Unit Cost:</b>	\$75.00
<b>Orig. Service:</b>	2007	<b>% of Unit Cost:</b>	100.0%
<b>Useful Life:</b>	15	<b>Total Current Cost:</b>	\$3,375.00
<b>RUL Adjustment:</b>	0	<b>Cost Explanation:</b>	Estimate to replace
<b>Rem. Useful Life:</b>	4	<b>Cost Source:</b>	GeoReserves Database
<b>Vendor:</b>			
<b>Description:</b>	This component includes the various traffic signs. These include the "Stop", "Speed Limit" and other traffic signs. If any sign becomes broken due to vandalism or other circumstance, it should be replaced immediately. However, in total, these signs have a useful life of approximately 15 years.		
<b>Evaluation:</b>	No problems with these signs noted.		
<b>Quantity Notes:</b>

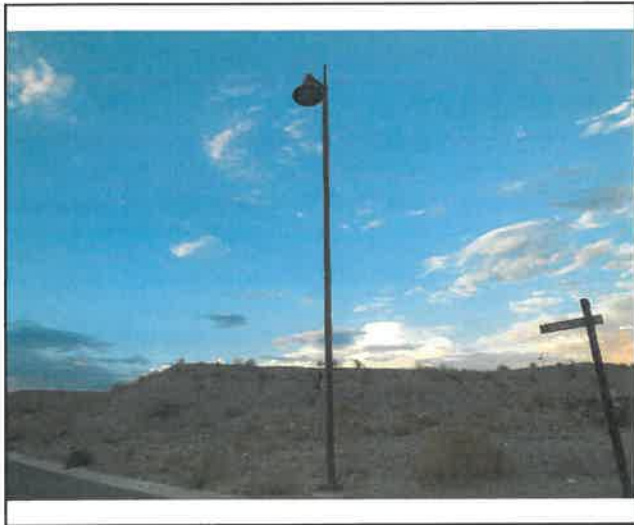
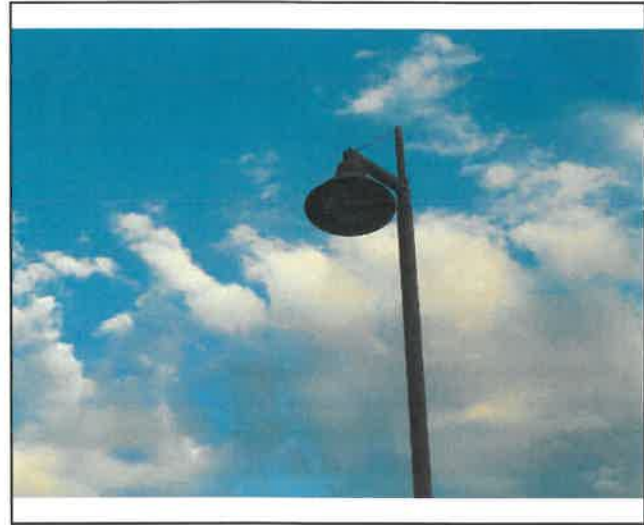
**Comp #: 1.111 Street Light Fixtures - Replace**

<b>Evaluation:</b>	<p>No problems with these street light fixtures noted at time of site visit. However, this community should regularly inspect these lights during nighttime hours to check for any issues.</p>		
<b>Quantity Notes:</b>

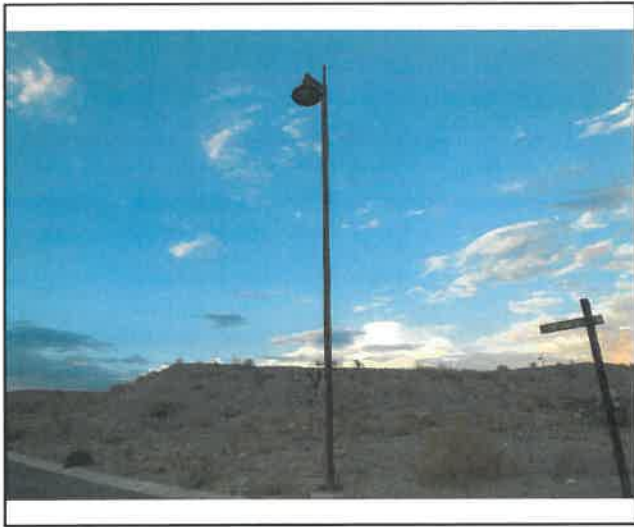
**Comp #: 1.112 Street Light Poles - Repaint**

<b>Quantity:</b>	59 Light Poles	<b>Unit Cost:</b>	\$125.00
<b>Orig. Service:</b>	2012	<b>% of Unit Cost:</b>	100.0%
<b>Useful Life:</b>	5	<b>Total Current Cost:</b>	\$7,375.00
<b>RUL Adjustment:</b>	1	<b>Cost Explanation:</b>	Estimate to repaint
<b>Rem. Useful Life:</b>	0	<b>Cost Source:</b>	GeoReserves Database
<b>Vendor:</b>			
<b>Description:</b>	This component includes repainting and repairing the street light poles. These poles should be painted and inspected for repairs approximately every 5 years or when necessary. With proper maintenance the poles should have an extended useful life with no expectation to replace.		
<b>Evaluation:</b>	These light poles appeared painted and should be painted in the near future.		
<b>Quantity Notes:</b>

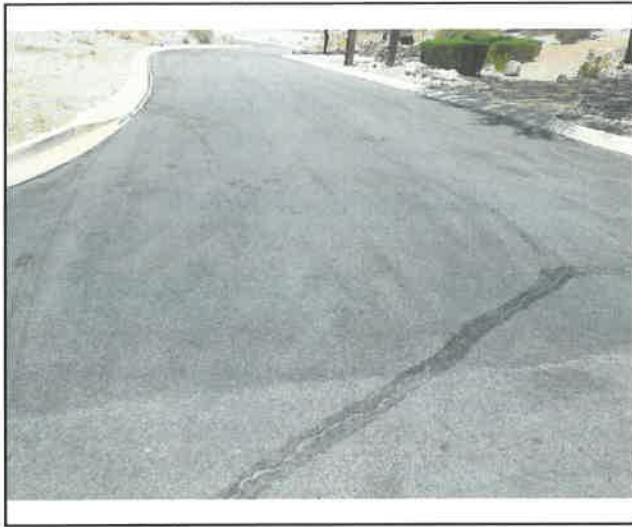
**Comp #: 1.201 Asphalt - Preservation**

<b>Evaluation:</b>	No problems noted at time of site visit.		
<b>Quantity Notes:</b>

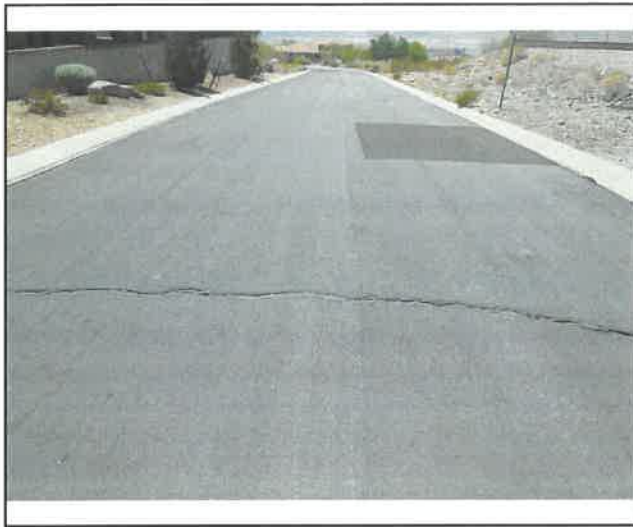
**Comp #: 1.204 Asphalt - Major Rehab**

<b>Evaluation:</b>	No problems noted.		
<b>Quantity Notes:</b>

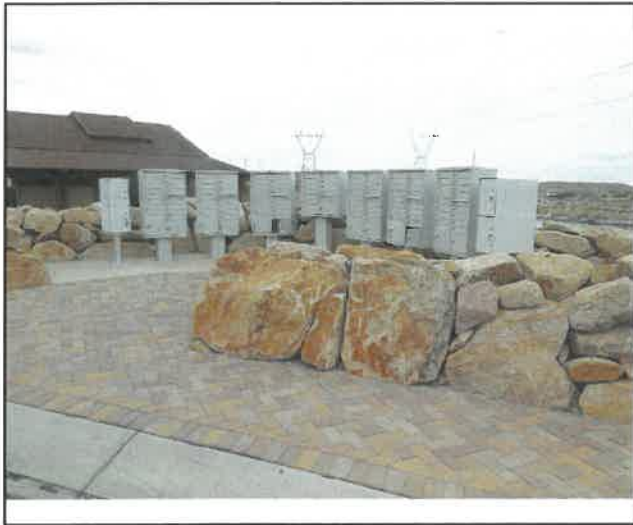
**Comp #: 2.117 Mailbox Area 01 - Refurbish (Ft Mojave Dr & Riverport Dr)**

<b>Quantity:</b>	1 Area	<b>Unit Cost:</b>	\$17,000.00
<b>Orig. Service:</b>	2006	<b>% of Unit Cost:</b>	100.0%
<b>Useful Life:</b>	20	<b>Total Current Cost:</b>	\$17,000.00
<b>RUL Adjustment:</b>	0	<b>Cost Explanation:</b>	Estimate to replace CBUs and refurbish area
<b>Rem. Useful Life:</b>	8	<b>Cost Source:</b>	GeoReserves Database
<b>Vendor:</b>			
<b>Description:</b>	This component funds to replace the Cluster Box Units (CBU's) and make any other repairs, refurbishments, or replacements to the surrounding mailbox area such as any concrete pavers, standard concrete, rock wall, or other associated costs. Current standard Cluster Box Units (CBU's) are usually made of a heavy duty aluminum and stainless steel hardware and should be replaced every 20 years. Some of the paint may fade or peel, and other minor issues may arise which can be addressed as an operating expense.		
<b>Evaluation:</b>	Usually these CBUs will show some minor cosmetic issues such as faded or peeling paint. However, no major functionality problems were noted at time of site visit.

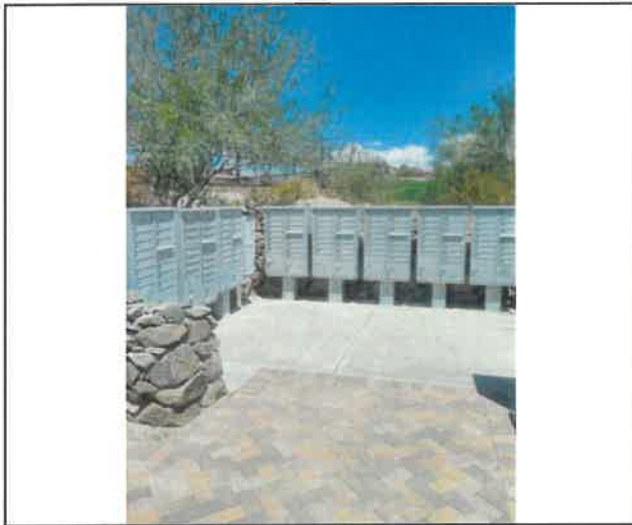
**Comp #: 2.117 Mailbox Area 02 - Refurbish (Riverport Dr & Sidewheel Dr)**

<b>Quantity:</b>	1 Area	<b>Unit Cost:</b>	\$25,000.00
<b>Orig. Service:</b>	2006	<b>% of Unit Cost:</b>	100.0%
<b>Useful Life:</b>	20	<b>Total Current Cost:</b>	\$25,000.00
<b>RUL Adjustment:</b>	0	<b>Cost Explanation:</b>	Estimate to replace CBUs and refurbish area
<b>Rem. Useful Life:</b>	8	<b>Cost Source:</b>	GeoReserves Database
<b>Vendor:</b>			
<b>Description:</b>	This component funds to replace the Cluster Box Units (CBU's) and make any other repairs, refurbishments, or replacements to the surrounding mailbox area such as any concrete pavers, standard concrete, rock wall, or other associated costs. Current standard Cluster Box Units (CBU's) are usually made of a heavy duty aluminum and stainless steel hardware and should be replaced every 20 years. Some of the paint may fade or peel, and other minor issues may arise which can be addressed as an operating expense.		
<b>Evaluation:</b>	Usually these CBUs will show some minor cosmetic issues such as faded or peeling paint. However, no major functionality problems were noted at time of site visit.

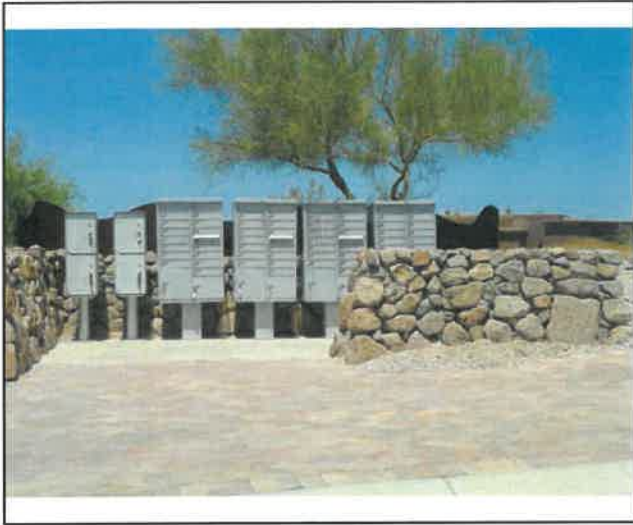
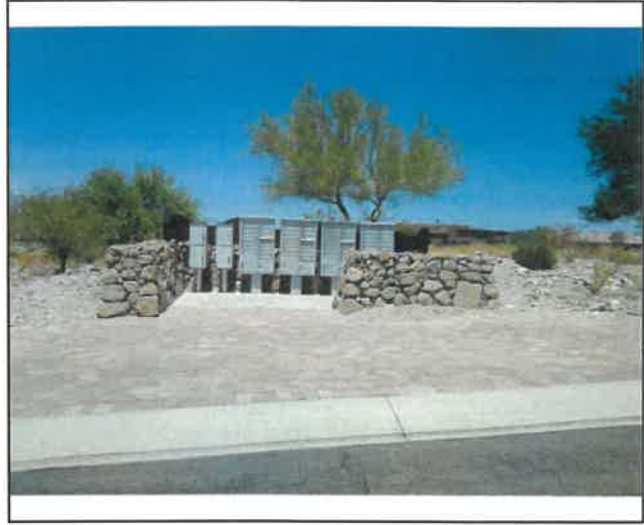
**Comp #: 2.117 Mailbox Area 03 - Refurbish (Ft Mojave Dr & Pioneer Tr)**

<b>Quantity:</b>	1 Area	<b>Unit Cost:</b>	\$12,000.00
<b>Orig. Service:</b>	2006	<b>% of Unit Cost:</b>	100.0%
<b>Useful Life:</b>	20	<b>Total Current Cost:</b>	\$12,000.00
<b>RUL Adjustment:</b>	0	<b>Cost Explanation:</b>	Estimate to replace CBUs and refurbish area
<b>Rem. Useful Life:</b>	8	<b>Cost Source:</b>	GeoReserves Database
<b>Vendor:</b>			
<b>Description:</b>	This component funds to replace the Cluster Box Units (CBU's) and make any other repairs, refurbishments, or replacements to the surrounding mailbox area such as any concrete pavers, standard concrete, rock wall, or other associated costs. Current standard Cluster Box Units (CBU's) are usually made of a heavy duty aluminum and stainless steel hardware and should be replaced every 20 years. Some of the paint may fade or peel, and other minor issues may arise which can be addressed as an operating expense.		
<b>Evaluation:</b>	Usually these CBUs will show some minor cosmetic issues such as faded or peeling paint. However, no major functionality problems were noted at time of site visit.

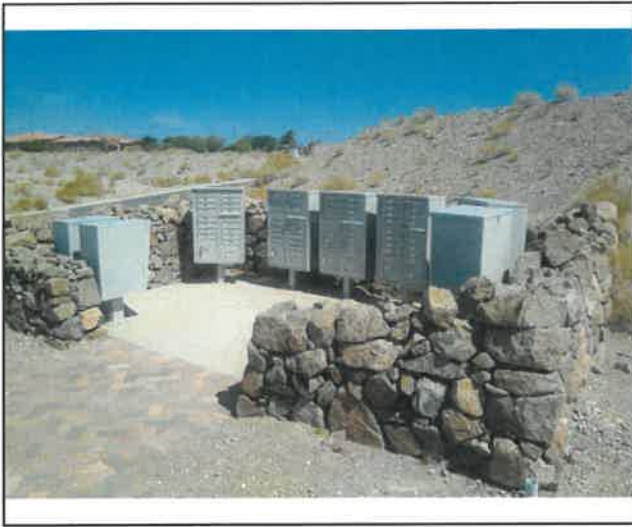
**Comp #: 2.117 Mailbox Area 04 - Refurbish (Esmerelda Dr & William Hardy Dr)**

<b>Quantity:</b>	1 Area	<b>Unit Cost:</b>	\$15,000.00
<b>Orig. Service:</b>	2006	<b>% of Unit Cost:</b>	100.0%
<b>Useful Life:</b>	20	<b>Total Current Cost:</b>	\$15,000.00
<b>RUL Adjustment:</b>	0	<b>Cost Explanation:</b>	Estimate to replace CBUs and refurbish area
<b>Rem. Useful Life:</b>	8	<b>Cost Source:</b>	GeoReserves Database
<b>Vendor:</b>			
<b>Description:</b>	This component funds to replace the Cluster Box Units (CBU's) and make any other repairs, refurbishments, or replacements to the surrounding mailbox area such as any concrete pavers, standard concrete, rock wall, or other associated costs. Current standard Cluster Box Units (CBU's) are usually made of a heavy duty aluminum and stainless steel hardware and should be replaced every 20 years. Some of the paint may fade or peel, and other minor issues may arise which can be addressed as an operating expense.		
<b>Evaluation:</b>	Usually these CBUs will show some minor cosmetic issues such as faded or peeling paint. However, no major functionality problems were noted at time of site visit.

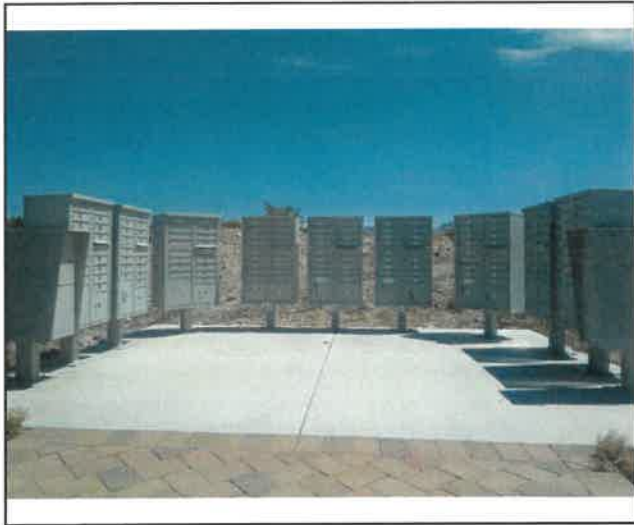
**Comp #: 2.117 Mailbox Area 05 - Refurbish (Sidewheel Dr & Schooner Cove)**

<b>Quantity:</b>	1 Area	<b>Unit Cost:</b>	\$19,000.00
<b>Orig. Service:</b>	2006	<b>% of Unit Cost:</b>	100.0%
<b>Useful Life:</b>	20	<b>Total Current Cost:</b>	\$19,000.00
<b>RUL Adjustment:</b>	0	<b>Cost Explanation:</b>	Estimate to replace CBUs and refurbish area
<b>Rem. Useful Life:</b>	8	<b>Cost Source:</b>	GeoReserves Database
<b>Vendor:</b>			
<b>Description:</b>	This component funds to replace the Cluster Box Units (CBU's) and make any other repairs, refurbishments, or replacements to the surrounding mailbox area such as any concrete pavers, standard concrete, rock wall, or other associated costs. Current standard Cluster Box Units (CBU's) are usually made of a heavy duty aluminum and stainless steel hardware and should be replaced every 20 years. Some of the paint may fade or peel, and other minor issues may arise which can be addressed as an operating expense.		
<b>Evaluation:</b>	Usually these CBUs will show some minor cosmetic issues such as faded or peeling paint. However, no major functionality problems were noted at time of site visit.

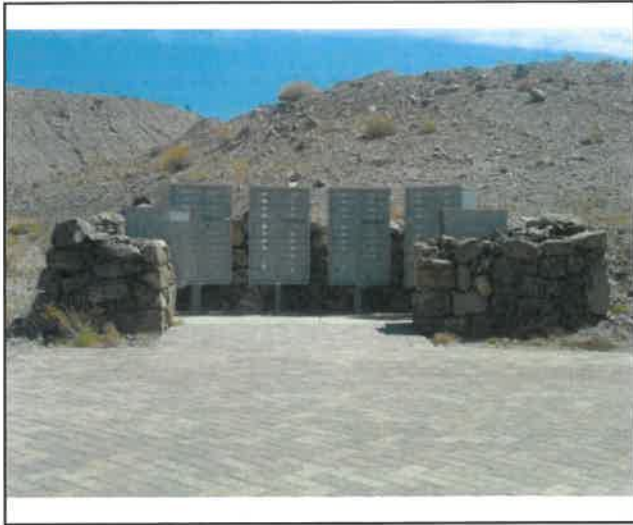
**Comp #: 2.117 Mailbox Area 06 - Refurbish (Secret Pass Canyon & Dutchman Trail)**

<b>Quantity:</b>	1 Area	<b>Unit Cost:</b>	\$13,000.00
<b>Orig. Service:</b>	2006	<b>% of Unit Cost:</b>	100.0%
<b>Useful Life:</b>	20	<b>Total Current Cost:</b>	\$13,000.00
<b>RUL Adjustment:</b>	0	<b>Cost Explanation:</b>	Estimate to replace CBUs and refurbish area
<b>Rem. Useful Life:</b>	8	<b>Cost Source:</b>	GeoReserves Database
<b>Vendor:</b>			
<b>Description:</b>	This component funds to replace the Cluster Box Units (CBU's) and make any other repairs, refurbishments, or replacements to the surrounding mailbox area such as any concrete pavers, standard concrete, rock wall, or other associated costs. Current standard Cluster Box Units (CBU's) are usually made of a heavy duty aluminum and stainless steel hardware and should be replaced every 20 years. Some of the paint may fade or peel, and other minor issues may arise which can be addressed as an operating expense.		
<b>Evaluation:</b>	Usually these CBUs will show some minor cosmetic issues such as faded or peeling paint. However, no major functionality problems were noted at time of site visit.

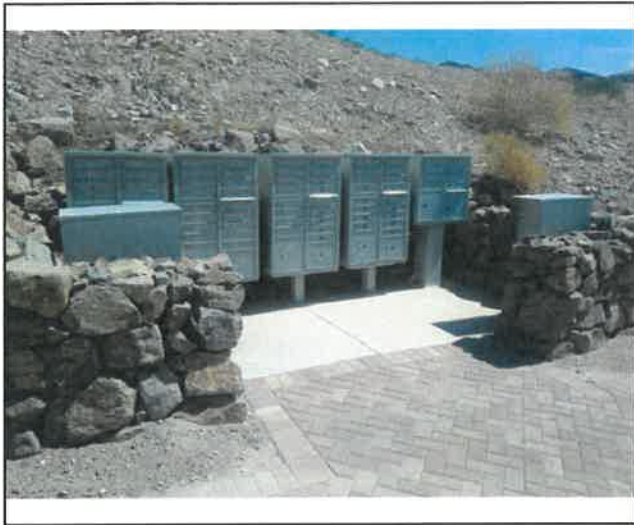
**Comp #: 2.117 Mailbox Area 07 - Refurbish (Secret Pass Canyon & Esmerelda)**

<b>Quantity:</b>	1 Area	<b>Unit Cost:</b>	\$13,000.00
<b>Orig. Service:</b>	2006	<b>% of Unit Cost:</b>	100.0%
<b>Useful Life:</b>	20	<b>Total Current Cost:</b>	\$13,000.00
<b>RUL Adjustment:</b>	0	<b>Cost Explanation:</b>	Estimate to replace CBUs and refurbish area
<b>Rem. Useful Life:</b>	8	<b>Cost Source:</b>	GeoReserves Database
<b>Vendor:</b>			
<b>Description:</b>	This component funds to replace the Cluster Box Units (CBU's) and make any other repairs, refurbishments, or replacements to the surrounding mailbox area such as any concrete pavers, standard concrete, rock wall, or other associated costs. Current standard Cluster Box Units (CBU's) are usually made of a heavy duty aluminum and stainless steel hardware and should be replaced every 20 years. Some of the paint may fade or peel, and other minor issues may arise which can be addressed as an operating expense.		
<b>Evaluation:</b>	Usually these CBUs will show some minor cosmetic issues such as faded or peeling paint. However, no major functionality problems were noted at time of site visit.

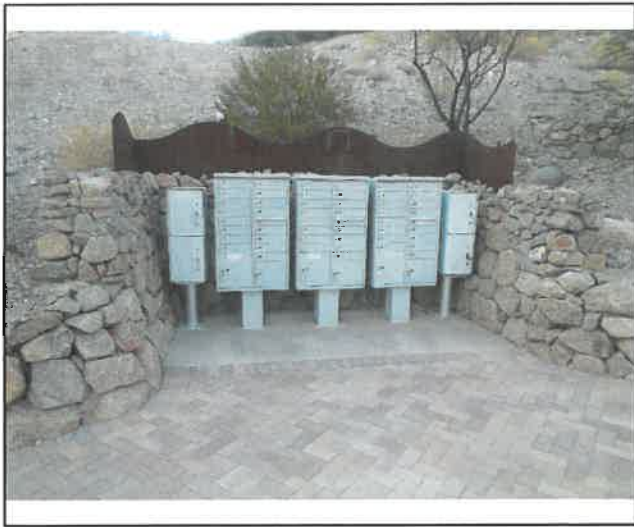
**Comp #: 2.117 Mailbox Area 08 - Refurbish (Esmerelda & William Hardy)**

<b>Quantity:</b>	1 Area	<b>Unit Cost:</b>	\$9,000.00
<b>Orig. Service:</b>	2006	<b>% of Unit Cost:</b>	100.0%
<b>Useful Life:</b>	20	<b>Total Current Cost:</b>	\$9,000.00
<b>RUL Adjustment:</b>	0	<b>Cost Explanation:</b>	Estimate to replace CBU's and refurbish area
<b>Rem. Useful Life:</b>	8	<b>Cost Source:</b>	GeoReserves Database
<b>Vendor:</b>			
<b>Description:</b>	This component funds to replace the Cluster Box Units (CBU's) and make any other repairs, refurbishments, or replacements to the surrounding mailbox area such as any concrete pavers, standard concrete, rock wall, or other associated costs. Current standard Cluster Box Units (CBU's) are usually made of a heavy duty aluminum and stainless steel hardware and should be replaced every 20 years. Some of the paint may fade or peel, and other minor issues may arise which can be addressed as an operating expense.		
<b>Evaluation:</b>	Usually these CBU's will show some minor cosmetic issues such as faded or peeling paint. However, no major functionality problems were noted at time of site visit.

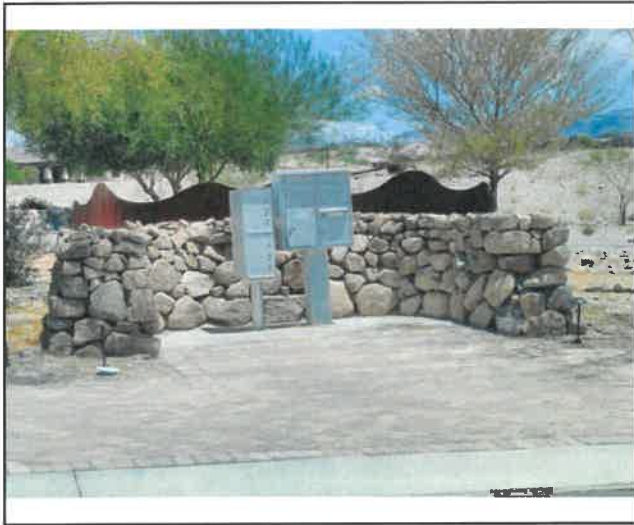
**Comp #: 2.117 Mailbox Area 09 - Refurbish (Pioneer Trail, South of Fort Mojave)**

<b>Quantity:</b>	1 Area	<b>Unit Cost:</b>	\$4,000.00
<b>Orig. Service:</b>	2006	<b>% of Unit Cost:</b>	100.0%
<b>Useful Life:</b>	20	<b>Total Current Cost:</b>	\$4,000.00
<b>RUL Adjustment:</b>	0	<b>Cost Explanation:</b>	Estimate to replace CBUs and refurbish area
<b>Rem. Useful Life:</b>	8	<b>Cost Source:</b>	GeoReserves Database
<b>Vendor:</b>			
<b>Description:</b>	This component funds to replace the Cluster Box Units (CBU's) and make any other repairs, refurbishments, or replacements to the surrounding mailbox area such as any concrete pavers, standard concrete, rock wall, or other associated costs. Current standard Cluster Box Units (CBU's) are usually made of a heavy duty aluminum and stainless steel hardware and should be replaced every 20 years. Some of the paint may fade or peel, and other minor issues may arise which can be addressed as an operating expense.		
<b>Evaluation:</b>	Usually these CBUs will show some minor cosmetic issues such as faded or peeling paint. However, no major functionality problems were noted at time of site visit.

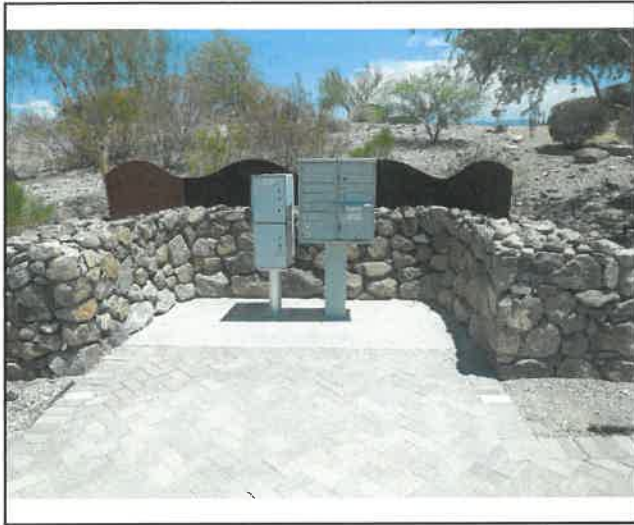
**Comp #: 2.117 Mailbox Area 10 - Refurbish (Pioneer Trail, North of Fort Mojave)**

<b>Quantity:</b>	1 Area	<b>Unit Cost:</b>	\$4,000.00
<b>Orig. Service:</b>	2006	<b>% of Unit Cost:</b>	100.0%
<b>Useful Life:</b>	20	<b>Total Current Cost:</b>	\$4,000.00
<b>RUL Adjustment:</b>	0	<b>Cost Explanation:</b>	Estimate to replace CBUs and refurbish area
<b>Rem. Useful Life:</b>	8	<b>Cost Source:</b>	GeoReserves Database
<b>Vendor:</b>			
<b>Description:</b>	This component funds to replace the Cluster Box Units (CBU's) and make any other repairs, refurbishments, or replacements to the surrounding mailbox area such as any concrete pavers, standard concrete, rock wall, or other associated costs. Current standard Cluster Box Units (CBU's) are usually made of a heavy duty aluminum and stainless steel hardware and should be replaced every 20 years. Some of the paint may fade or peel, and other minor issues may arise which can be addressed as an operating expense.		
<b>Evaluation:</b>	Usually these CBUs will show some minor cosmetic issues such as faded or peeling paint. However, no major functionality problems were noted at time of site visit.

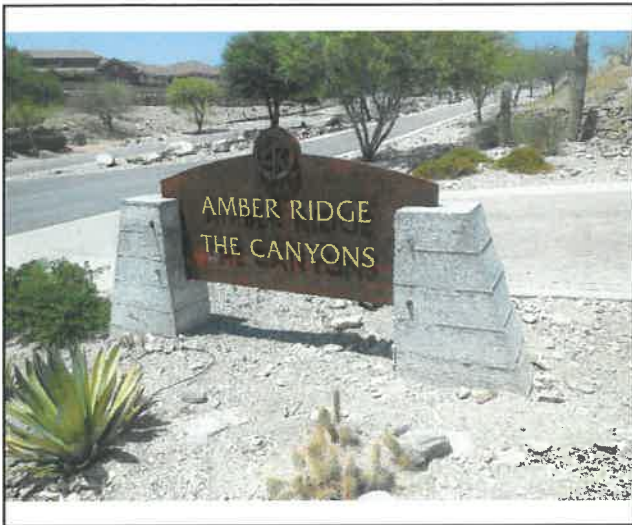
**Comp #: 3.104 Monument - Refurbish**

<b>Quantity:</b>	1 Monument	<b>Unit Cost:</b>	\$5,000.00
<b>Orig. Service:</b>	2016	<b>% of Unit Cost:</b>	100.0%
<b>Useful Life:</b>	20	<b>Total Current Cost:</b>	\$5,000.00
<b>RUL Adjustment:</b>	0	<b>Cost Explanation:</b>	Estimate to refurbish
<b>Rem. Useful Life:</b>	18	<b>Cost Source:</b>	GeoReserves Database
<b>Vendor:</b>			
<b>Description:</b>	Monuments can come in a wide range of sizes, materials, and designs. However, over time they will eventually need to be updated to maintain appearance and to keep a current look. This component can include a general refurbishment or a complete replacement. The cost and useful life of this project can vary depending on what type of monument the association has installed. Any minor repairs should be done regularly as an operating expense.		
<b>Evaluation:</b>	No major appearance concerns noted.		
<b>Quantity Notes:</b>

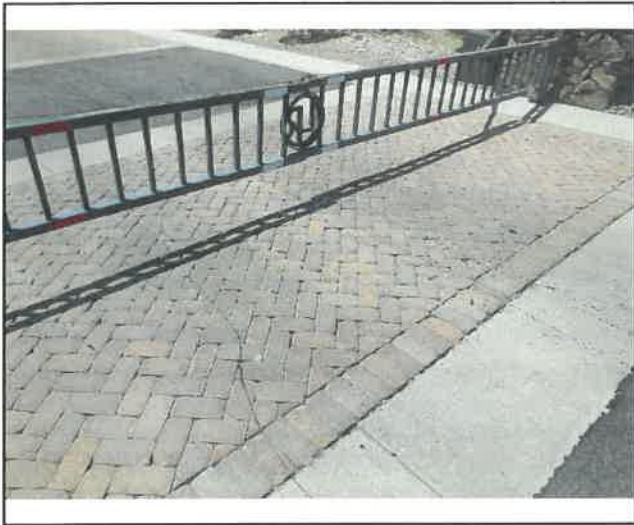
**Comp #: 3.210 Concrete Pavers - Repair/Replace**

<b>Quantity:</b>	1450 Sq.ft.	<b>Unit Cost:</b>	\$10.00
<b>Orig. Service:</b>	2007	<b>% of Unit Cost:</b>	15.0%
<b>Useful Life:</b>	10	<b>Total Current Cost:</b>	\$2,175.00
<b>RUL Adjustment:</b>	5	<b>Cost Explanation:</b>	Estimate to make repairs
<b>Rem. Useful Life:</b>	4	<b>Cost Source:</b>	GeoReserves Database
<b>Vendor:</b>			
<b>Description:</b>	This component includes making any repairs to the concrete pavers. These pavers should have a very long useful life. However, over time some pavers may break and repairs and replacements will be necessary. This component funds to repair and replace 15% of the total area every 10 years. This schedule may need to be adjusted as a cost history is developed.		
<b>Evaluation:</b>	No problems noted.		
<b>Quantity Notes:</b>

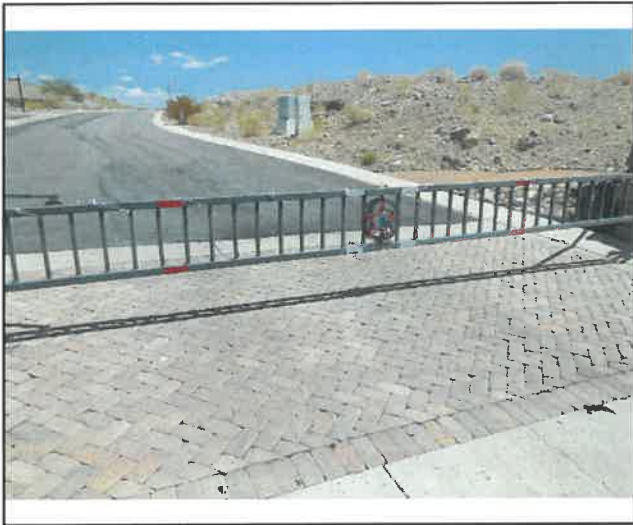
**Comp #: 3.501 Vehicle Gates - Replace**

<b>Quantity:</b>	4 Vehicle Gates	<b>Unit Cost:</b>	\$2,500.00
<b>Orig. Service:</b>	2015	<b>% of Unit Cost:</b>	100.0%
<b>Useful Life:</b>	30	<b>Total Current Cost:</b>	\$10,000.00
<b>RUL Adjustment:</b>	0	<b>Cost Explanation:</b>	Estimate to replace
<b>Rem. Useful Life:</b>	27	<b>Cost Source:</b>	GeoReserves Database
<b>Vendor:</b>			
<b>Description:</b>	This component includes replacing the vehicle gates. These gates should last approximately 25 to 30 years before they should be replaced to improve the appearance of the entrance area. Any accidents from cars hitting these gates should be considered an insurance issue and not a normal reserve expense. Additional information can be found at <a href="http://iframe.americanfenceassociation.com">iframe.americanfenceassociation.com</a> .		
<b>Evaluation:</b>	No problems with these gates noted.		
<b>Quantity Notes:</b>

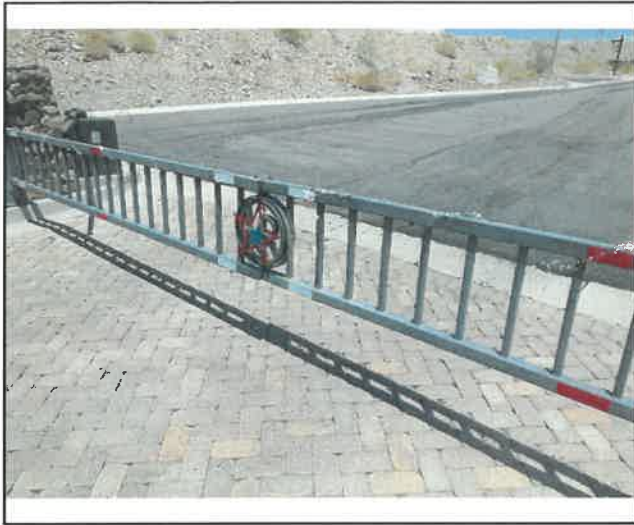
**Comp #: 3.502 Vehicle Gates - Repaint**

<b>Quantity:</b>	4 Gate Leafs	<b>Unit Cost:</b>	\$125.00
<b>Orig. Service:</b>	2015	<b>% of Unit Cost:</b>	100.0%
<b>Useful Life:</b>	5	<b>Total Current Cost:</b>	\$500.00
<b>RUL Adjustment:</b>	0	<b>Cost Explanation:</b>	Estimate to repaint
<b>Rem. Useful Life:</b>	2	<b>Cost Source:</b>	GeoReserves Database
<b>Vendor:</b>			
<b>Description:</b>	This component includes painting the gates, along with making any repairs to bent or rusted areas. This project should be performed every 5 years or when necessary to maintain appearance and ensure the fence realizes a full useful life. Different paint materials and techniques will determine the actual useful life and may result in adjusting this schedule.		
<b>Evaluation:</b>	No rusting or other appearance concerns such as faded paint noted.		
<b>Quantity Notes:</b>

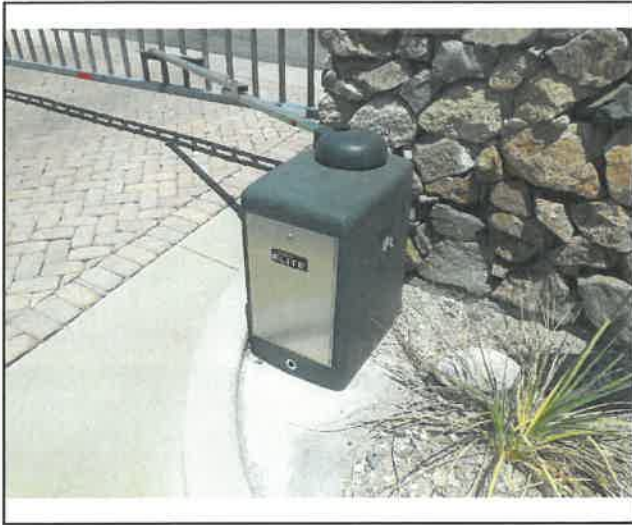
**Comp #: 3.504 Vehicle Gate Operators - Repair/Part Replacement**

<b>Quantity:</b>	4 Gate Operators	<b>Unit Cost:</b>	\$125.00
<b>Orig. Service:</b>	2017	<b>% of Unit Cost:</b>	100.0%
<b>Useful Life:</b>	1	<b>Total Current Cost:</b>	\$500.00
<b>RUL Adjustment:</b>	0	<b>Cost Explanation:</b>	Estimate to make repairs and replacements
<b>Rem. Useful Life:</b>	0	<b>Cost Source:</b>	GeoReserves Database
<b>Vendor:</b>			
<b>Description:</b>	This component includes the battery backups, which are replaced every year as a reserve expense. This component also funds for any additional parts may need to be repaired or replaced as necessary.		
<b>Evaluation:</b>	No operational problems noted. This site visit does not include any mechanical testing and a maintenance plan with frequent inspections from a trained professional is recommended.		
<b>Quantity Notes:</b>

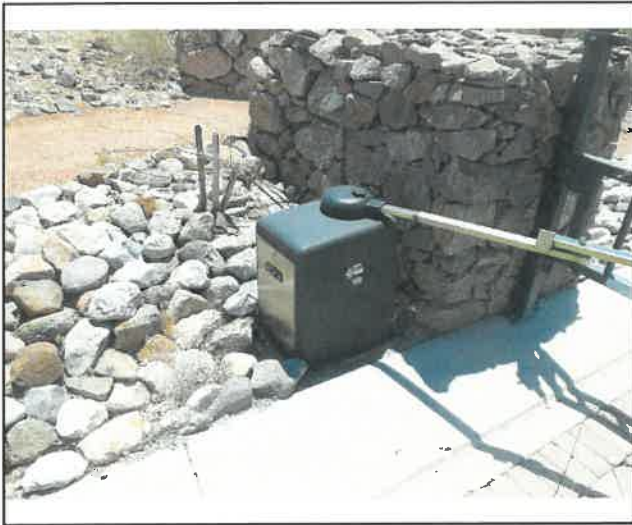
**Comp #: 3.505 Vehicle Gate Operators - Replace**

<b>Quantity:</b>	4 Gate Operators	<b>Unit Cost:</b>	\$4,000.00
<b>Orig. Service:</b>	2015	<b>% of Unit Cost:</b>	100.0%
<b>Useful Life:</b>	12	<b>Total Current Cost:</b>	\$16,000.00
<b>RUL Adjustment:</b>	0	<b>Cost Explanation:</b>	Estimate to replace
<b>Rem. Useful Life:</b>	9	<b>Cost Source:</b>	GeoReserves Database
<b>Vendor:</b>			
<b>Description:</b>	This component includes replacing the entire gate operator unit. During the normal life of these gate operators certain parts, such as battery backups, circuit boards and motors may need to be repaired or replaced. For most associations, these minor costs should be considered an operating expense. Gate operators should last between 10 to 12 years however the actual life could be longer if individual parts are routinely replaced. Additional information can be found at <a href="http://www.dasma.com">www.dasma.com</a> .		
<b>Evaluation:</b>	These gate operators were functioning normally at time of site visit with no problems noted.

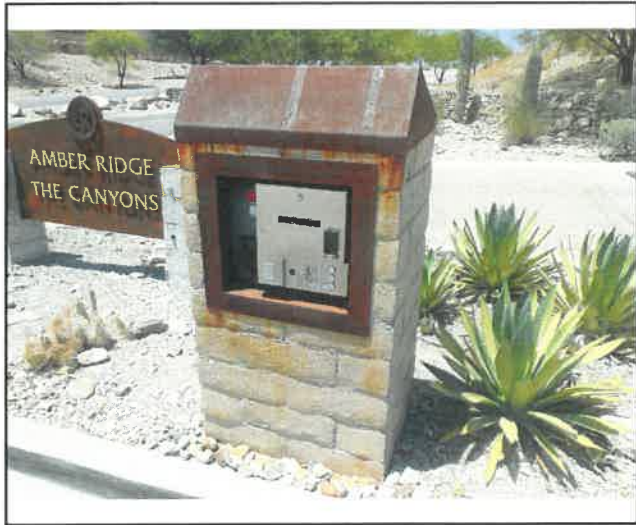
**Comp #: 3.507 Vehicle Gate Entrance System - Replace**

<b>Evaluation:</b>	This component is functional with no major problems noted.		
<b>Quantity Notes:</b>

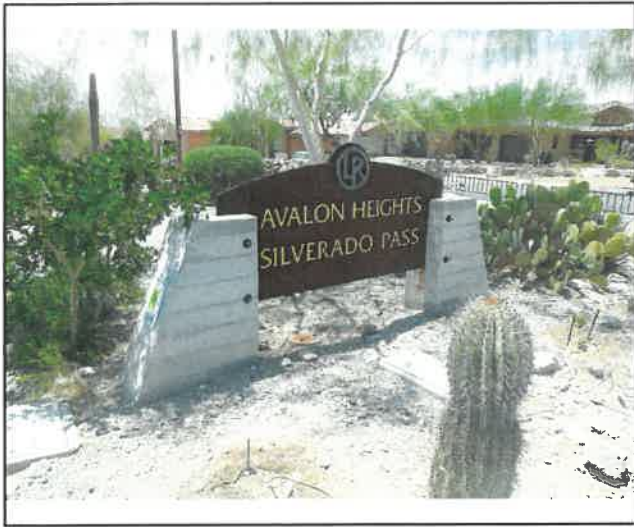
**Comp #: 4.104 Monument - Refurbish**

<b>Quantity:</b>	1 Monument	<b>Unit Cost:</b>	\$5,000.00
<b>Orig. Service:</b>	2006	<b>% of Unit Cost:</b>	100.0%
<b>Useful Life:</b>	20	<b>Total Current Cost:</b>	\$5,000.00
<b>RUL Adjustment:</b>	0	<b>Cost Explanation:</b>	Estimate to refurbish
<b>Rem. Useful Life:</b>	8	<b>Cost Source:</b>	GeoReserves Database
<b>Vendor:</b>			
<b>Description:</b>	Monuments can come in a wide range of sizes, materials, and designs. However, over time they will eventually need to be updated to maintain appearance and to keep a current look. This component can include a general refurbishment or a complete replacement. The cost and useful life of this project can vary depending on what type of monument the association has installed. Any minor repairs should be done regularly as an operating expense.		
<b>Evaluation:</b>	No major appearance concerns noted.		
<b>Quantity Notes:</b>

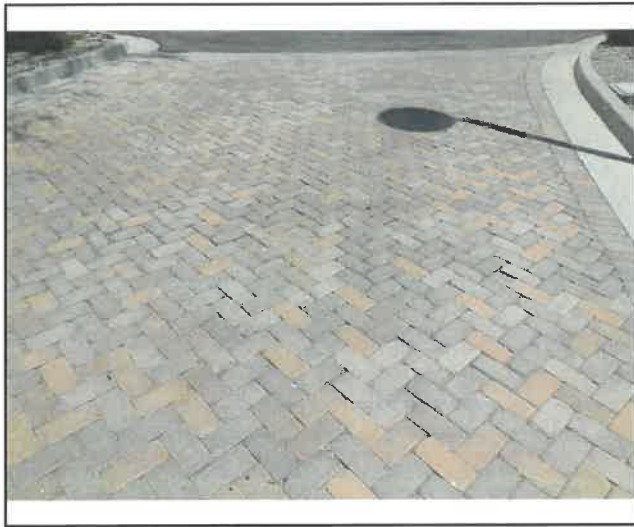
**Comp #: 4.210 Concrete Pavers - Repair/Replace**

<b>Quantity:</b>	1950 Sq.ft.	<b>Unit Cost:</b>	\$10.00
<b>Orig. Service:</b>	2007	<b>% of Unit Cost:</b>	15.0%
<b>Useful Life:</b>	10	<b>Total Current Cost:</b>	\$2,925.00
<b>RUL Adjustment:</b>	5	<b>Cost Explanation:</b>	Estimate to repair and replace
<b>Rem. Useful Life:</b>	4	<b>Cost Source:</b>	GeoReserves Database
<b>Vendor:</b>			
<b>Description:</b>	This component includes making any repairs to the concrete pavers. These pavers should have a very long useful life. However, over time some pavers may break and repairs and replacements will be necessary. This component funds to repair and replace 15% of the total area every 10 years. This schedule may need to be adjusted as a cost history is developed.		
<b>Evaluation:</b>	No problems noted.		
<b>Quantity Notes:</b>

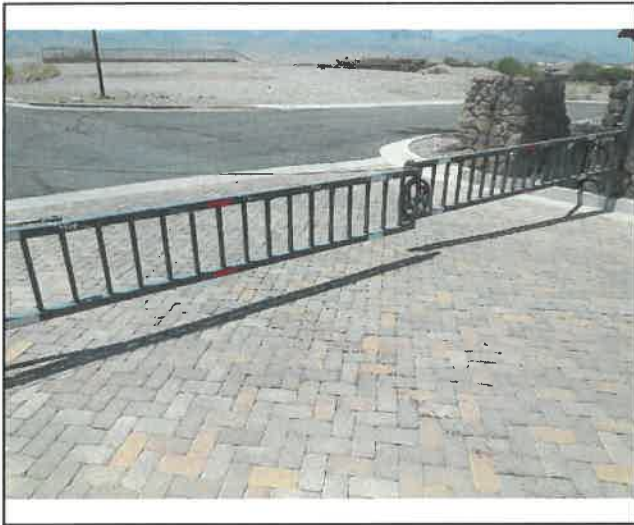
**Comp #: 4.501 Vehicle Gates - Replace**

<b>Quantity:</b>	4 Gate Leafs	<b>Unit Cost:</b>	\$2,500.00
<b>Orig. Service:</b>	2007	<b>% of Unit Cost:</b>	100.0%
<b>Useful Life:</b>	30	<b>Total Current Cost:</b>	\$10,000.00
<b>RUL Adjustment:</b>	0	<b>Cost Explanation:</b>	Estimate to replace
<b>Rem. Useful Life:</b>	19	<b>Cost Source:</b>	GeoReserves Database
<b>Vendor:</b>			
<b>Description:</b>	This component includes replacing the vehicle gates. These gates should last approximately 25 to 30 years before they should be replaced to improve the appearance of the entrance area. Any accidents from cars hitting these gates should be considered an insurance issue and not a normal reserve expense. Additional information can be found at <a href="http://iframe.americanfenceassociation.com">iframe.americanfenceassociation.com</a> .		
<b>Evaluation:</b>	No problems with these gates noted.		
<b>Quantity Notes:</b>

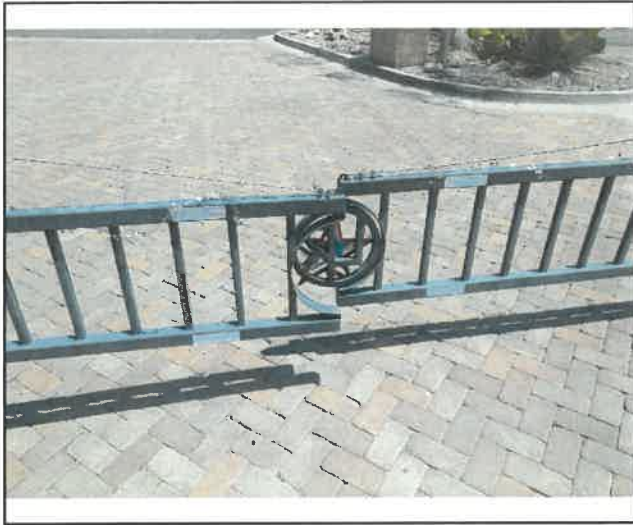
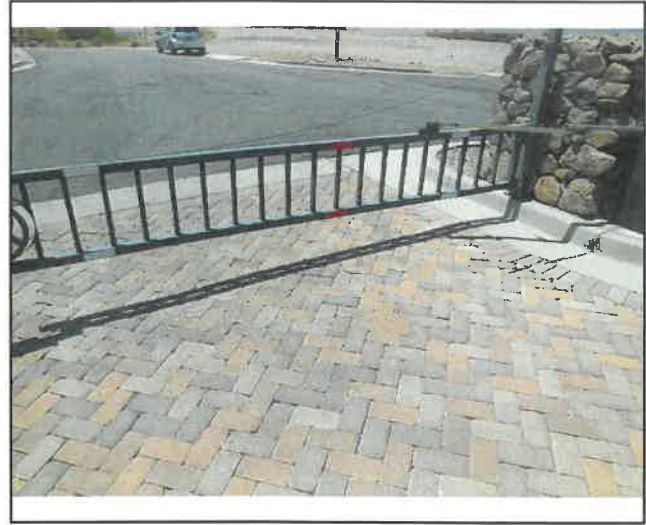
**Comp #: 4.502 Vehicle Gates - Repaint**

<b>Quantity:</b>	4 Gate Leafs	<b>Unit Cost:</b>	\$125.00
<b>Orig. Service:</b>	2017	<b>% of Unit Cost:</b>	100.0%
<b>Useful Life:</b>	5	<b>Total Current Cost:</b>	\$500.00
<b>RUL Adjustment:</b>	0	<b>Cost Explanation:</b>	Estimate to repaint
<b>Rem. Useful Life:</b>	4	<b>Cost Source:</b>	GeoReserves Database
<b>Vendor:</b>			
<b>Description:</b>	This component includes painting the gates, along with making any repairs to bent or rusted areas. This project should be performed every 5 years or when necessary to maintain appearance and ensure the fence realizes a full useful life. Different paint materials and techniques will determine the actual useful life and may result in adjusting this schedule.		
<b>Evaluation:</b>	No rusting or other appearance concerns such as faded paint noted.		
<b>Quantity Notes:</b>

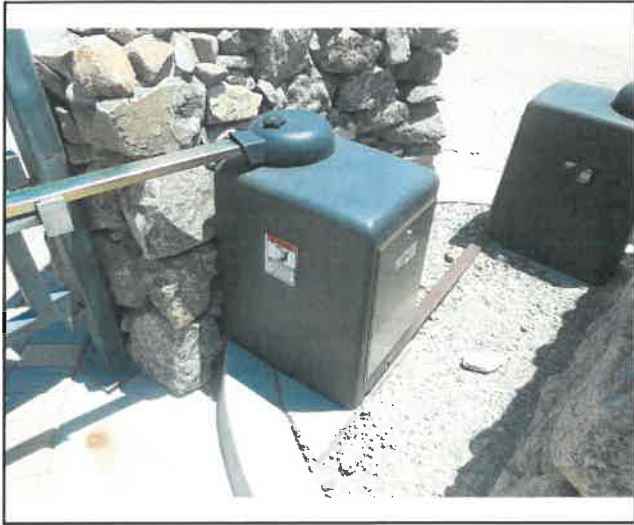
**Comp #: 4.504 Vehicle Gate Operators - Repair/Part Replacement**

<b>Quantity:</b>	4 Gate Operators	<b>Unit Cost:</b>	\$125.00
<b>Orig. Service:</b>	2017	<b>% of Unit Cost:</b>	100.0%
<b>Useful Life:</b>	1	<b>Total Current Cost:</b>	\$500.00
<b>RUL Adjustment:</b>	0	<b>Cost Explanation:</b>	Estimate to make repairs and replacements
<b>Rem. Useful Life:</b>	0	<b>Cost Source:</b>	GeoReserves Database
<b>Vendor:</b>			
<b>Description:</b>	This component includes the battery backups, which are replaced every year as a reserve expense. This component also funds for any additional parts may need to be repaired or replaced as necessary.		
<b>Evaluation:</b>	No operational problems noted. This site visit does not include any mechanical testing and a maintenance plan with frequent inspections from a trained professional is recommended.		
<b>Quantity Notes:</b>

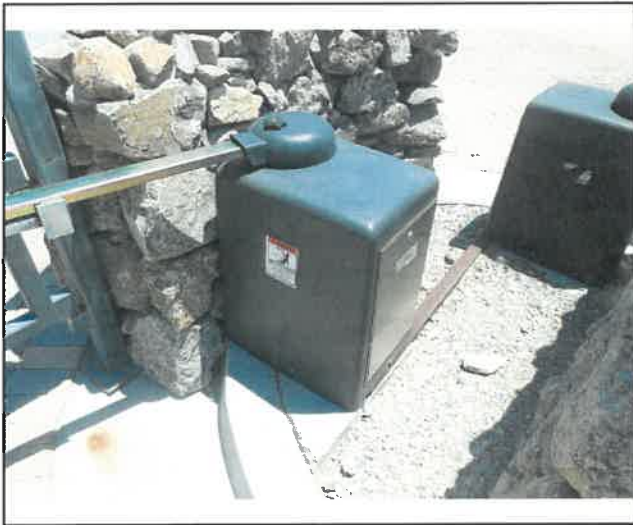
**Comp #: 4.505 Vehicle Gate Operators - Replace**

<b>Quantity:</b>	4 Gate Operators	<b>Unit Cost:</b>	\$4,000.00
<b>Orig. Service:</b>	2017	<b>% of Unit Cost:</b>	100.0%
<b>Useful Life:</b>	12	<b>Total Current Cost:</b>	\$16,000.00
<b>RUL Adjustment:</b>	0	<b>Cost Explanation:</b>	Estimate to replace
<b>Rem. Useful Life:</b>	11	<b>Cost Source:</b>	GeoReserves Database
<b>Vendor:</b>			
<b>Description:</b>	This component includes replacing the entire gate operator unit. During the normal life of these gate operators certain parts, such as battery backups, circuit boards and motors may need to be repaired or replaced. For most associations, these minor costs should be considered an operating expense. Gate operators should last between 10 to 12 years however the actual life could be longer if individual parts are routinely replaced. Additional information can be found at <a href="http://www.dasma.com">www.dasma.com</a> .		
<b>Evaluation:</b>	These gate operators were functioning normally at time of site visit with no problems noted.

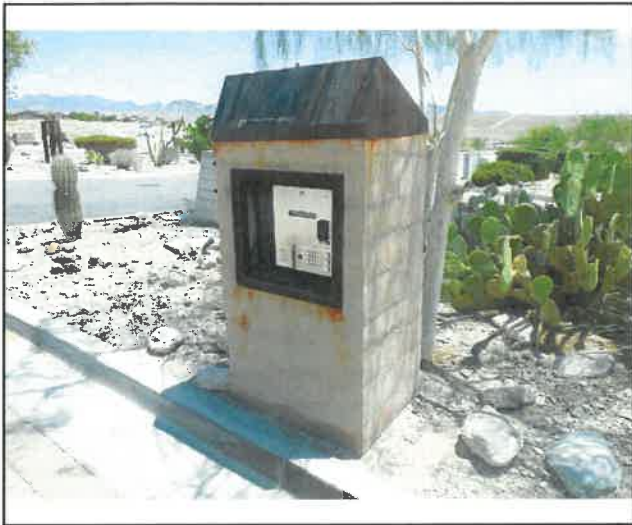
**Comp #: 4.507 Vehicle Gate Entrance System - Replace**

<b>Evaluation:</b>	This component is functional with no major problems noted.		
<b>Quantity Notes:</b>

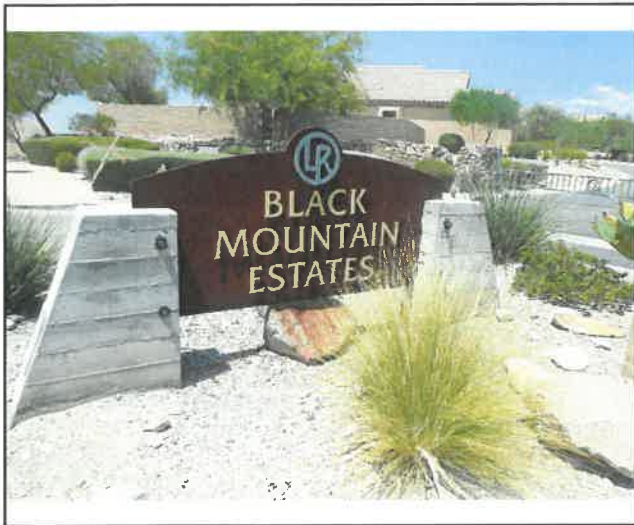
**Comp #: 5.104 Monument - Refurbish**

<b>Quantity:</b>	1 Monument	<b>Unit Cost:</b>	\$5,000.00
<b>Orig. Service:</b>	2006	<b>% of Unit Cost:</b>	100.0%
<b>Useful Life:</b>	20	<b>Total Current Cost:</b>	\$5,000.00
<b>RUL Adjustment:</b>	0	<b>Cost Explanation:</b>	Estimate to refurbish
<b>Rem. Useful Life:</b>	8	<b>Cost Source:</b>	GeoReserves Database
<b>Vendor:</b>			
<b>Description:</b>	Monuments can come in a wide range of sizes, materials, and designs. However, over time they will eventually need to be updated to maintain appearance and to keep a current look. This component can include a general refurbishment or a complete replacement. The cost and useful life of this project can vary depending on what type of monument the association has installed. Any minor repairs should be done regularly as an operating expense.		
<b>Evaluation:</b>	No major appearance concerns noted.		
<b>Quantity Notes:</b>

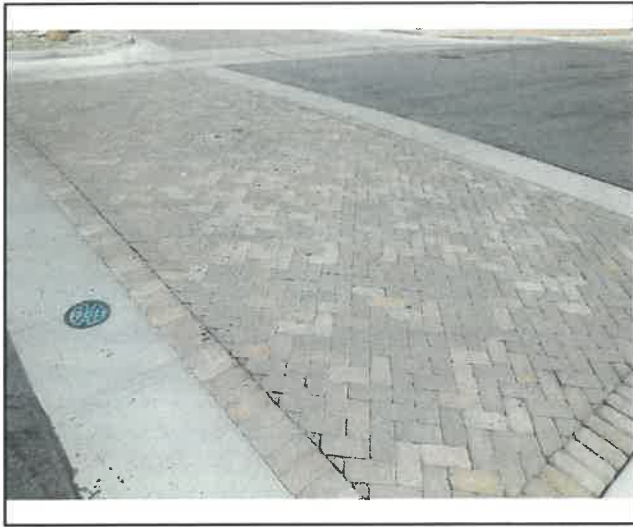
**Comp #: 5.210 Concrete Pavers - Repair/Replace**

<b>Quantity:</b>	1500 Sq.ft.	<b>Unit Cost:</b>	\$10.00
<b>Orig. Service:</b>	2007	<b>% of Unit Cost:</b>	15.0%
<b>Useful Life:</b>	10	<b>Total Current Cost:</b>	\$2,250.00
<b>RUL Adjustment:</b>	5	<b>Cost Explanation:</b>	Estimate to repair
<b>Rem. Useful Life:</b>	4	<b>Cost Source:</b>	GeoReserves Database
<b>Vendor:</b>			
<b>Description:</b>	This component includes making any repairs to the concrete pavers. These pavers should have a very long useful life. However, over time some pavers may break and repairs and replacments will be necessary. This component funds to repair and replace 15% of the total area every 10 years. This schedule may need to be adjusted as a cost history is developed.		
<b>Evaluation:</b>	No problems noted.		
<b>Quantity Notes:</b>

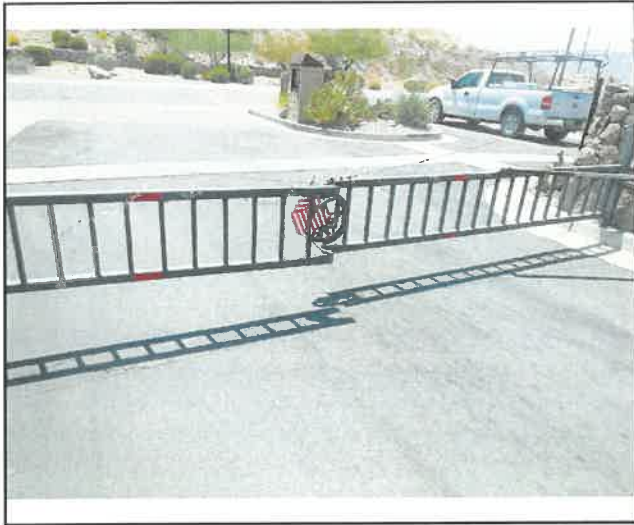
**Comp #: 5.501 Vehicle Gates - Replace**

<b>Quantity:</b>	4 Gate Leafs	<b>Unit Cost:</b>	\$2,500.00
<b>Orig. Service:</b>	2007	<b>% of Unit Cost:</b>	100.0%
<b>Useful Life:</b>	30	<b>Total Current Cost:</b>	\$10,000.00
<b>RUL Adjustment:</b>	0	<b>Cost Explanation:</b>	Estimate to replace
<b>Rem. Useful Life:</b>	19	<b>Cost Source:</b>	GeoReserves Database
<b>Vendor:</b>			
<b>Description:</b>	This component includes replacing the vehicle gates. These gates should last approximately 25 to 30 years before they should be replaced to improve the appearance of the entrance area. Any accidents from cars hitting these gates should be considered an insurance issue and not a normal reserve expense. Additional information can be found at <a href="http://iframe.americanfenceassociation.com">iframe.americanfenceassociation.com</a> .		
<b>Evaluation:</b>	No problems with these gates noted.		
<b>Quantity Notes:</b>

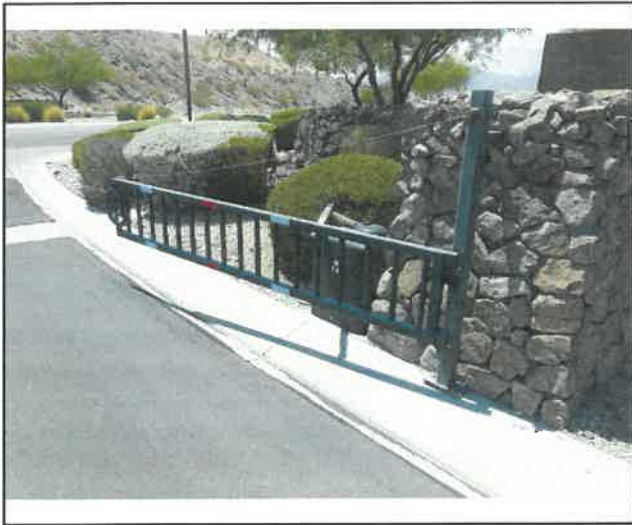
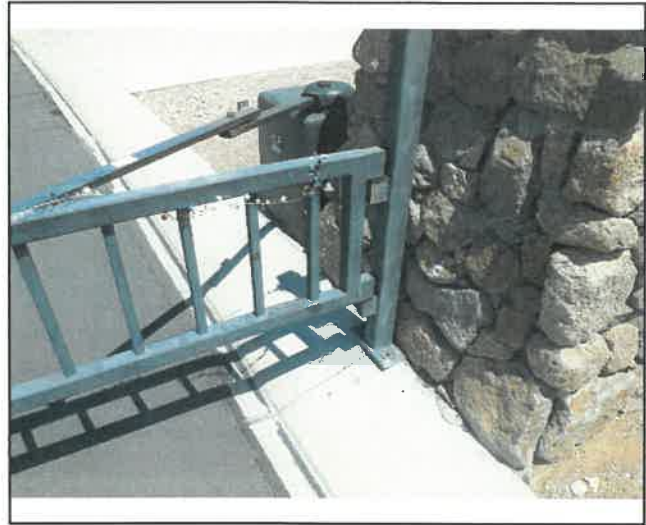
**Comp #: 5.502 Vehicle Gates - Repaint**

<b>Quantity:</b>	4 Gate Leafs	<b>Unit Cost:</b>	\$125.00
<b>Orig. Service:</b>	2017	<b>% of Unit Cost:</b>	100.0%
<b>Useful Life:</b>	5	<b>Total Current Cost:</b>	\$500.00
<b>RUL Adjustment:</b>	0	<b>Cost Explanation:</b>	Estimate to repaint
<b>Rem. Useful Life:</b>	4	<b>Cost Source:</b>	GeoReserves Database
<b>Vendor:</b>			
<b>Description:</b>	This component includes painting the gates, along with making any repairs to bent or rusted areas. This project should be performed every 5 years or when necessary to maintain appearance and ensure the fence realizes a full useful life. Different paint materials and techniques will determine the actual useful life and may result in adjusting this schedule.		
<b>Evaluation:</b>	No rusting or other appearance concerns such as faded paint noted.		
<b>Quantity Notes:</b>
