**LAUGHLIN RANCH OWNERS ASSOCIATION (NEIGHBORHOODS)**

## **Level 1 -- Full Reserve Study with Site Visit**

**Prepared By: Byron Goetting      NV Permit #072**

**Date of Site Inspection:      07/07/2017**

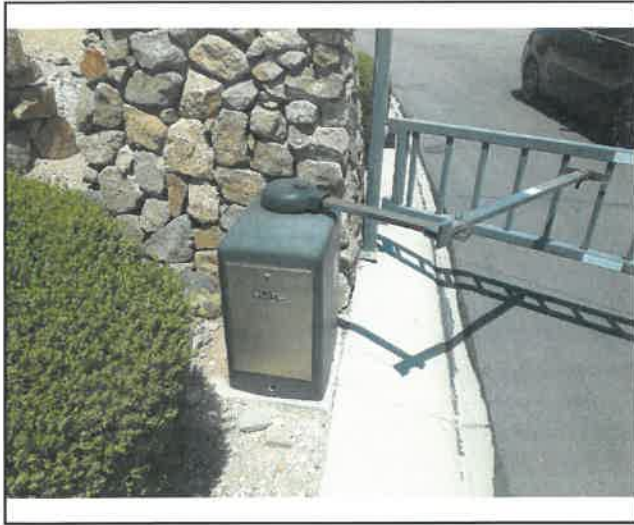
**Comp #: 5.504 Vehicle Gate Operators - Repair/Part Replacement**

<b>Quantity:</b>	4 Gate Operators	<b>Unit Cost:</b>	\$125.00
<b>Orig. Service:</b>	2017	<b>% of Unit Cost:</b>	100.0%
<b>Useful Life:</b>	1	<b>Total Current Cost:</b>	\$500.00
<b>RUL Adjustment:</b>	0	<b>Cost Explanation:</b>	Estimate to make repairs and replacements
<b>Rem. Useful Life:</b>	0	<b>Cost Source:</b>	GeoReserves Database
<b>Vendor:</b>			
<b>Description:</b>	This component includes the battery backups, which are replaced every year as a reserve expense. This component also funds for any additional parts may need to be repaired or replaced as necessary.		
<b>Evaluation:</b>	No operational problems noted. This site visit does not include any mechanical testing and a maintenance plan with frequent inspections from a trained professional is recommended.		
<b>Quantity Notes:</b>

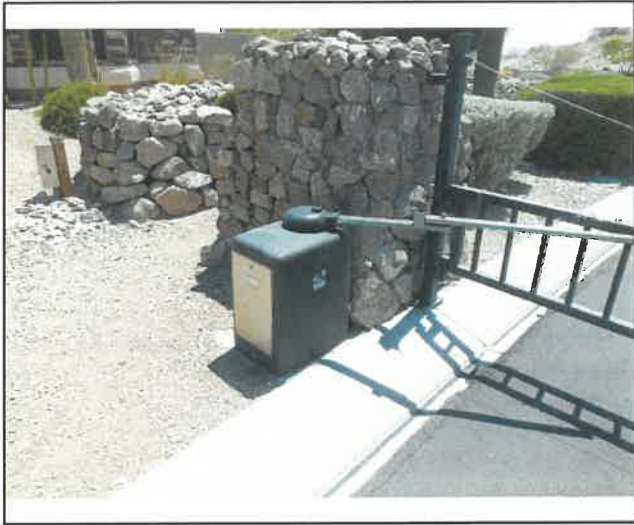
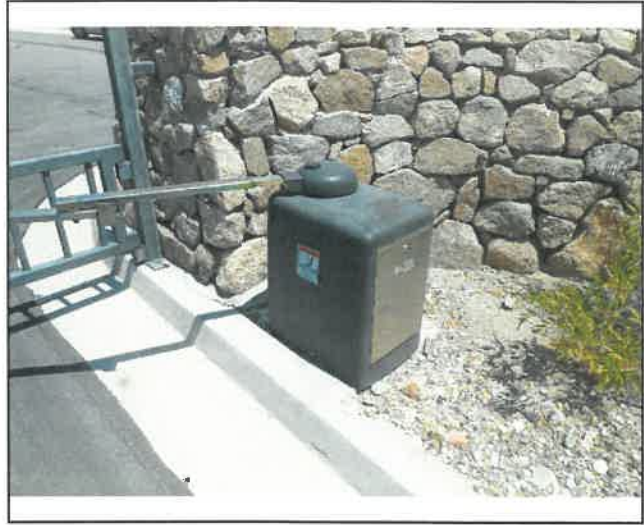
**Comp #: 5.505 Vehicle Gate Operators - Replace**

<b>Quantity:</b>	4 Gate Operators	<b>Unit Cost:</b>	\$4,000.00
<b>Orig. Service:</b>	2017	<b>% of Unit Cost:</b>	100.0%
<b>Useful Life:</b>	12	<b>Total Current Cost:</b>	\$16,000.00
<b>RUL Adjustment:</b>	0	<b>Cost Explanation:</b>	Estimate to replace
<b>Rem. Useful Life:</b>	11	<b>Cost Source:</b>	GeoReserves Database
<b>Vendor:</b>			
<b>Description:</b>	This component includes replacing the entire gate operator unit. During the normal life of these gate operators certain parts, such as battery backups, circuit boards and motors may need to be repaired or replaced. For most associations, these minor costs should be considered an operating expense. Gate operators should last between 10 to 12 years however the actual life could be longer if individual parts are routinely replaced. Additional information can be found at <a href="http://www.dasma.com">www.dasma.com</a> .		
<b>Evaluation:</b>	These gate operators were functioning normally at time of site visit with no problems noted.

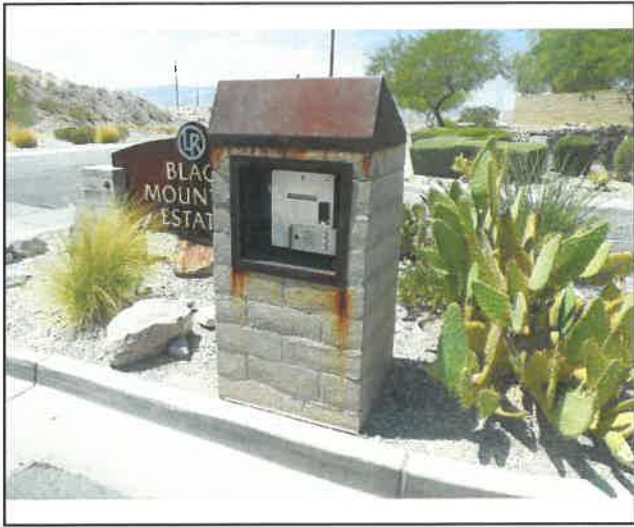
**Comp #: 5.507 Vehicle Gate Entrance System - Replace**

<b>Evaluation:</b>	This component is functional with no major problems noted.		
<b>Quantity Notes:</b>

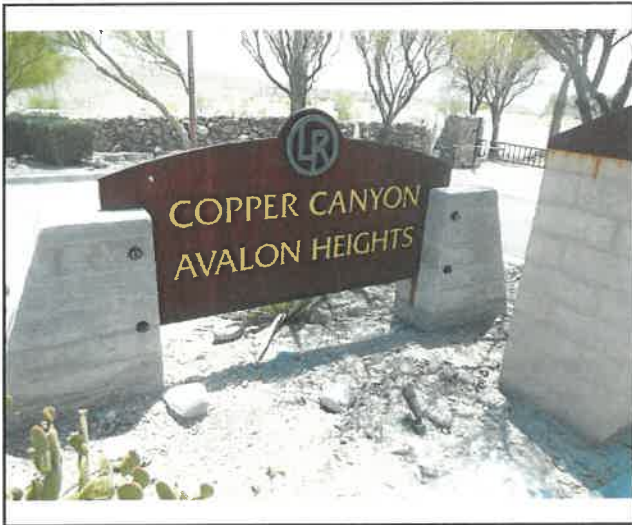
**Comp #: 6.104 Monument - Refurbish**

<b>Quantity:</b>	1 Monument	<b>Unit Cost:</b>	\$5,000.00
<b>Orig. Service:</b>	2006	<b>% of Unit Cost:</b>	100.0%
<b>Useful Life:</b>	20	<b>Total Current Cost:</b>	\$5,000.00
<b>RUL Adjustment:</b>	0	<b>Cost Explanation:</b>	Estimate to refurbish
<b>Rem. Useful Life:</b>	8	<b>Cost Source:</b>	GeoReserves Database
<b>Vendor:</b>			
<b>Description:</b>	Monuments can come in a wide range of sizes, materials, and designs. However, over time they will eventually need to be updated to maintain appearance and to keep a current look. This component can include a general refurbishment or a complete replacement. The cost and useful life of this project can vary depending on what type of monument the association has installed. Any minor repairs should be done regularly as an operating expense.		
<b>Evaluation:</b>	No major appearance concerns noted.		
<b>Quantity Notes:</b>

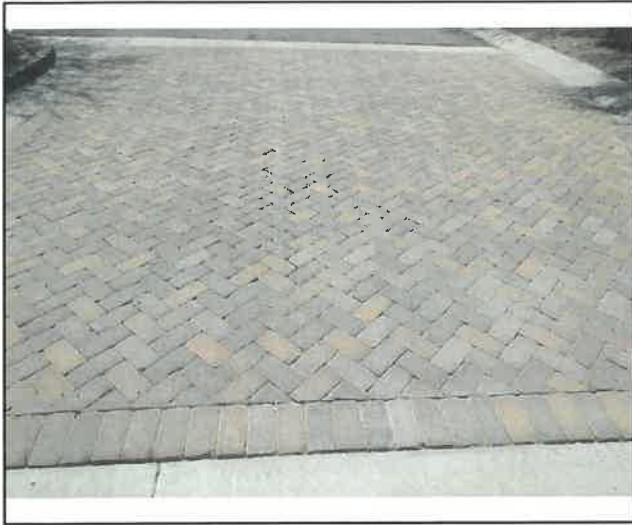
**Comp #: 6.210 Concrete Pavers - Repair/Replace**

<b>Quantity:</b>	1150 Sq.ft.	<b>Unit Cost:</b>	\$10.00
<b>Orig. Service:</b>	2007	<b>% of Unit Cost:</b>	15.0%
<b>Useful Life:</b>	10	<b>Total Current Cost:</b>	\$1,725.00
<b>RUL Adjustment:</b>	5	<b>Cost Explanation:</b>	Estimate to repair
<b>Rem. Useful Life:</b>	4	<b>Cost Source:</b>	GeoReserves Database
<b>Vendor:</b>			
<b>Description:</b>	This component includes making any repairs to the concrete pavers. These pavers should have a very long useful life. However, over time some pavers may break and repairs and replacements will be necessary. This component funds to repair and replace 15% of the total area every 10 years. This schedule may need to be adjusted as a cost history is developed.		
<b>Evaluation:</b>	No problems noted.		
<b>Quantity Notes:</b>

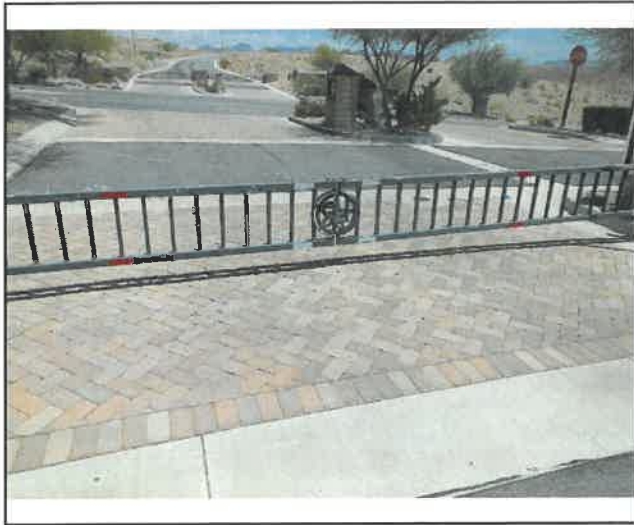
**Comp #: 6.501 Vehicle Gates - Replace**

<b>Quantity:</b>	4 Gate Leafs	<b>Unit Cost:</b>	\$2,500.00
<b>Orig. Service:</b>	2007	<b>% of Unit Cost:</b>	100.0%
<b>Useful Life:</b>	30	<b>Total Current Cost:</b>	\$10,000.00
<b>RUL Adjustment:</b>	0	<b>Cost Explanation:</b>	Estimate to replace
<b>Rem. Useful Life:</b>	19	<b>Cost Source:</b>	GeoReserves Database
<b>Vendor:</b>			
<b>Description:</b>	This component includes replacing the vehicle gates. These gates should last approximately 25 to 30 years before they should be replaced to improve the appearance of the entrance area. Any accidents from cars hitting these gates should be considered an insurance issue and not a normal reserve expense. Additional information can be found at <a href="http://iframe.americanfenceassociation.com">iframe.americanfenceassociation.com</a> .		
<b>Evaluation:</b>	No problems with these gates noted.		
<b>Quantity Notes:</b>

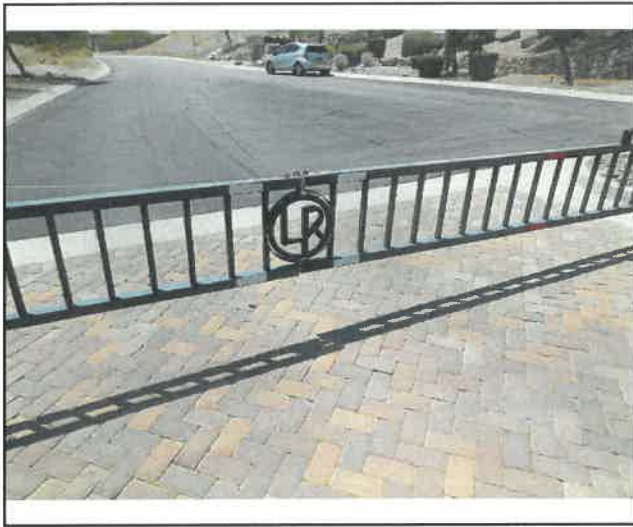
**Comp #: 6.502 Vehicle Gates - Repaint**

<b>Quantity:</b>	4 Gate Leafs	<b>Unit Cost:</b>	\$125.00
<b>Orig. Service:</b>	2017	<b>% of Unit Cost:</b>	100.0%
<b>Useful Life:</b>	5	<b>Total Current Cost:</b>	\$500.00
<b>RUL Adjustment:</b>	0	<b>Cost Explanation:</b>	Estimate to repaint
<b>Rem. Useful Life:</b>	4	<b>Cost Source:</b>	GeoReserves Database
<b>Vendor:</b>			
<b>Description:</b>	This component includes painting the gates, along with making any repairs to bent or rusted areas. This project should be performed every 5 years or when necessary to maintain appearance and ensure the fence realizes a full useful life. Different paint materials and techniques will determine the actual useful life and may result in adjusting this schedule.		
<b>Evaluation:</b>	No rusting or other appearance concerns such as faded paint noted.		
<b>Quantity Notes:</b>

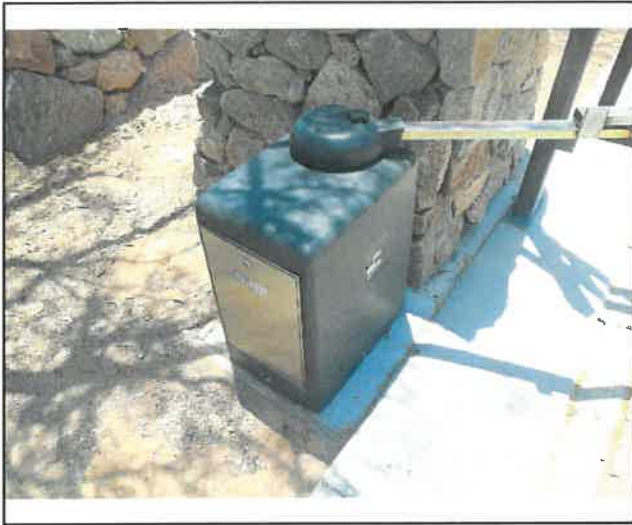
**Comp #: 6.504 Vehicle Gate Operators - Repair/Part Replacement**

<b>Quantity:</b>	4 Gate Operators	<b>Unit Cost:</b>	\$125.00
<b>Orig. Service:</b>	2017	<b>% of Unit Cost:</b>	100.0%
<b>Useful Life:</b>	1	<b>Total Current Cost:</b>	\$500.00
<b>RUL Adjustment:</b>	0	<b>Cost Explanation:</b>	Estimate to make repairs and replacements
<b>Rem. Useful Life:</b>	0	<b>Cost Source:</b>	GeoReserves Database
<b>Vendor:</b>			
<b>Description:</b>	This component includes the battery backups, which are replaced every year as a reserve expense. This component also funds for any additional parts may need to be repaired or replaced as necessary.		
<b>Evaluation:</b>	No operational problems noted. This site visit does not include any mechanical testing and a maintenance plan with frequent inspections from a trained professional is recommended.		
<b>Quantity Notes:</b>

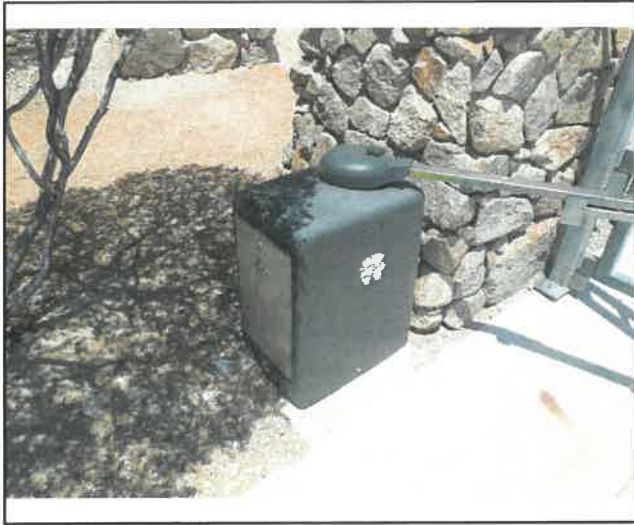
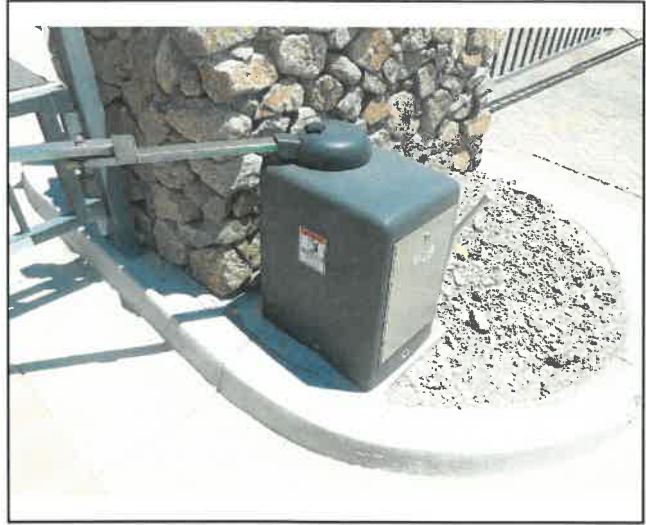
**Comp #: 6.505 Vehicle Gate Operators - Replace**

<b>Quantity:</b>	4 Gate Operators	<b>Unit Cost:</b>	\$4,000.00
<b>Orig. Service:</b>	2017	<b>% of Unit Cost:</b>	100.0%
<b>Useful Life:</b>	12	<b>Total Current Cost:</b>	\$16,000.00
<b>RUL Adjustment:</b>	0	<b>Cost Explanation:</b>	Estimate to replace
<b>Rem. Useful Life:</b>	11	<b>Cost Source:</b>	GeoReserves Database
<b>Vendor:</b>			
<b>Description:</b>	This component includes replacing the entire gate operator unit. During the normal life of these gate operators certain parts, such as battery backups, circuit boards and motors may need to be repaired or replaced. For most associations, these minor costs should be considered an operating expense. Gate operators should last between 10 to 12 years however the actual life could be longer if individual parts are routinely replaced. Additional information can be found at <a href="http://www.dasma.com">www.dasma.com</a> .		
<b>Evaluation:</b>	These gate operators were functioning normally at time of site visit with no problems noted.

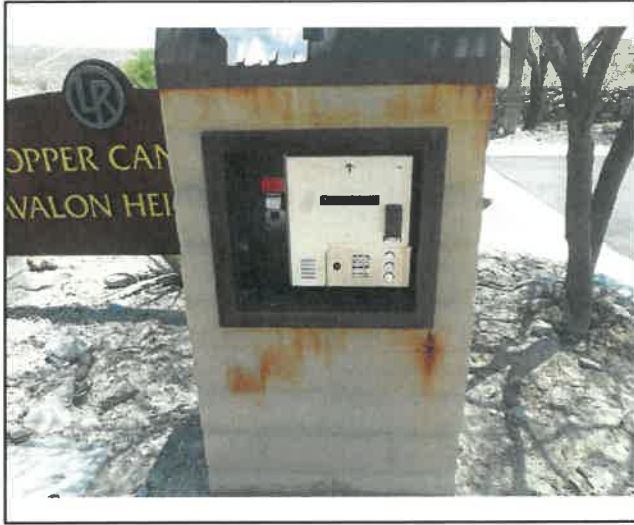
**Comp #: 6.507 Vehicle Gate Entrance System - Replace**

<b>Evaluation:</b>	This component is functional with no major problems noted.		
<b>Quantity Notes:</b>

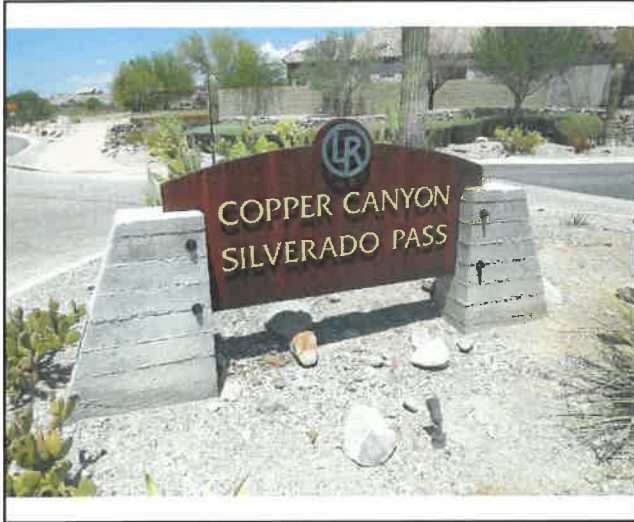
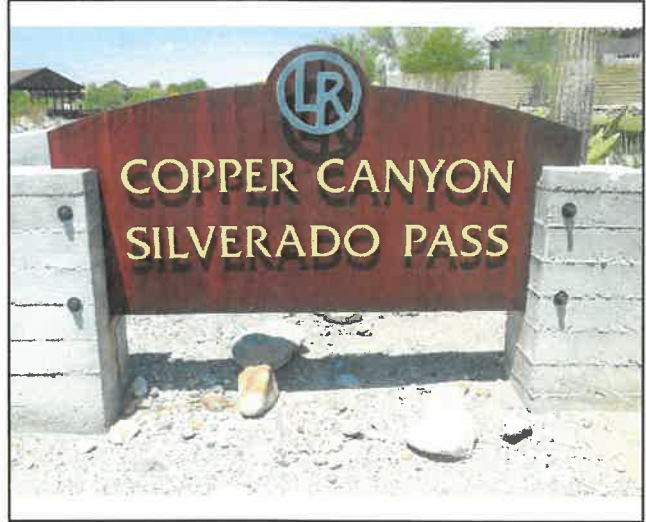
**Comp #: 7.104 Monument - Refurbish**

<b>Quantity:</b>	1 Monument	<b>Unit Cost:</b>	\$5,000.00
<b>Orig. Service:</b>	2006	<b>% of Unit Cost:</b>	100.0%
<b>Useful Life:</b>	20	<b>Total Current Cost:</b>	\$5,000.00
<b>RUL Adjustment:</b>	0	<b>Cost Explanation:</b>	Estimate to refurbish
<b>Rem. Useful Life:</b>	8	<b>Cost Source:</b>	GeoReserves Database
<b>Vendor:</b>			
<b>Description:</b>	Monuments can come in a wide range of sizes, materials, and designs. However, over time they will eventually need to be updated to maintain appearance and to keep a current look. This component can include a general refurbishment or a complete replacement. The cost and useful life of this project can vary depending on what type of monument the association has installed. Any minor repairs should be done regularly as an operating expense.		
<b>Evaluation:</b>	No major appearance concerns noted.		
<b>Quantity Notes:</b>

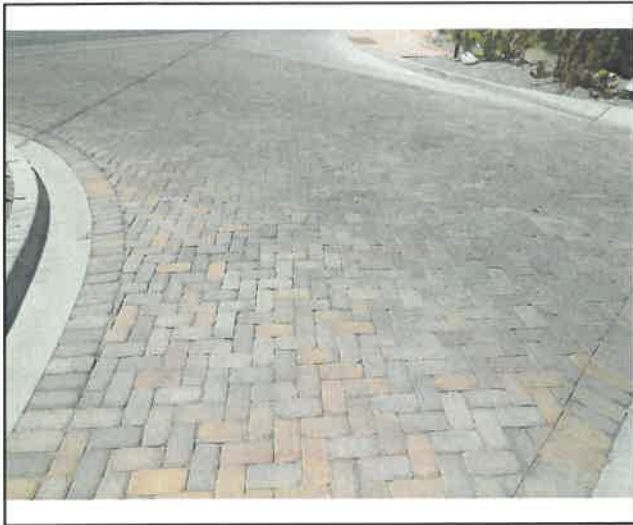
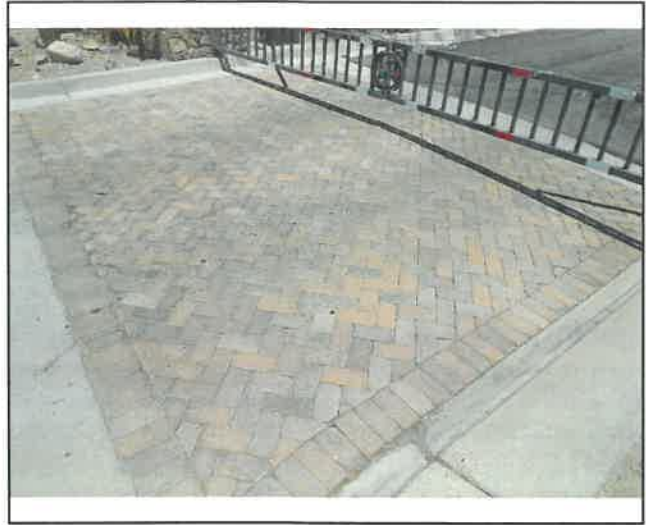
**Comp #: 7.210 Concrete Pavers - Repair/Replace**

<b>Quantity:</b>	2225 Sq.ft.	<b>Unit Cost:</b>	\$10.00
<b>Orig. Service:</b>	2007	<b>% of Unit Cost:</b>	15.0%
<b>Useful Life:</b>	10	<b>Total Current Cost:</b>	\$3,337.50
<b>RUL Adjustment:</b>	5	<b>Cost Explanation:</b>	Estimate to repair
<b>Rem. Useful Life:</b>	4	<b>Cost Source:</b>	GeoReserves Database
<b>Vendor:</b>			
<b>Description:</b>	This component includes making any repairs to the concrete pavers. These pavers should have a very long useful life. However, over time some pavers may break and repairs and replacements will be necessary. This component funds to repair and replace 15% of the total area every 10 years. This schedule may need to be adjusted as a cost history is developed.		
<b>Evaluation:</b>	No problems noted.		
<b>Quantity Notes:</b>

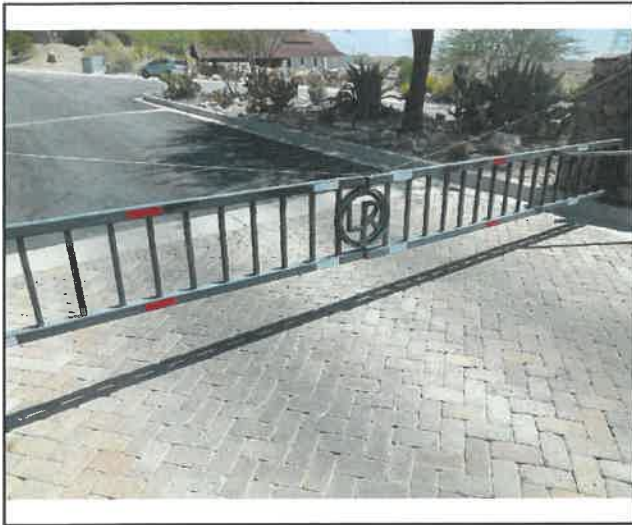
**Comp #: 7.501 Vehicle Gates - Replace**

<b>Quantity:</b>	4 Gate Leafs	<b>Unit Cost:</b>	\$2,500.00
<b>Orig. Service:</b>	2007	<b>% of Unit Cost:</b>	100.0%
<b>Useful Life:</b>	30	<b>Total Current Cost:</b>	\$10,000.00
<b>RUL Adjustment:</b>	0	<b>Cost Explanation:</b>	Estimate to replace
<b>Rem. Useful Life:</b>	19	<b>Cost Source:</b>	GeoReserves Database
<b>Vendor:</b>			
<b>Description:</b>	This component includes replacing the vehicle gates. These gates should last approximately 25 to 30 years before they should be replaced to improve the appearance of the entrance area. Any accidents from cars hitting these gates should be considered an insurance issue and not a normal reserve expense. Additional information can be found at <a href="http://iframe.americanfenceassociation.com">iframe.americanfenceassociation.com</a> .		
<b>Evaluation:</b>	No problems with these gates noted.		
<b>Quantity Notes:</b>

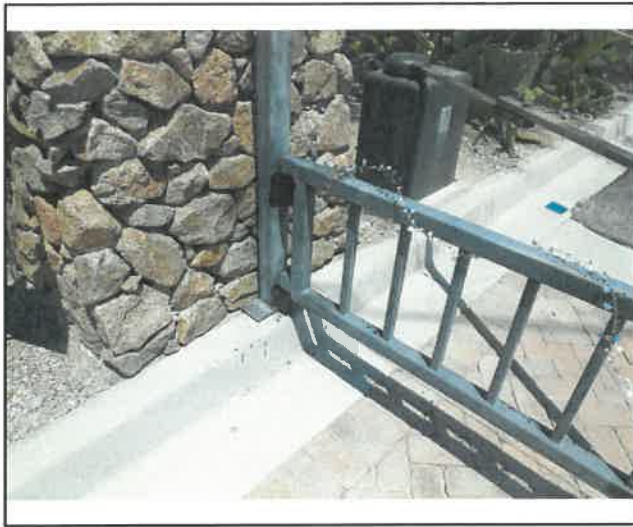
**Comp #: 7.502 Vehicle Gates - Repaint**

<b>Quantity:</b>	4 Gate Leafs	<b>Unit Cost:</b>	\$125.00
<b>Orig. Service:</b>	2017	<b>% of Unit Cost:</b>	100.0%
<b>Useful Life:</b>	5	<b>Total Current Cost:</b>	\$500.00
<b>RUL Adjustment:</b>	0	<b>Cost Explanation:</b>	Estimate to repaint
<b>Rem. Useful Life:</b>	4	<b>Cost Source:</b>	GeoReserves Database
<b>Vendor:</b>			
<b>Description:</b>	This component includes painting the gates, along with making any repairs to bent or rusted areas. This project should be performed every 5 years or when necessary to maintain appearance and ensure the fence realizes a full useful life. Different paint materials and techniques will determine the actual useful life and may result in adjusting this schedule.		
<b>Evaluation:</b>	No rusting or other appearance concerns such as faded paint noted.		
<b>Quantity Notes:</b>

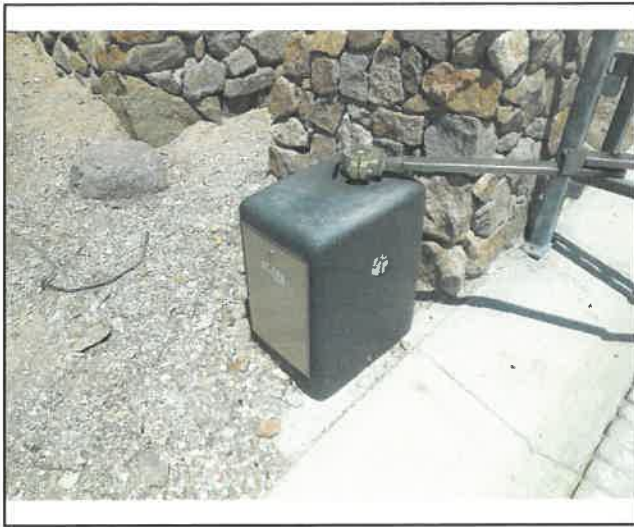
**Comp #: 7.504 Vehicle Gate Operators - Repair/Part Replacement**

<b>Quantity:</b>	4 Gate Operators	<b>Unit Cost:</b>	\$125.00
<b>Orig. Service:</b>	2017	<b>% of Unit Cost:</b>	100.0%
<b>Useful Life:</b>	1	<b>Total Current Cost:</b>	\$500.00
<b>RUL Adjustment:</b>	0	<b>Cost Explanation:</b>	Estimate to make repairs and replacements
<b>Rem. Useful Life:</b>	0	<b>Cost Source:</b>	GeoReserves Database
<b>Vendor:</b>			
<b>Description:</b>	This component includes the battery backups, which are replaced every year as a reserve expense. This component also funds for any additional parts may need to be repaired or replaced as necessary.		
<b>Evaluation:</b>	No operational problems noted. This site visit does not include any mechanical testing and a maintenance plan with frequent inspections from a trained professional is recommended.		
<b>Quantity Notes:</b>

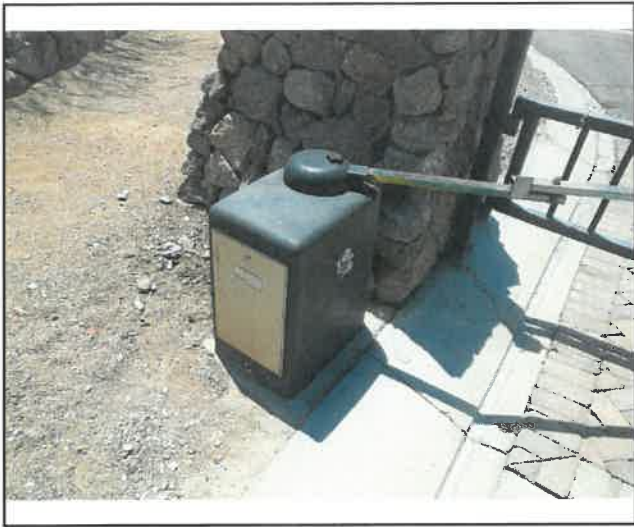
**Comp #: 7.505 Vehicle Gate Operators - Replace**

<b>Quantity:</b>	4 Gate Operators	<b>Unit Cost:</b>	\$4,000.00
<b>Orig. Service:</b>	2017	<b>% of Unit Cost:</b>	100.0%
<b>Useful Life:</b>	12	<b>Total Current Cost:</b>	\$16,000.00
<b>RUL Adjustment:</b>	0	<b>Cost Explanation:</b>	Estimate to replace
<b>Rem. Useful Life:</b>	11	<b>Cost Source:</b>	GeoReserves Database
<b>Vendor:</b>			
<b>Description:</b>	This component includes replacing the entire gate operator unit. During the normal life of these gate operators certain parts, such as battery backups, circuit boards and motors may need to be repaired or replaced. For most associations, these minor costs should be considered an operating expense. Gate operators should last between 10 to 12 years however the actual life could be longer if individual parts are routinely replaced. Additional information can be found at <a href="http://www.dasma.com">www.dasma.com</a> .		
<b>Evaluation:</b>	These gate operators were functioning normally at time of site visit with no problems noted.

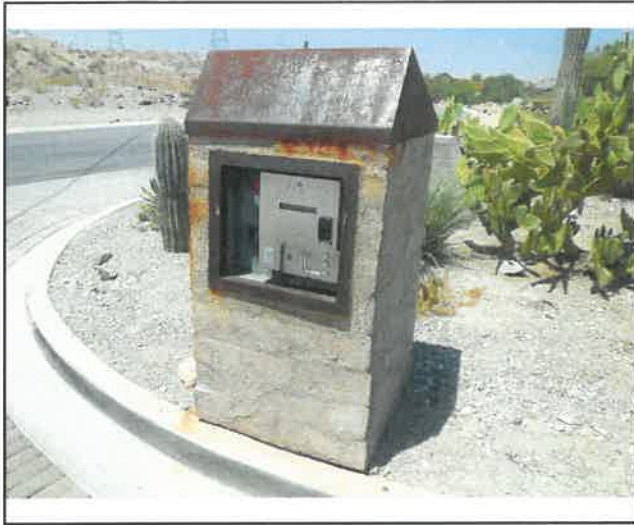
**Comp #: 7.507 Vehicle Gate Entrance System - Replace**

<b>Evaluation:</b>	<p>This component is functional with no major problems noted.</p>		
<b>Quantity Notes:</b>

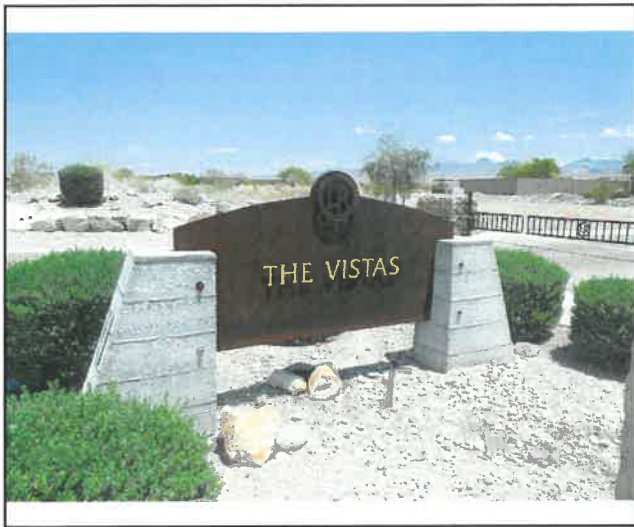
**Comp #: 8.104 Monument - Refurbish**

<b>Quantity:</b>	1 Monument	<b>Unit Cost:</b>	\$5,000.00
<b>Orig. Service:</b>	2016	<b>% of Unit Cost:</b>	100.0%
<b>Useful Life:</b>	20	<b>Total Current Cost:</b>	\$5,000.00
<b>RUL Adjustment:</b>	0	<b>Cost Explanation:</b>	Estimate to refurbish
<b>Rem. Useful Life:</b>	18	<b>Cost Source:</b>	GeoReserves Database
<b>Vendor:</b>			
<b>Description:</b>	Monuments can come in a wide range of sizes, materials, and designs. However, over time they will eventually need to be updated to maintain appearance and to keep a current look. This component can include a general refurbishment or a complete replacement. The cost and useful life of this project can vary depending on what type of monument the association has installed. Any minor repairs should be done regularly as an operating expense.		
<b>Evaluation:</b>	No major appearance concerns noted.		
<b>Quantity Notes:</b>

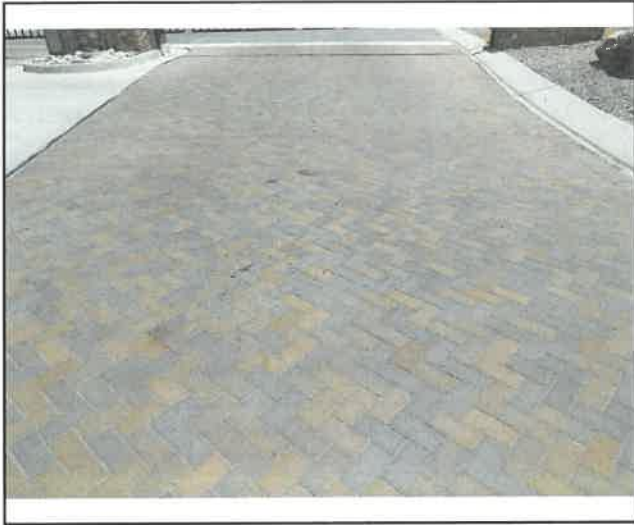
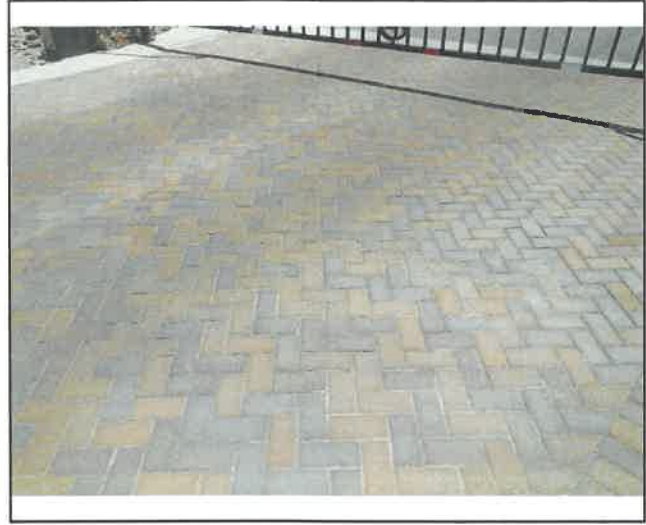
**Comp #: 8.210 Concrete Pavers - Repair/Replace**

<b>Quantity:</b>	2650 Sq.ft.	<b>Unit Cost:</b>	\$10.00
<b>Orig. Service:</b>	2016	<b>% of Unit Cost:</b>	15.0%
<b>Useful Life:</b>	10	<b>Total Current Cost:</b>	\$3,975.00
<b>RUL Adjustment:</b>	0	<b>Cost Explanation:</b>	Estimate to repair
<b>Rem. Useful Life:</b>	8	<b>Cost Source:</b>	GeoReserves Database
<b>Vendor:</b>			
<b>Description:</b>	This component includes making any repairs to the concrete pavers. These pavers should have a very long useful life. However, over time some pavers may break and repairs and replacements will be necessary. This component funds to repair and replace 15% of the total area every 10 years. This schedule may need to be adjusted as a cost history is developed.		
<b>Evaluation:</b>	No problems noted.		
<b>Quantity Notes:</b>

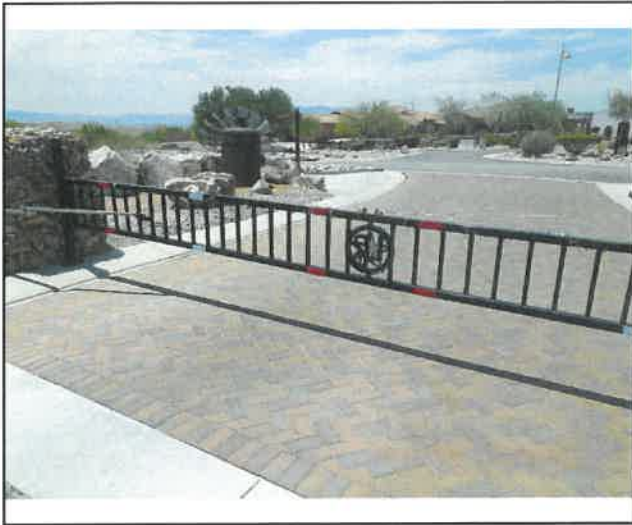
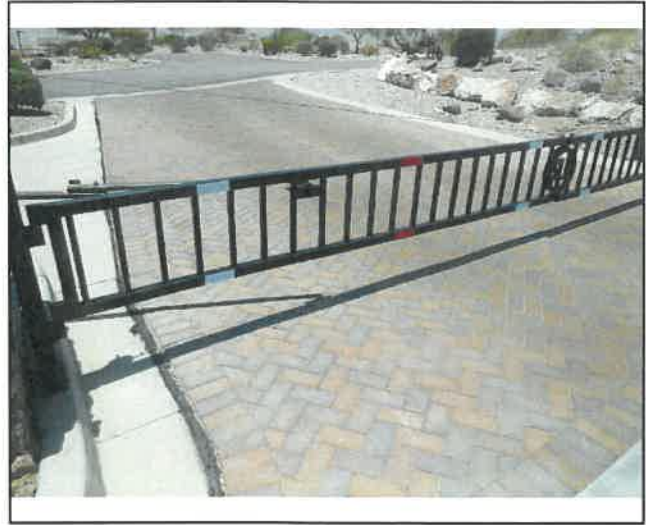
**Comp #: 8.501 Vehicle Gates - Replace**

<b>Quantity:</b>	4 Gate Leafs	<b>Unit Cost:</b>	\$2,500.00
<b>Orig. Service:</b>	2015	<b>% of Unit Cost:</b>	100.0%
<b>Useful Life:</b>	30	<b>Total Current Cost:</b>	\$10,000.00
<b>RUL Adjustment:</b>	0	<b>Cost Explanation:</b>	Estimate to replace
<b>Rem. Useful Life:</b>	27	<b>Cost Source:</b>	GeoReserves Database
<b>Vendor:</b>			
<b>Description:</b>	This component includes replacing the vehicle gates. These gates should last approximately 25 to 30 years before they should be replaced to improve the appearance of the entrance area. Any accidents from cars hitting these gates should be considered an insurance issue and not a normal reserve expense. Additional information can be found at <a href="http://iframe.americanfenceassociation.com">iframe.americanfenceassociation.com</a> .		
<b>Evaluation:</b>	No problems with these gates noted.		
<b>Quantity Notes:</b>

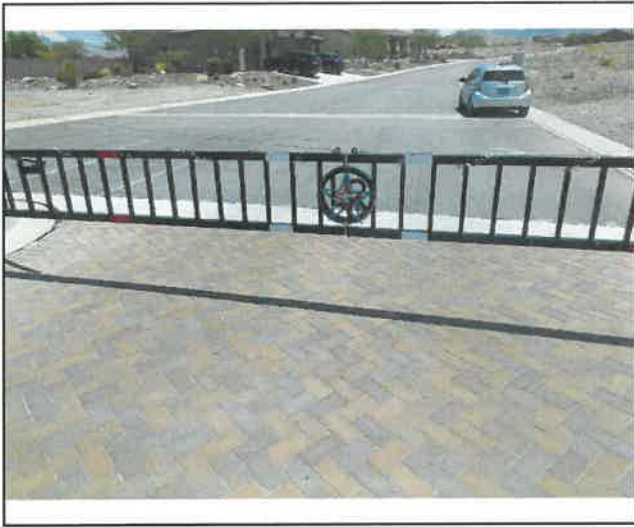
**Comp #: 8.502 Vehicle Gates - Repaint**

<b>Quantity:</b>	4 Gate Leafs	<b>Unit Cost:</b>	\$125.00
<b>Orig. Service:</b>	2015	<b>% of Unit Cost:</b>	100.0%
<b>Useful Life:</b>	5	<b>Total Current Cost:</b>	\$500.00
<b>RUL Adjustment:</b>	0	<b>Cost Explanation:</b>	Estimate to repaint
<b>Rem. Useful Life:</b>	2	<b>Cost Source:</b>	GeoReserves Database
<b>Vendor:</b>			
<b>Description:</b>	This component includes painting the gates, along with making any repairs to bent or rusted areas. This project should be performed every 5 years or when necessary to maintain appearance and ensure the fence realizes a full useful life. Different paint materials and techniques will determine the actual useful life and may result in adjusting this schedule.		
<b>Evaluation:</b>	No rusting or other appearance concerns such as faded paint noted.		
<b>Quantity Notes:</b>

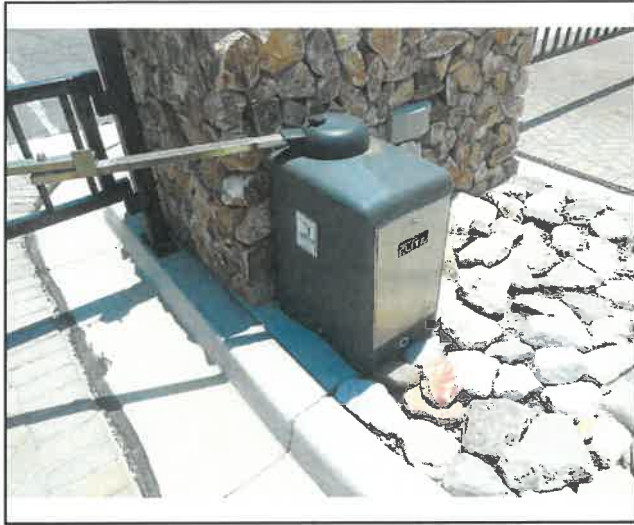
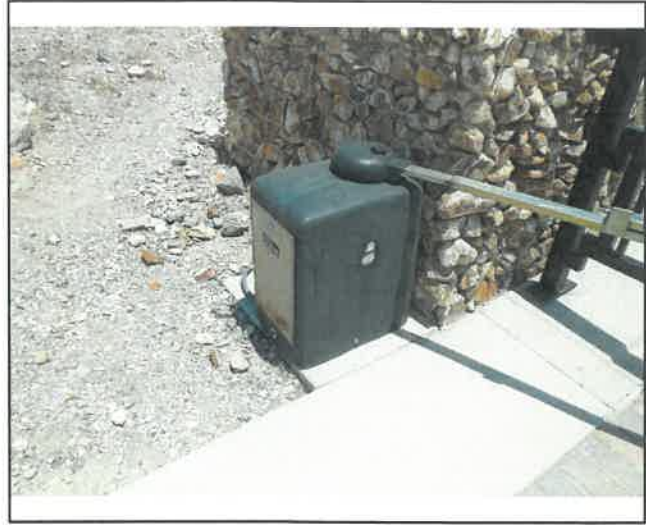
**Comp #: 8.504 Vehicle Gate Operators - Repair/Part Replacement**

<b>Quantity:</b>	4 Gate Operators	<b>Unit Cost:</b>	\$125.00
<b>Orig. Service:</b>	2017	<b>% of Unit Cost:</b>	100.0%
<b>Useful Life:</b>	1	<b>Total Current Cost:</b>	\$500.00
<b>RUL Adjustment:</b>	0	<b>Cost Explanation:</b>	Estimate to make repairs and replacements
<b>Rem. Useful Life:</b>	0	<b>Cost Source:</b>	GeoReserves Database
<b>Vendor:</b>			
<b>Description:</b>	This component includes the battery backups, which are replaced every year as a reserve expense. This component also funds for any additional parts may need to be repaired or replaced as necessary.		
<b>Evaluation:</b>	No operational problems noted. This site visit does not include any mechanical testing and a maintenance plan with frequent inspections from a trained professional is recommended.		
<b>Quantity Notes:</b>

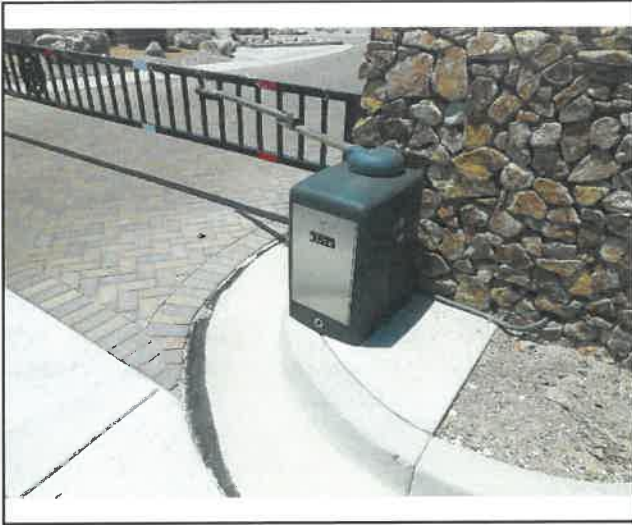
**Comp #: 8.505 Vehicle Gate Operators - Replace**

<b>Quantity:</b>	4 Gate Operators	<b>Unit Cost:</b>	\$4,000.00
<b>Orig. Service:</b>	2015	<b>% of Unit Cost:</b>	100.0%
<b>Useful Life:</b>	12	<b>Total Current Cost:</b>	\$16,000.00
<b>RUL Adjustment:</b>	0	<b>Cost Explanation:</b>	Estimate to replace
<b>Rem. Useful Life:</b>	9	<b>Cost Source:</b>	GeoReserves Database
<b>Vendor:</b>			
<b>Description:</b>	This component includes replacing the entire gate operator unit. During the normal life of these gate operators certain parts, such as battery backups, circuit boards and motors may need to be repaired or replaced. For most associations, these minor costs should be considered an operating expense. Gate operators should last between 10 to 12 years however the actual life could be longer if individual parts are routinely replaced. Additional information can be found at <a href="http://www.dasma.com">www.dasma.com</a> .		
<b>Evaluation:</b>	These gate operators were functioning normally at time of site visit with no problems noted.

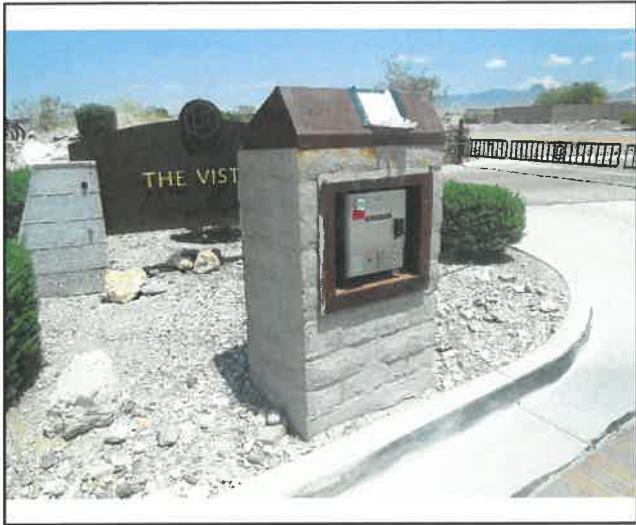
**Comp #: 8.507 Vehicle Gate Entrance System - Replace**

<b>Evaluation:</b>	<p>This component is functional with no major problems noted.</p>		
<b>Quantity Notes:</b>

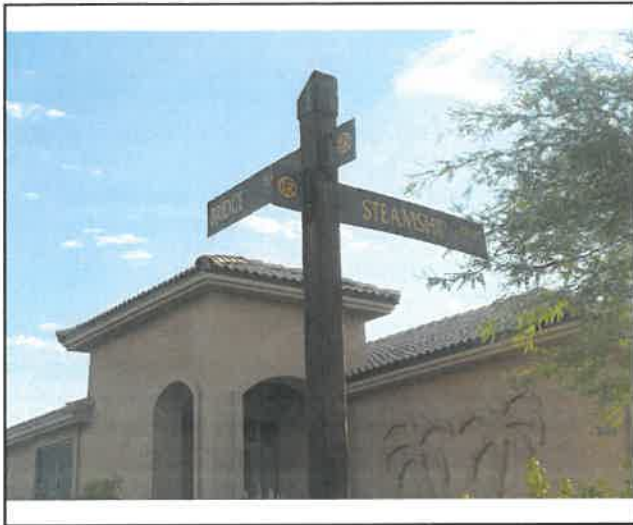
**Comp #: 9.101 Street Signs - Replace**

<b>Evaluation:</b>	These street signs are aging normally.		
<b>Quantity Notes:</b>

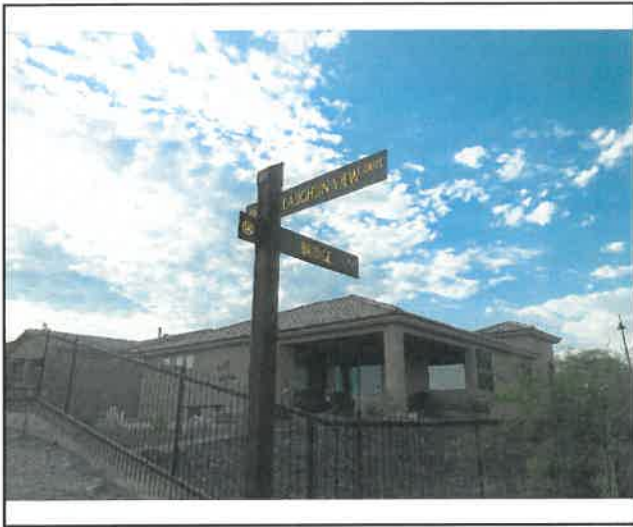
**Comp #: 9.102 Street Sign Poles - Repaint**

<b>Quantity:</b>	7 Sign Poles	<b>Unit Cost:</b>	\$75.00
<b>Orig. Service:</b>	2012	<b>% of Unit Cost:</b>	100.0%
<b>Useful Life:</b>	5	<b>Total Current Cost:</b>	\$525.00
<b>RUL Adjustment:</b>	1	<b>Cost Explanation:</b>	Estimate to repaint
<b>Rem. Useful Life:</b>	0	<b>Cost Source:</b>	GeoReserves Database
<b>Vendor:</b>			
<b>Description:</b>	This component includes repainting and repairing the street sign poles. These poles should be painted and inspected for repairs approximately every 5 years or when necessary. With proper maintenance the poles should have an extended useful life with no expectation to replace.		
<b>Evaluation:</b>	These street poles appear faded and should be painted in the near future.		
<b>Quantity Notes:</b>

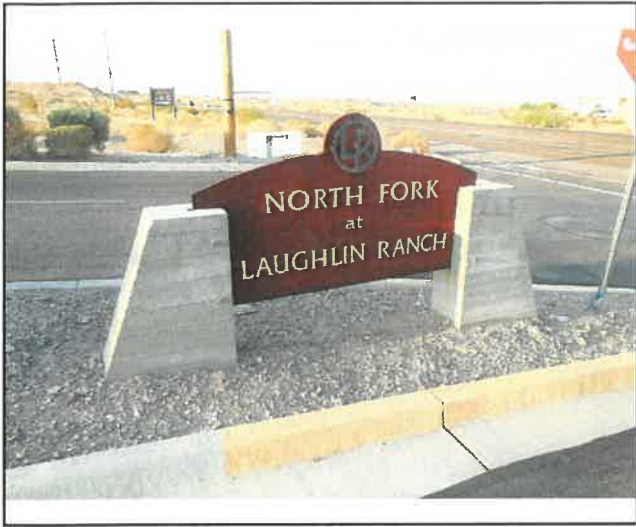
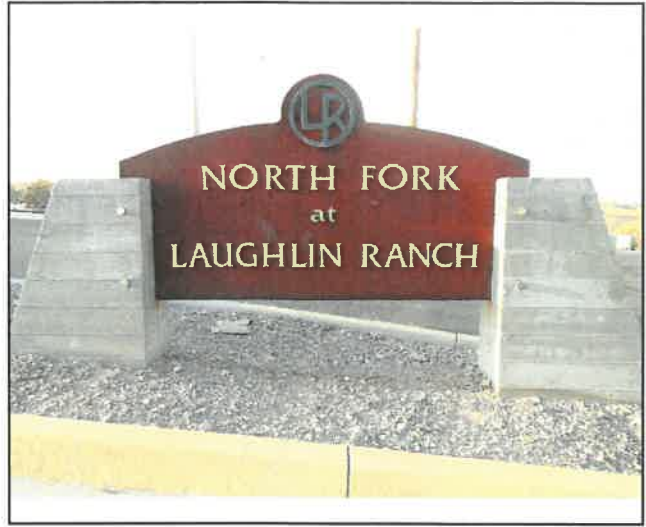
**Comp #: 9.104 Monument - Refurbish**

<b>Quantity:</b>	1 Monument	<b>Unit Cost:</b>	\$5,000.00
<b>Orig. Service:</b>	2013	<b>% of Unit Cost:</b>	100.0%
<b>Useful Life:</b>	20	<b>Total Current Cost:</b>	\$5,000.00
<b>RUL Adjustment:</b>	0	<b>Cost Explanation:</b>	Estimate to refurbish
<b>Rem. Useful Life:</b>	15	<b>Cost Source:</b>	GeoReserves Database
<b>Vendor:</b>			
<b>Description:</b>	Monuments can come in a wide range of sizes, materials, and designs. However, over time they will eventually need to be updated to maintain appearance and to keep a current look. This component can include a general refurbishment or a complete replacement. The cost and useful life of this project can vary depending on what type of monument the association has installed. Any minor repairs should be done regularly as an operating expense.		
<b>Evaluation:</b>	No major appearance concerns noted. The Remaining Useful Life is based on both age and overall condition.

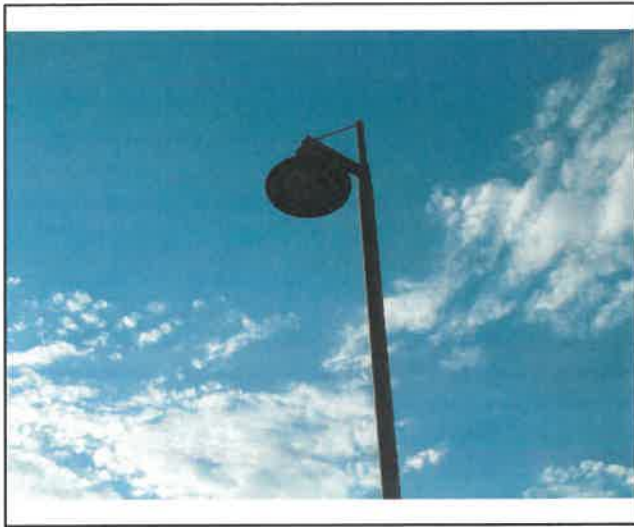
**Comp #: 9.111 Street Light Fixtures - Replace**

<b>Evaluation:</b>	<p>No problems with these street light fixtures noted at time of site visit. However, this community should regularly inspect these lights during nighttime hours to check for any issues.</p>		
<b>Quantity Notes:</b>

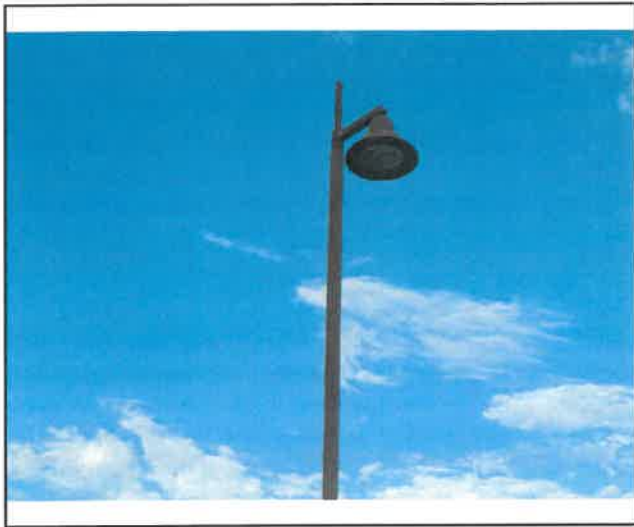
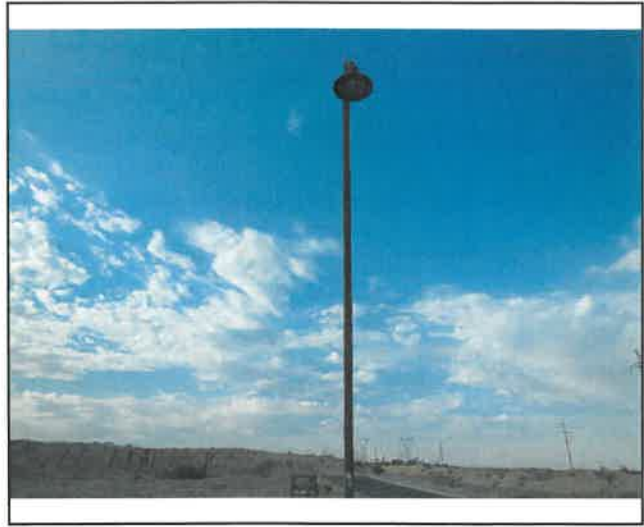
**Comp #: 9.112 Street Light Poles - Repaint**

<b>Quantity:</b>	10 Light Poles	<b>Unit Cost:</b>	\$125.00
<b>Orig. Service:</b>	2012	<b>% of Unit Cost:</b>	100.0%
<b>Useful Life:</b>	5	<b>Total Current Cost:</b>	\$1,250.00
<b>RUL Adjustment:</b>	1	<b>Cost Explanation:</b>	Estimate to repaint
<b>Rem. Useful Life:</b>	0	<b>Cost Source:</b>	GeoReserves Database
<b>Vendor:</b>			
<b>Description:</b>	This component includes repainting and repairing the street light poles. These poles should be painted and inspected for repairs approximately every 5 years or when necessary. With proper maintenance the poles should have an extended useful life with no expectation to replace.		
<b>Evaluation:</b>	These poles should be painted in the near future.		
<b>Quantity Notes:</b>

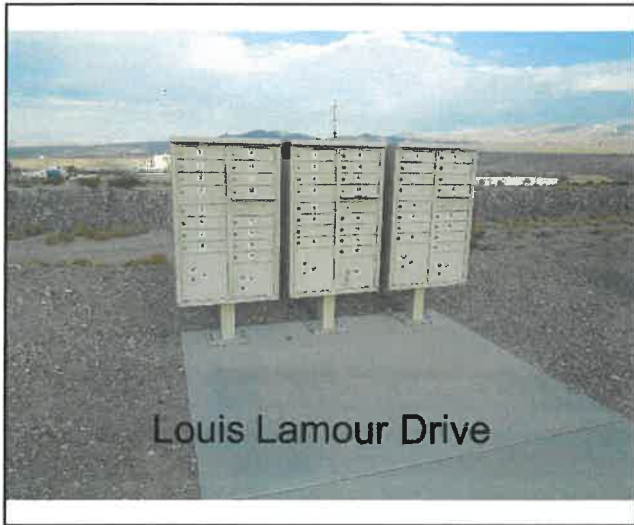
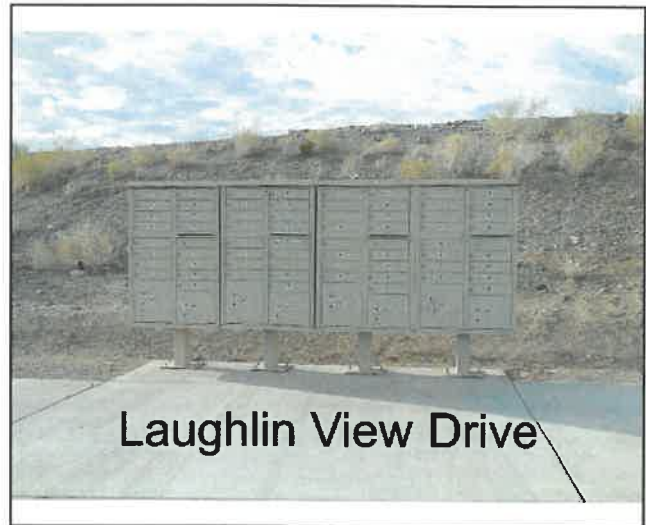
**Comp #: 9.117 Mailbox Cluster Box Units (CBUs) - Replace**

<b>Evaluation:</b>	Usually these CBUs will show some minor cosmetic issues such as faded or peeling paint. However, no major functionality problems were noted at time of site visit.		
<b>Quantity Notes:</b>

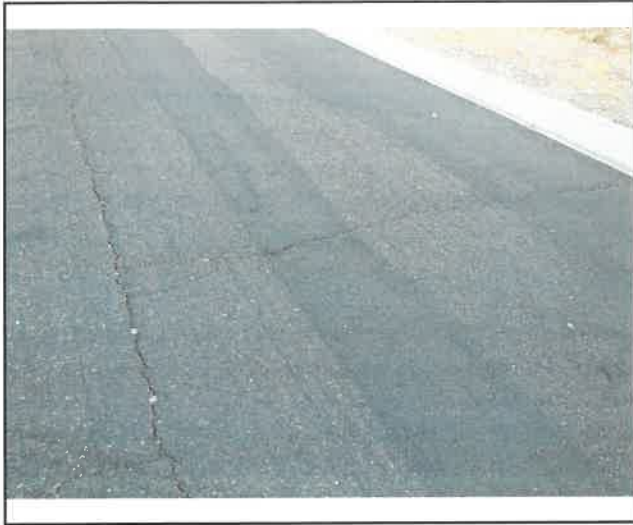
**Comp #: 9.201 Asphalt - Preservation**

<b>Evaluation:</b>	This asphalt should have some type of preservation treatment applied in the near future.		
<b>Quantity Notes:</b>

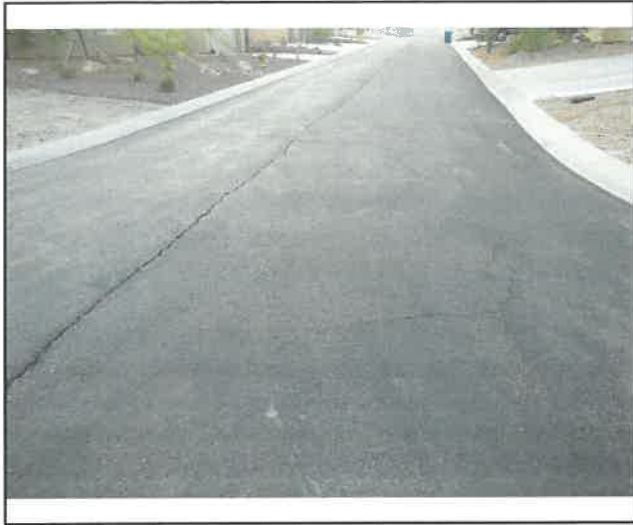
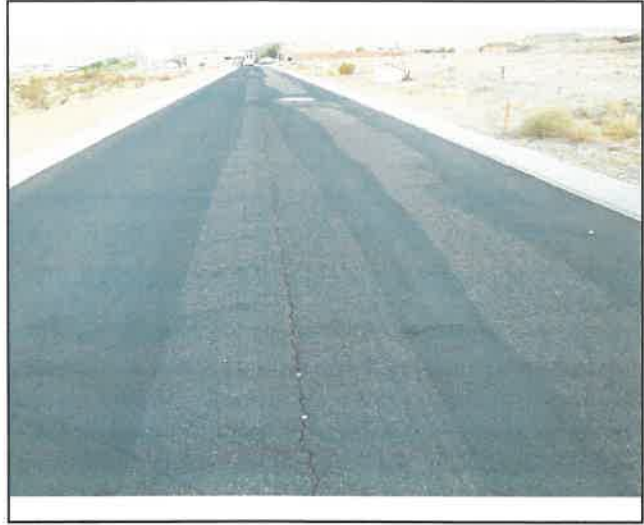
**Comp #: 9.204 Asphalt - Major Rehab**

<b>Evaluation:</b>	No problems noted.		
<b>Quantity Notes:</b>

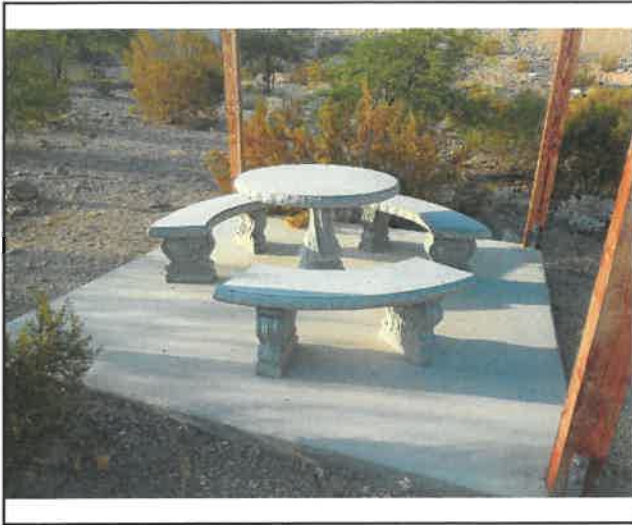
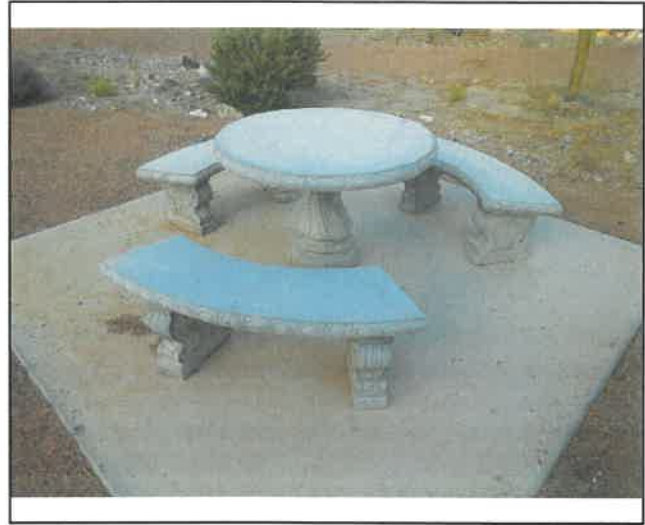
**Comp #: 9.601 Park Furniture - Replace**

<b>Quantity:</b>	3 Tables	<b>Unit Cost:</b>	\$4,000.00
<b>Orig. Service:</b>	2014	<b>% of Unit Cost:</b>	100.0%
<b>Useful Life:</b>	20	<b>Total Current Cost:</b>	\$12,000.00
<b>RUL Adjustment:</b>	0	<b>Cost Explanation:</b>	Estimate to replace
<b>Rem. Useful Life:</b>	16	<b>Cost Source:</b>	GeoReserves Database
<b>Vendor:</b>			
<b>Description:</b>	This component includes the concrete tables and their benches. These concrete items should have a life expectancy of 20 years or longer depending on the amount of use.		
<b>Evaluation:</b>	No problems with these tables or benches noted.		
<b>Quantity Notes:</b>	Quantity breakdown: 3 Tables with Benches

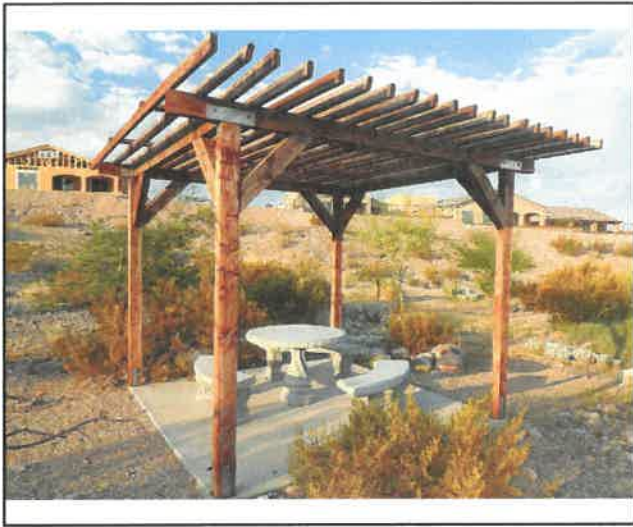
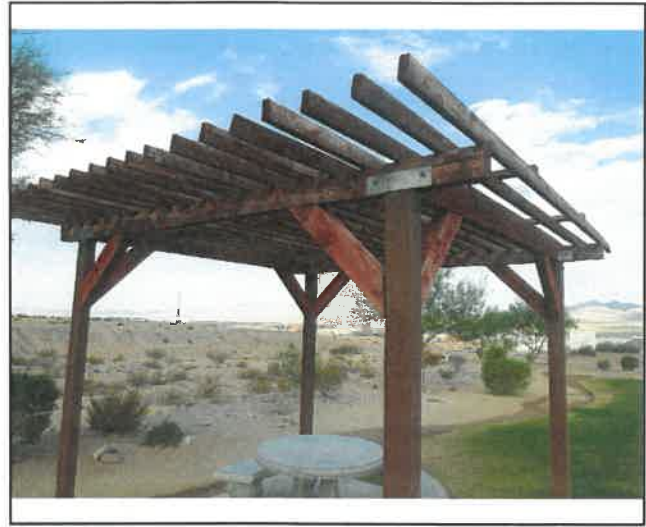
**Comp #: 9.612 Shade Structure - Replace**

<b>Quantity:</b>	2 Structures	<b>Unit Cost:</b>	\$4,000.00
<b>Orig. Service:</b>	2014	<b>% of Unit Cost:</b>	100.0%
<b>Useful Life:</b>	20	<b>Total Current Cost:</b>	\$8,000.00
<b>RUL Adjustment:</b>	0	<b>Cost Explanation:</b>	Estimate to replace
<b>Rem. Useful Life:</b>	16	<b>Cost Source:</b>	GeoReserves Database
<b>Vendor:</b>			
<b>Description:</b>	This component includes replacing the wood shade structures. These structures should be sealed and maintained regularly as an operating expense. This component has been given a 20 year useful life but that can be adjusted as these structures age, depending on the amount of maintenance performed.		
<b>Evaluation:</b>	These shade structures need to be sealed and stained. No structural problems noted.		
<b>Quantity Notes:</b>
